**ON ACCIDENT TO
M/S KINGFISHER AIRLINES ATR-72 AIRCRAFT
VT-KAC AT MUMBAI ON 10.11.2009.**

**AIR SAFETY DIRECTORATE
O/o DIRECTOR GENERAL OF CIVIL AVIATION
OPP. SAFDARJUNG AIRPORT, NEW DELHI**

REPORT ON ACCIDENT
TO M/S KINGFISHER AIRLINES ATR-72 AIRCRAFT
VT-KAC AT MUMBAI ON 10.11.2009.

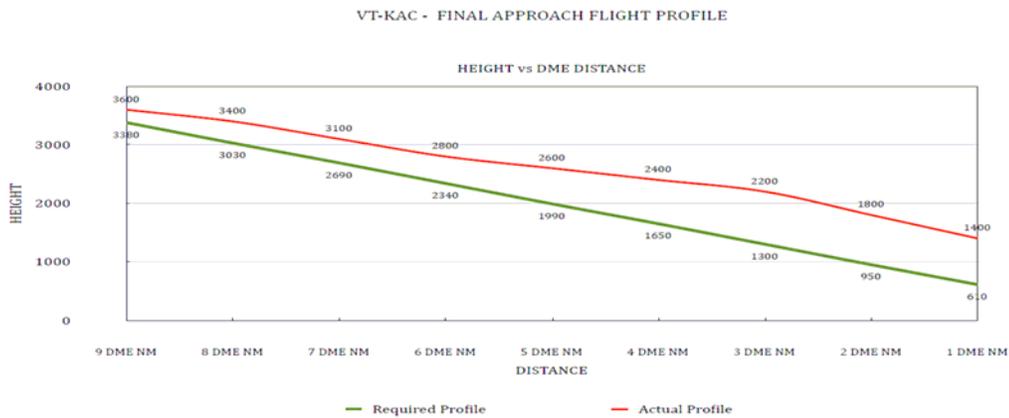
The crew had felt that although the speed was high, they corrected the speed using the condition lever in the full forward position and that correction were adequate enough to make a normal landing and stop the aircraft. Even below 500 ft the rate of descent was high and a maximum value of -2040 ft/min was reached at the radio altitude of 291 ft. The high sink rate warning was continuous till touchdown. The aircraft was high on the approach profile as at one DME from Touch down actual height was 1400 ft against the required height of 610 ft. At 4 DME , ATC had advised the crew to check altitude as they were high. Thus decision of the crew to continue was not in accordance with requirements of the company’s operations manual and regulatory instructions.

Though aircraft managed to touchdown with a speed of 103 kts but it consumed almost 700 meters of the landing distance before touchdown. The crew was left with only 1000 meters of landing distance against the required distance of 960 meters. Considering the weather condition and condition of R/w it was not appropriate decision of the crew to continue and land.
