AIRCRAFT ACCIDENT REPORT AND EXECUTIVE SUMMARY

Reference:	CA18/2/3/8719								
Aircraft Registration	ZS-SJW	Date of Accident	7 December 2009		Time of Accident	0901Z							
Type of Aircraft	Embraer 135-LR (Aeroplane)			Type of Operation	Domestic Schedule								
Pilot-in-command Licence Type		Airline Transport	Age	39	Licence Valid	Yes							
Pilot-in-command Flying Experience		Total Flying Hours	11 973,5		Hours on Type	2 905,8							
Last point of departure		Cape Town International Airport (FACT), Western Cape province											
Next point of intended landing		George Airport (FAGG), Western Cape province											
Location of the accident site with reference to easily defined geographical points (GPS readings if possible)													
On the R404, a public road adjacent to the aerodrome (geographical co-ordinates: S34°00.306' E022°23.534')													
Meteorological Information	Surface wind: 090°/2-5 kt; Temperature: 20°C; Cloud base: 8 000 ft, with light rain

The crew were unable to decelerate the aircraft to a safe stop due to ineffective braking of the aircraft on a wet runway surface, resulting in an overrun.

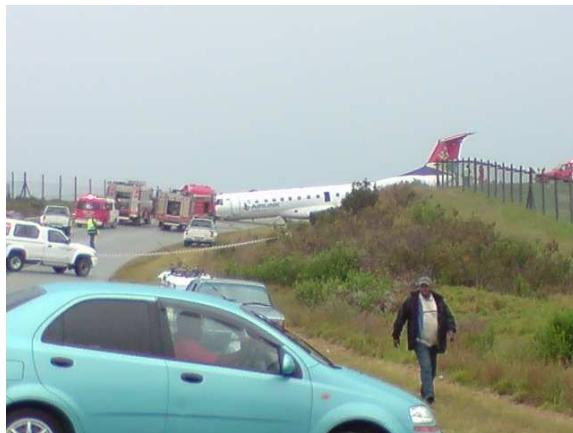
Figure 1(b): The size and angle of the embankment can be seen here.

- 1.4.1 No damage was caused to the runway surface. The PF managed to steer the aircraft to the right of the runway centreline, avoiding the ILS localiser antenna structure 163 m from the end of the runway stop-way. The aircraft then struck and damaged eleven runway approach lights before bursting through the aerodrome perimeter fence. About 100 m of wire-mesh and six wooden supports had to be replaced.
- 1.4.2 Minor damage was caused to the road surface and surrounding vegetation. The fuel tanks remained intact and no leakage occurred. All the fuel was drained from the aircraft prior to recovery.

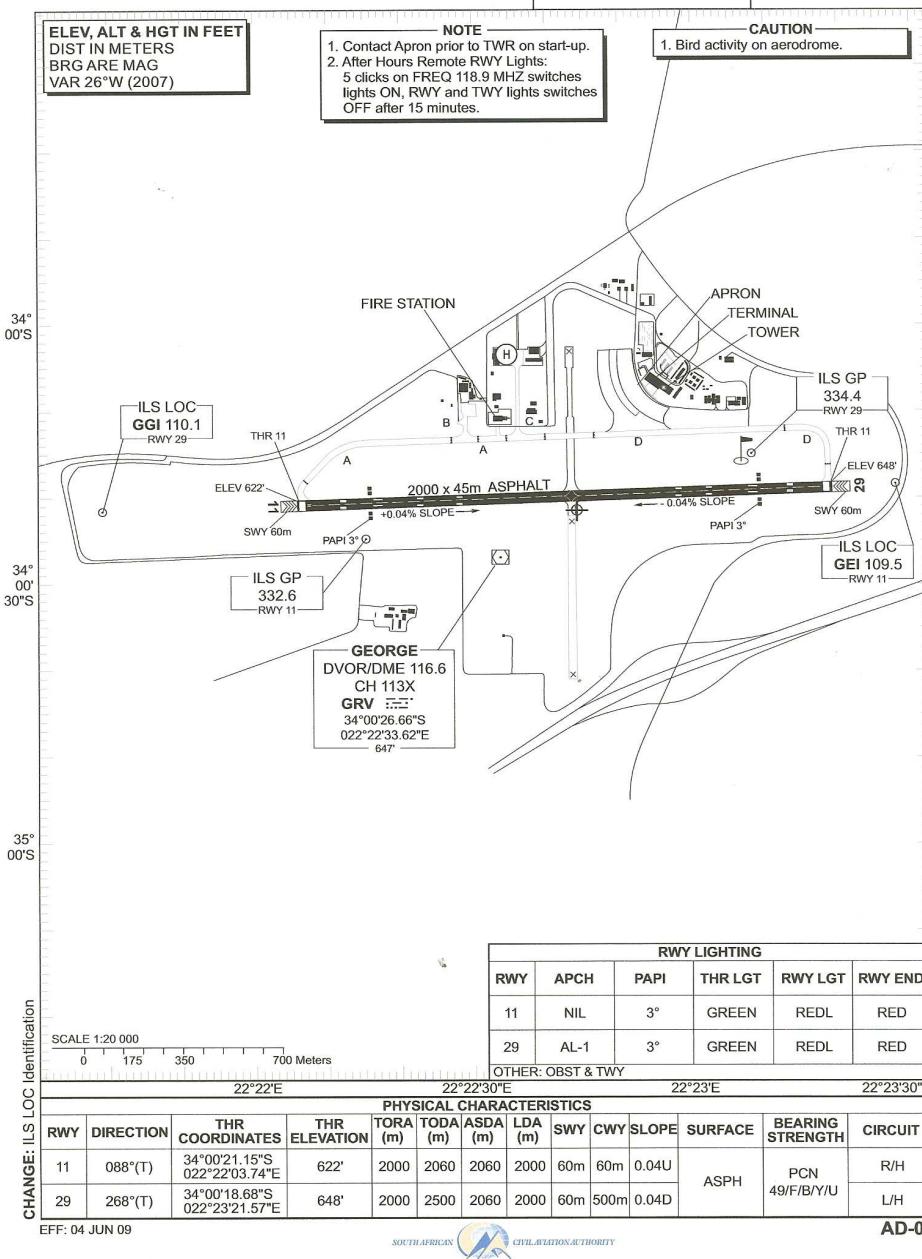
Figure 10: George aerodrome chart as published at the time of the accident.
Source: SACAA website (www.caa.co.za).

The chart contained two errors. The upslope and downslope of the runway – indicated as + 0,04% and – 0,04% – should read + 0,4% and – 0,4%. And the latitude reading shown as 35°00'S on the lower left vertical axis should be 34°01'00"S.

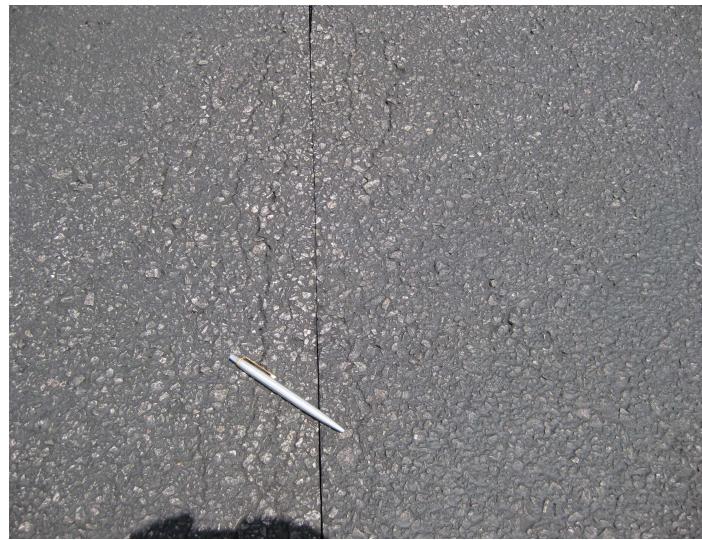
In 1989, slots were cut into runway 11 west of the intersection of runway 11/29 and the old runway 02/20 (now closed). Their purpose was to allow for water drainage, but they were not cut according to internationally accepted standards for runway grooving, as shown in Figures 14(a) and (b).

Figure 13: One of the closed-up slots.

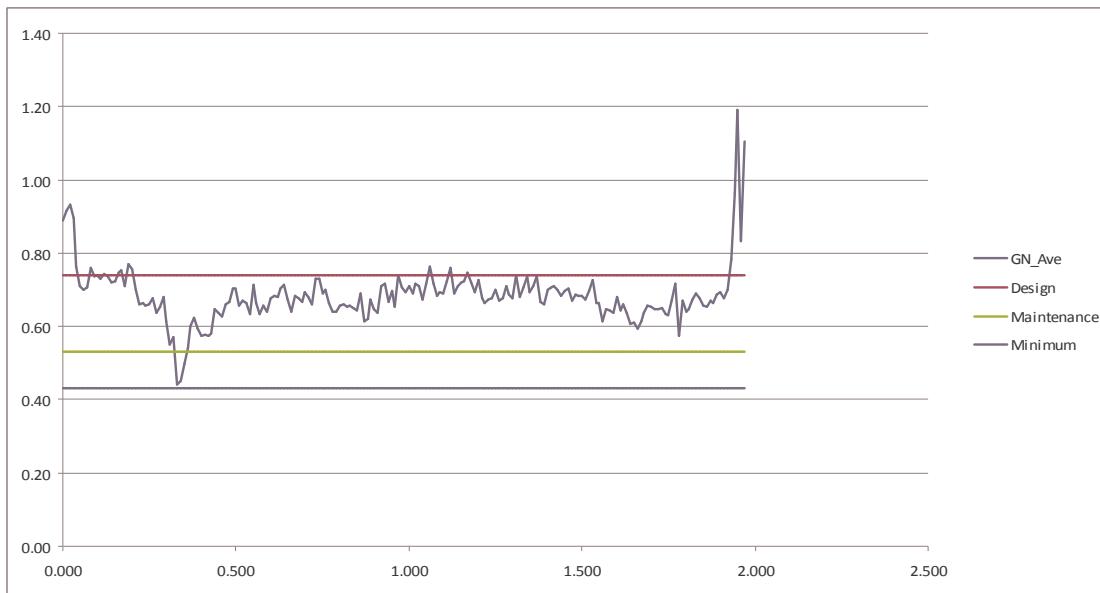
It was decided to treat a small patch of approximately 30 m² on the western side of runway 29 about 300 m from the start of the runway with SP 2000. The GripTester was then passed over the treated patch during its test runs. Analysis of the data indicated that the friction value had fallen to below the minimum friction level over that patch. Figures 16(a) and (b) display the GripTester data for the entire runway length measured at 1 m and 3 m intervals to the left of the centreline of runway 29 respectively. The downward spike about 300 m from the start of runway 29 showed a significant decrease in friction over the SP2000 treated area. The measurement recorded was below the minimum friction level (MFL) of 0,43 (grip number), and reflected the negative effect of the SP2000 on the skid resistance of the runway.

Figure 16(a): Friction test result for runway 29 – taken one metre to the left of the centreline.

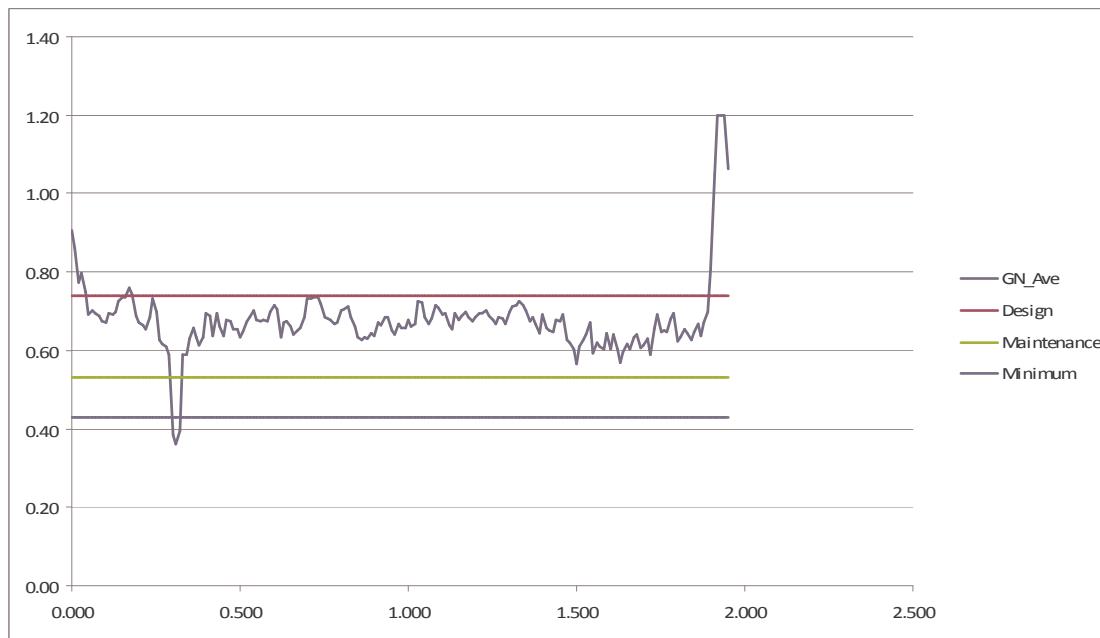
Figure 16(b): Friction test result for runway 29 – taken three metres to the left of the centreline.

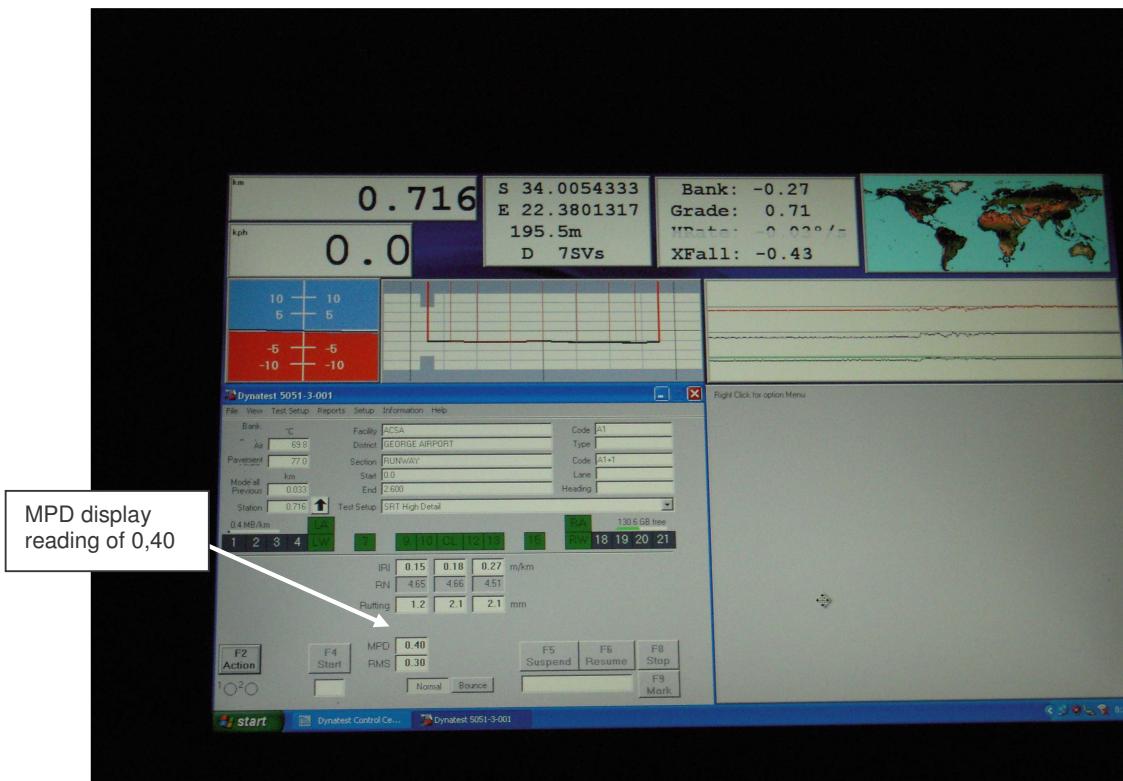
Figure 19: The onboard computer display of the MPD reading of 0,40 and other readings.

The results were obtained from the independent consulting engineering project report dated April 2010. The average texture depth was found to be in the order of 0,63 mm, as shown below. Certain areas on the runway displayed better values than others.

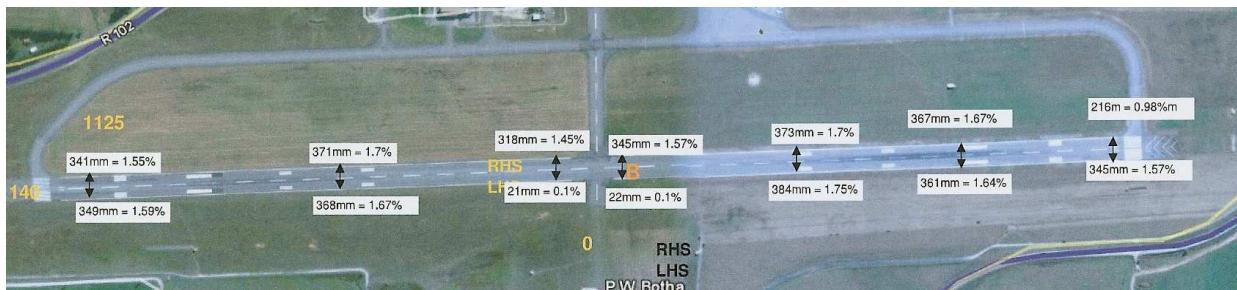
The runway transverse slope, also known as the camber, was measured by an independent service provider, who found an average crossfall of 333 mm left and 264 mm right of the centreline of runway 11. These values equate to 1,52% left and 1,20% right of the centreline (they were obtained from the runway map shown below, which was made available by the aerodrome licence holder).

To the right of the centreline of runway 11, in the area of the intersection, the crossfall was only 21 mm to 22 mm. The camber in the slotted area 36 m to the west of the intersection (see 1.10.5 above) was only 0,1%, which to all intents and purposes means that the runway was flat in this area. However, it did have a longitudinal slope of +0,4%.

Figure 21: Transverse slope data with values and positions.

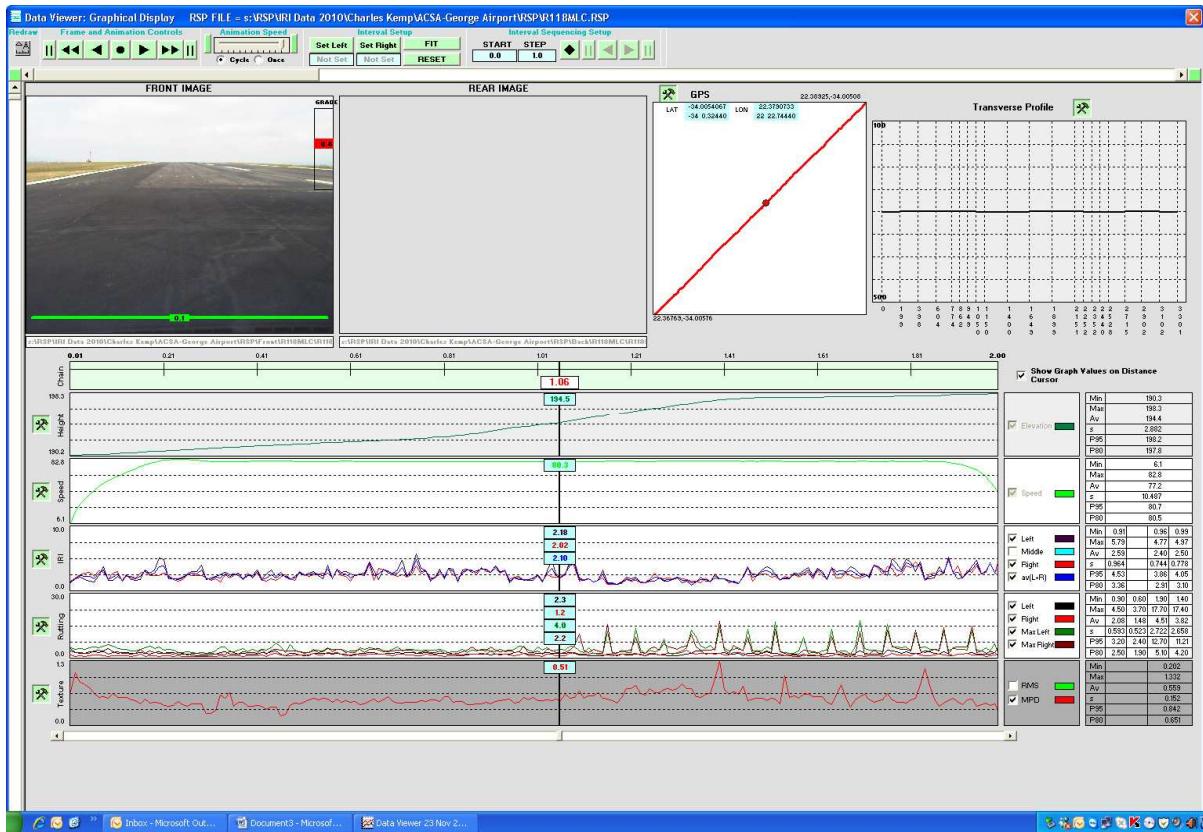
In addition to conducting a friction test on 15 February 2010, a laser profile vehicle was used to measure the runway camber and the international roughness index (IRI), the texture logged as the mean profile depth (MPD) as well as surface rutting. The laser profile software clip in Figure 22 includes a photograph from a video clip taken by the onboard camera of the laser profile vehicle. This displayed a runway camber value of 0,1% taken 8 m to the left of the centreline of runway 11 in the area of the intersection.

Figure 22: Map page from laser profile software, taken 8 m to the left of the centreline of runway 11.

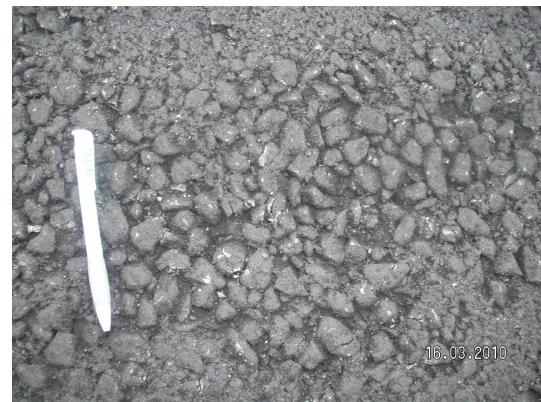
Figure 23(b): Close-up of the milled aggregate, which was 15-20 mm in diameter.

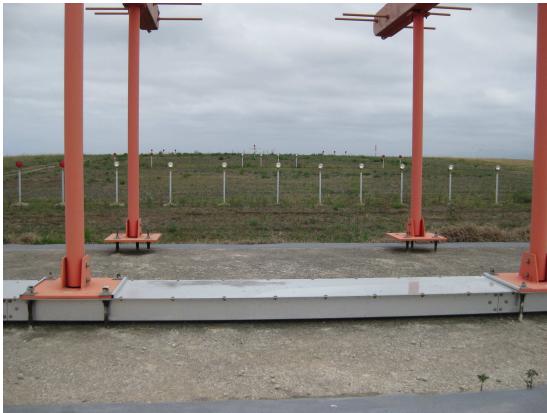
A 60 m asphalt stop-way was located at the end of the runway 11. Between the edge of this stop-way and the localiser antenna was an open grassy area of 163 m sloping downwards at approximately 5°. The antenna was in line with the extended centreline of the runway and fell within the 240 m runway end safety area recommended in paragraph 3.5.3 of ICAO Annex 14, volume I for a code number 3 or 4 runway. Figure 25 below shows the antenna and part of this open area.

Figure 25(a): A view from behind the ILS localiser antenna looking towards the runway

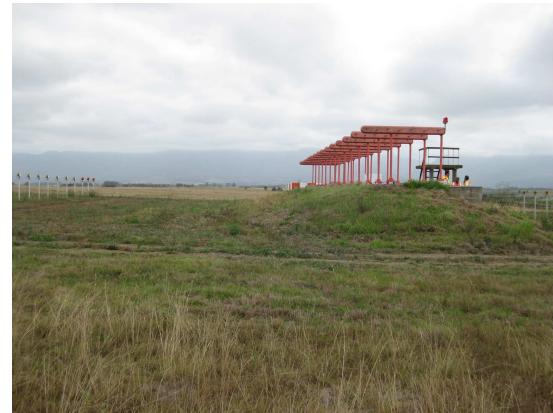
Figure 25(b): A side view of the antenna.

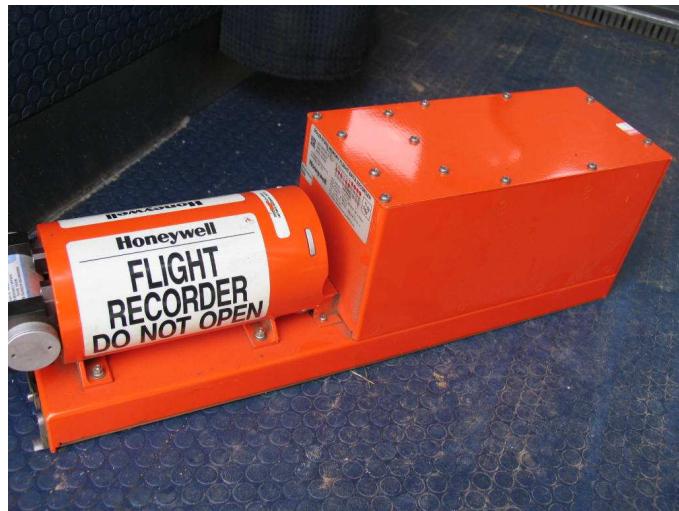
ZS-SJW was equipped with a Honeywell solid-state DFDR, part number 980-4700-042 and serial number SSFDR-07717. The unit was undamaged and there was no apparent impact damage to the ULB, which remained attached to its bracket. A recorder of this type can be downloaded directly without disassembly if there is no damage to the memory module connectors. The unit showed no signs of external damage and the memory board, was found to be in pristine condition. The memory modules, with a 25-hour recording capacity, were successfully downloaded and the data forwarded to Brazil (the State of design and manufacture) for analysis.

Figure 27: The flight data recorder recovered from the aircraft.

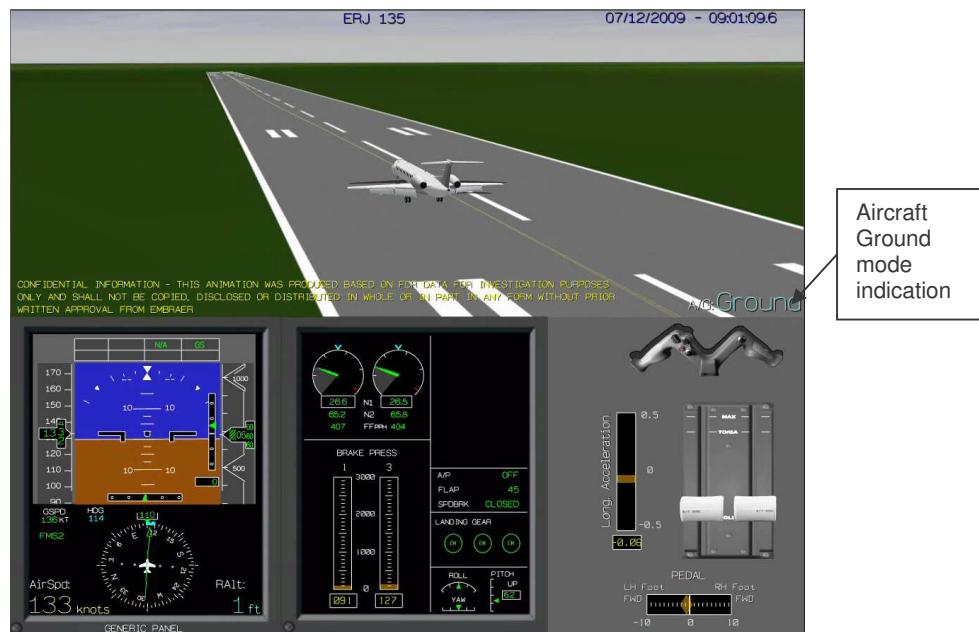
Air/Ground sensors transitioned to “ground” mode for a short period and returned to “air” mode (cycle time of 1,5 seconds). The airspeed indicated was 134 KIAS. (Figure 30 indicates the first touchdown point on the runway, with the aircraft in “ground” mode).

Figure 30: The touchdown point on the runway, with the aircraft in ground mode.

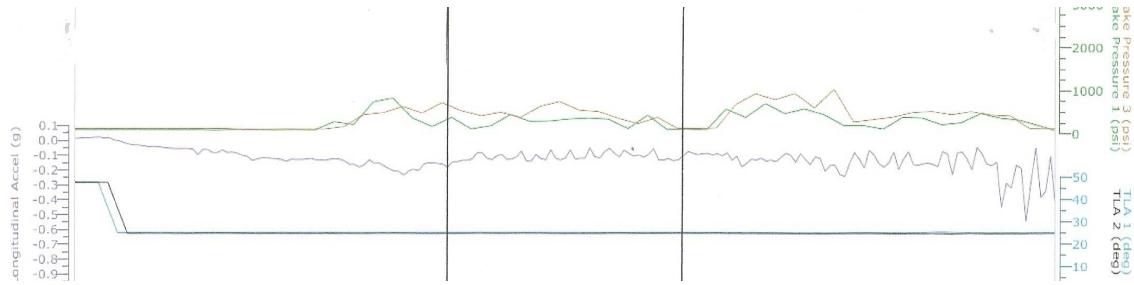
The longitudinal acceleration (g) displays a zigzag pattern that varies between -0,051g to -0,178g (average deceleration over this period was calculated to be -0,106g) with a variation in brake pressure of between 100 to 750 psi (see Figure 31 – applicable area between the two vertical lines; for a detailed DFDR graph, see Figures 32(a) and (b)).

Figure 31: Longitudinal acceleration (g) of ZS-SJW during landing rollout.

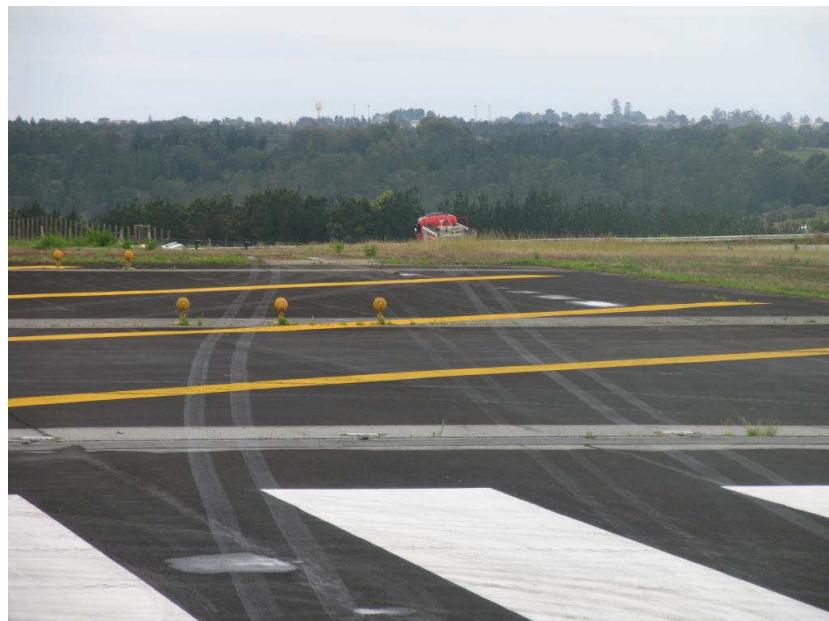
Tyre markings from the left and right main gear as well as the nose gear were evident to the right of the centreline towards the end of runway 11. The markings continued beyond the 60 m asphalt stop-way area and onto a grassy area that sloped downwards at approximately 5°. The pilot managed to avoid hitting the ILS localiser antenna on a concrete platform 163 m past the end of the stop-way by swerving to its right.

Figure 34: The tyre tracks indicating where the aircraft overran the runway surface onto the stop-way.

Figure 34 shows curved, light-coloured tracks from the tyres of the accident aircraft. These have the characteristics of viscous hydroplaning as described in the NTSB-AAR-73-13 report, of which a brief summary is contained in paragraph 1.18.8.

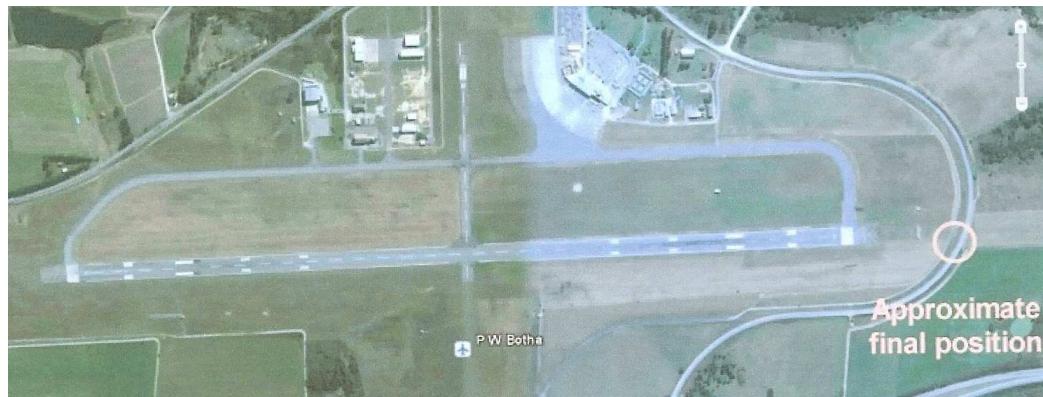
Figure 37: Final position of ZS-SJW.

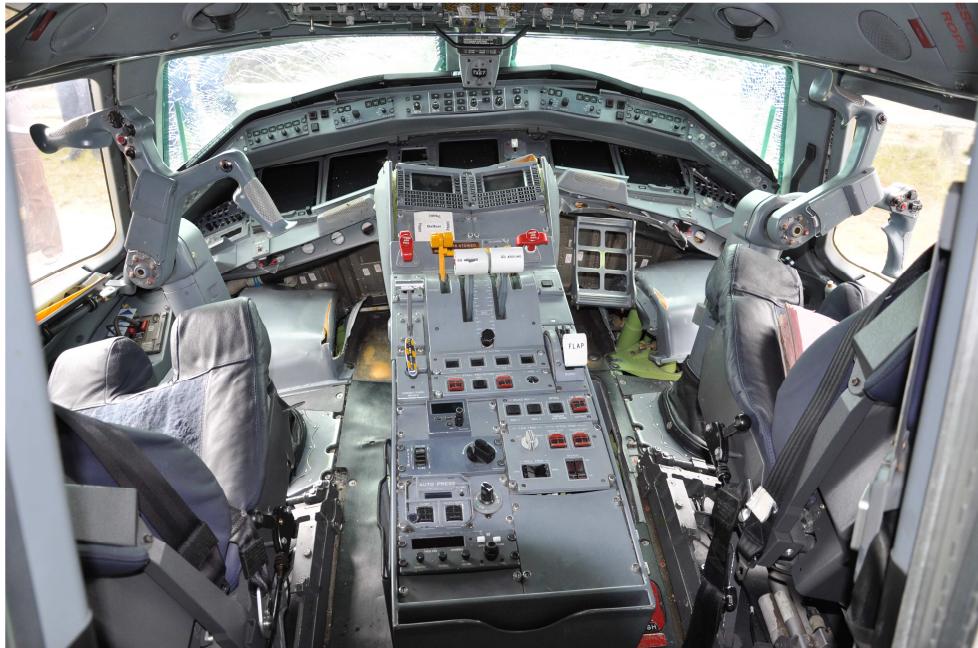
Both seats experienced high vertical forces during the accident sequence. The first officer's seat was substantially more elevated than that of the PIC, with the control column being pushed up nearly all the way to the roof structure.

Figure 42: Deformation of the cockpit resulting from the collapse of the nose gear.

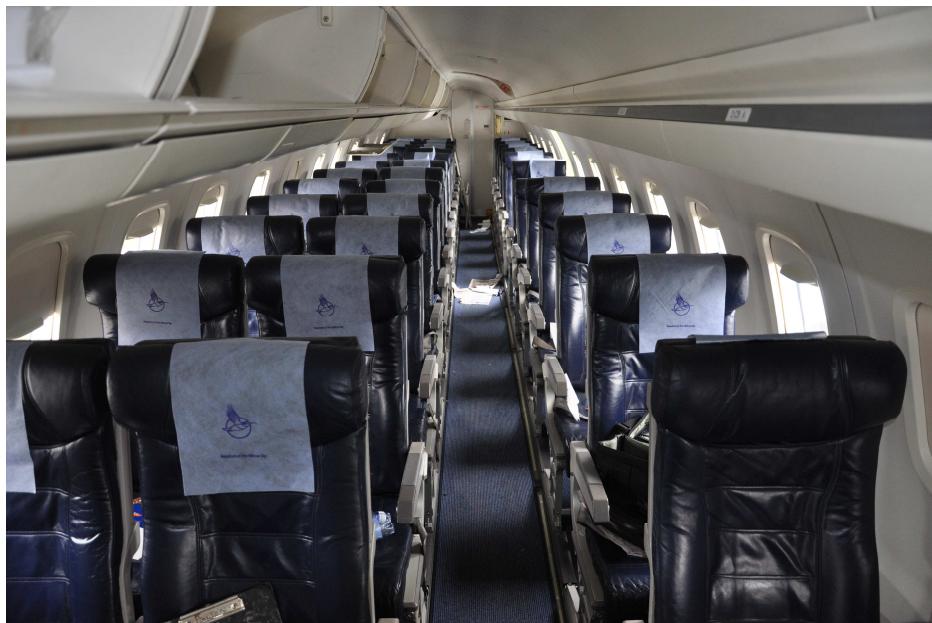
All passengers were wearing the aircraft-equipped safety harnesses (lap straps). The backrest in seat 7A collapsed partially and was found at a 45° angle. The passengers in seats 2A and 3A were travelling with infants who were seated on their laps and secured to their mothers' harnesses by infant safety harnesses (loop straps).

Figure 44: The cabin viewed from the front of the aircraft.

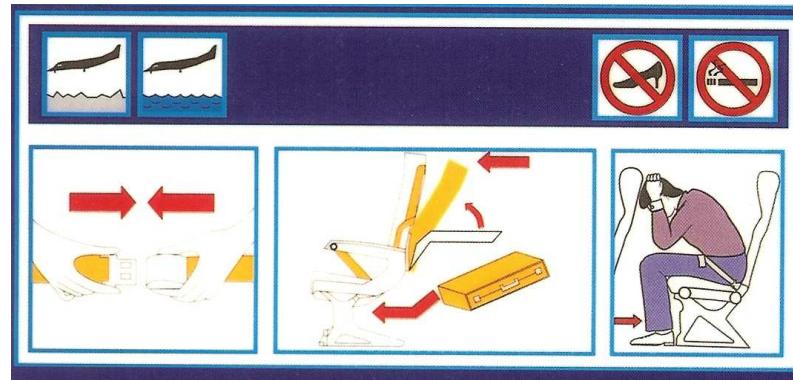
On flight SA8625, the safety information cards in the seat pockets in front of each passenger displayed only one brace position: bending forward and holding one's head with both hands. In addition, it was reported that the brace position depicted on the safety information cards was accepted by the SACAA as adequate.

Figure 49: Extract from the on-board safety card reflecting one brace position only.

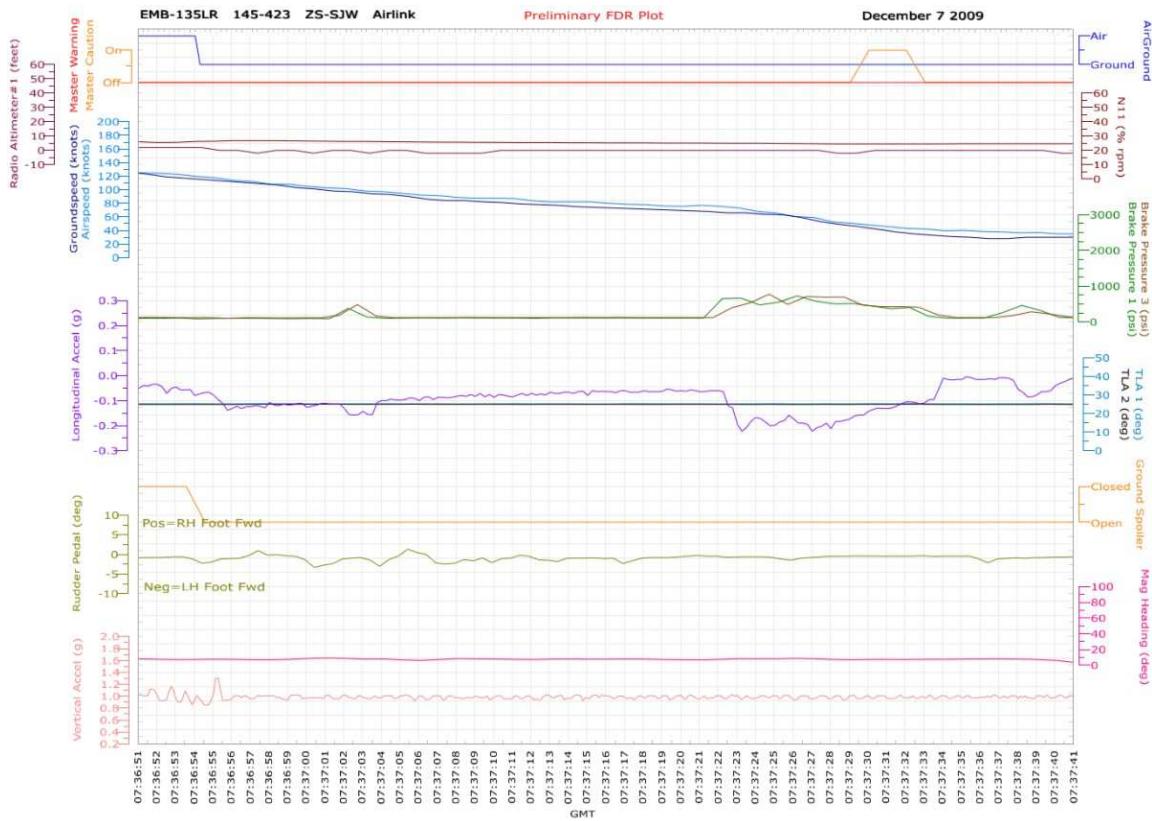
The landing at FACT (Figure 54), the departure destination for the aircraft prior to the landing at FAGG, was also conducted on a wet runway surface. The PF stated that during the landing at Cape Town he had experienced some hydroplaning but had been able to control the aircraft and bring it to a safe stop within the runway surface available. It was evident from the DFDR data that good braking action was obtained during brake application, with a deceleration of approximately -0,2g being obtained over a five-second time-frame, with an average brake pressure of approximately 800 psi. This was followed by a further deceleration of approximately -0,14g for another five seconds. The runway was 1 200 m longer than that at FAGG.

Figure 54: Landing #5, Cape Town International Airport, 7 December 2009.
Runway length 3 200 m, elevation 151 ft.

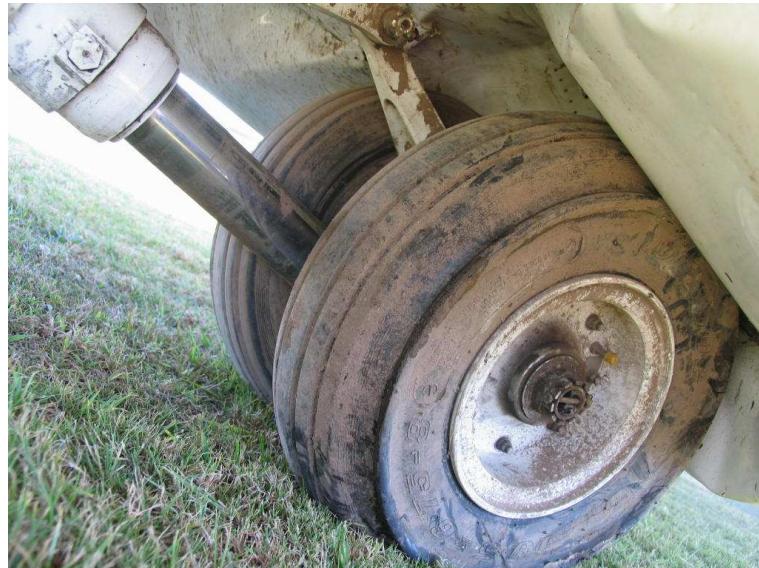
Both nose wheel tyres were found to be deflated, a fact attributed to impact damage. However, they displayed adequate tread depth. All four main tyres, which remained inflated, showed evidence of viscous hydroplaning. Two of the main tyres displayed a tread depth of approximately 0,5 mm.

Figure 55(a): The nose wheel tyres.

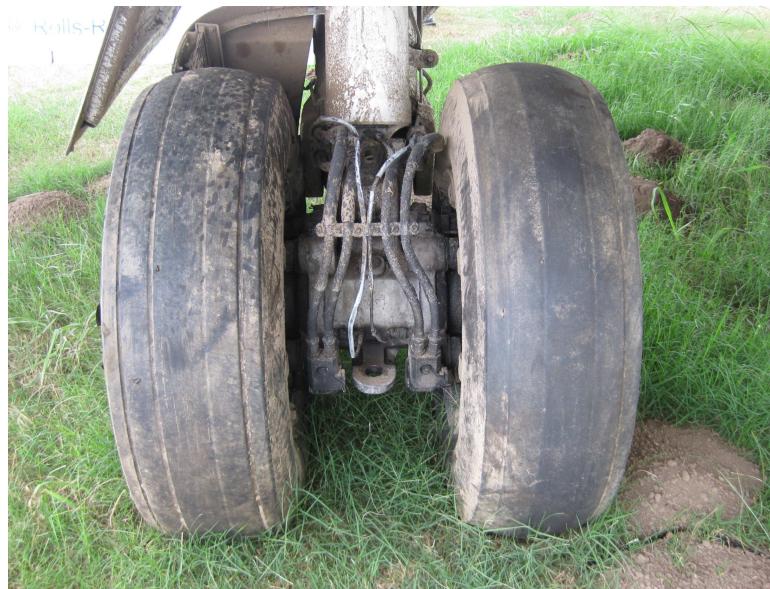
Figure 55(b): The left main gear tyres.

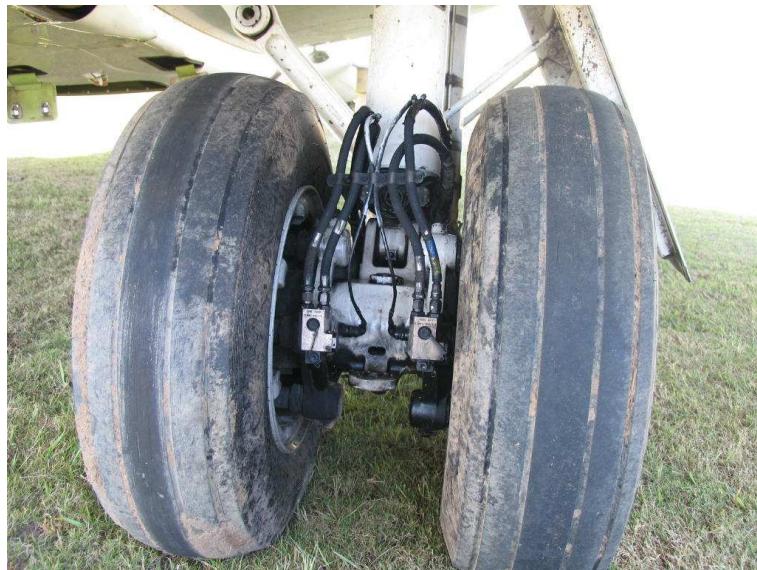
Figure 55(c): The right main gear tyres.

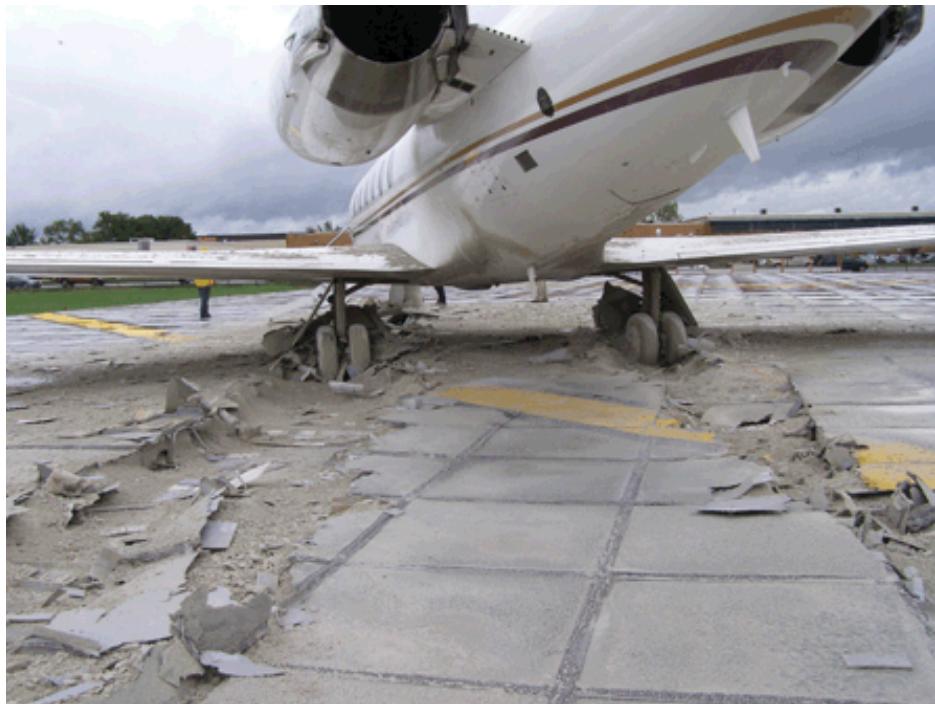
It is the opinion of the investigation team that an EMAS installed at the departure end of runway 11 could have stopped the accident aircraft and prevented it from bursting through the perimeter fence. Figure 56 shows an aircraft arrested by an EMAS, which consisted of covered blocks of crushable concrete and was located directly beyond the end of the runway. The concrete is designed to slow and stop an aircraft that overruns the runway.

Figure 56: A Cessna Citation 550 that overran the runway at Key West International Airport, Florida, USA. Note the crushable concrete blocks.

It is acknowledged that a 300 m RESA may be impracticable on the overrun area of runway 11 due to the ILS localiser antenna structure and the R404 public road running parallel to the aerodrome perimeter fence, 280 m beyond the end of the runway. An alternative means of compliance, such as an Engineered Material Arresting System (EMAS) to provide a level of safety equivalent to a 300 m RESA, should therefore be considered.

At the time of writing, EMAS is not a regulatory requirement in South Africa and has not been installed at a single aerodrome in South Africa. Considering the proven advantages of the system, and the nature of the SA8625 accident at FAGG, it is recommended that the system be implemented without delay at the country's major aerodromes in the interest of aviation safety. Compliance with EMAS would require that these aerodromes have the appropriate safety measures in place to avoid a similar accident to the one involving SA8625. The EMAS is considered a much safer system than a prepared RESA, as a RESA is just a cleared space that is not designed to stop the aircraft and may end in disaster.

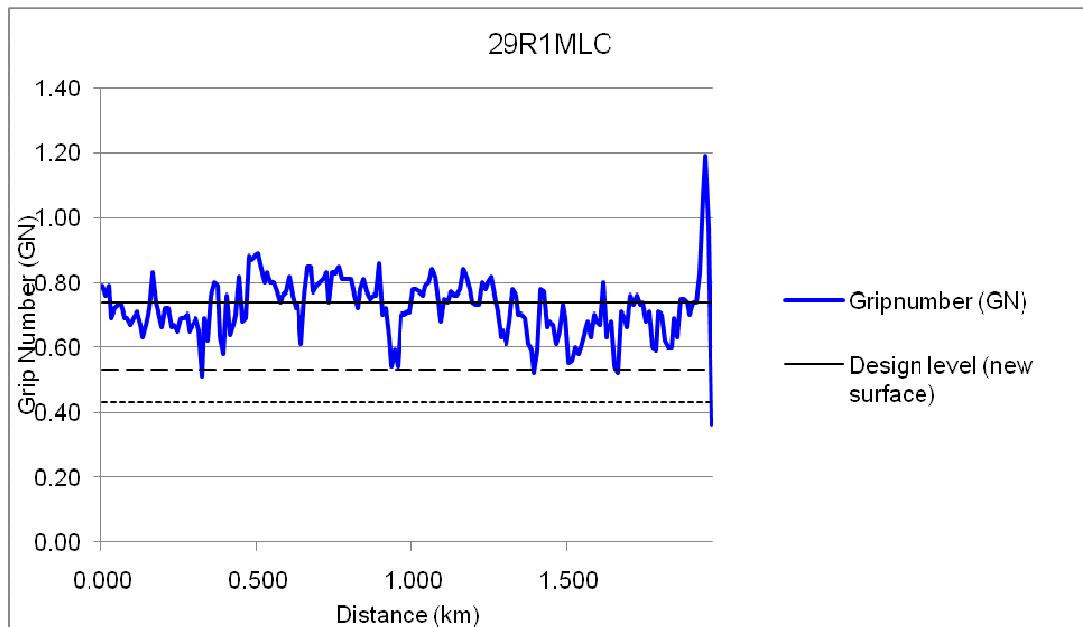
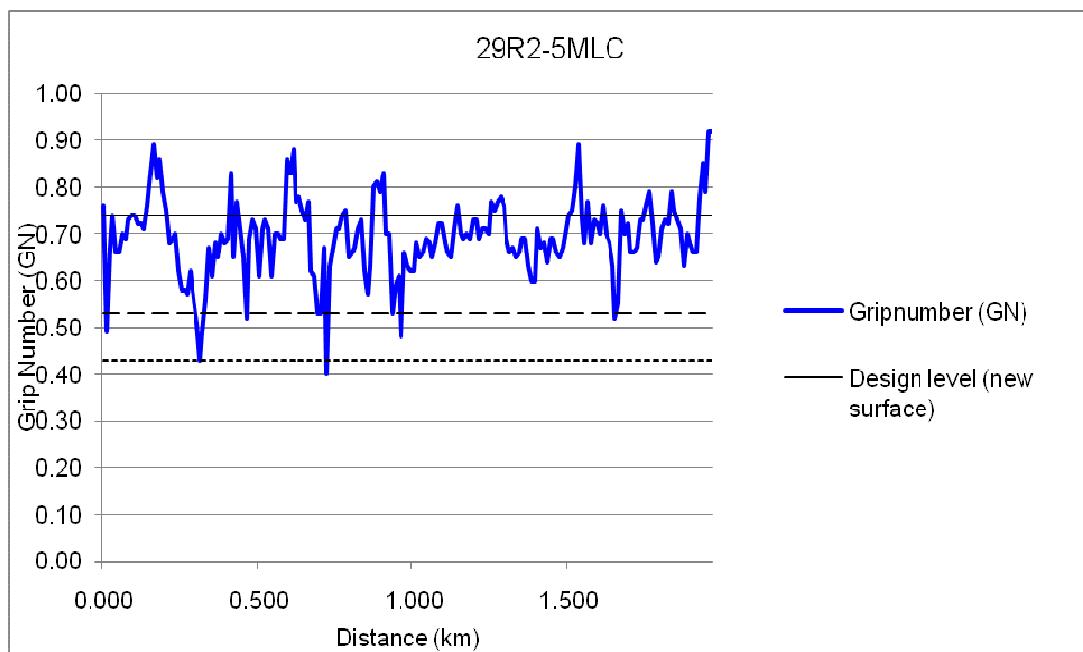
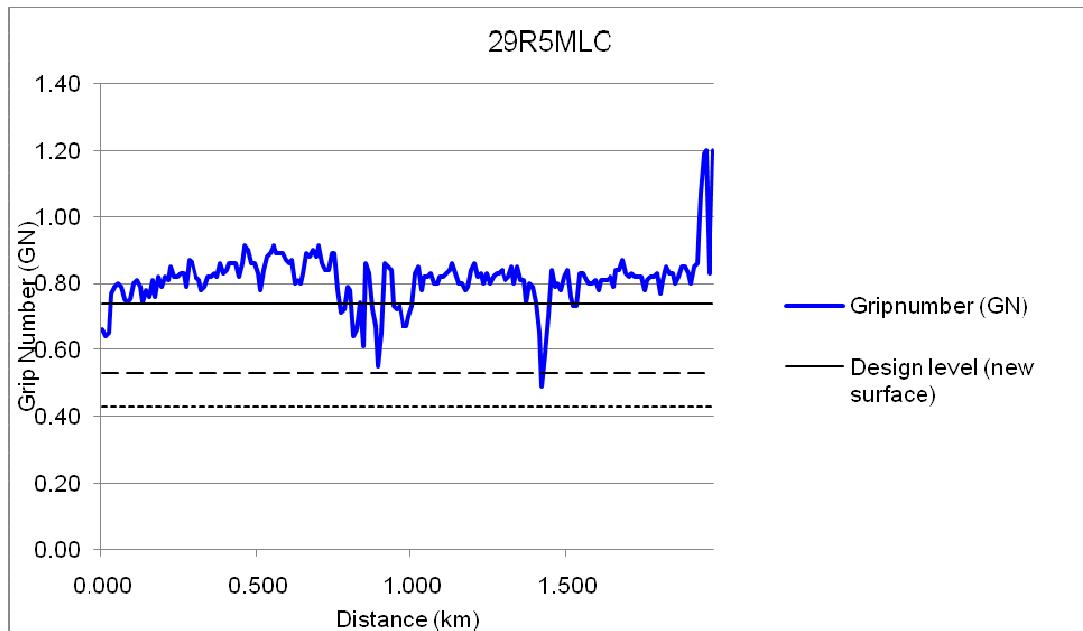
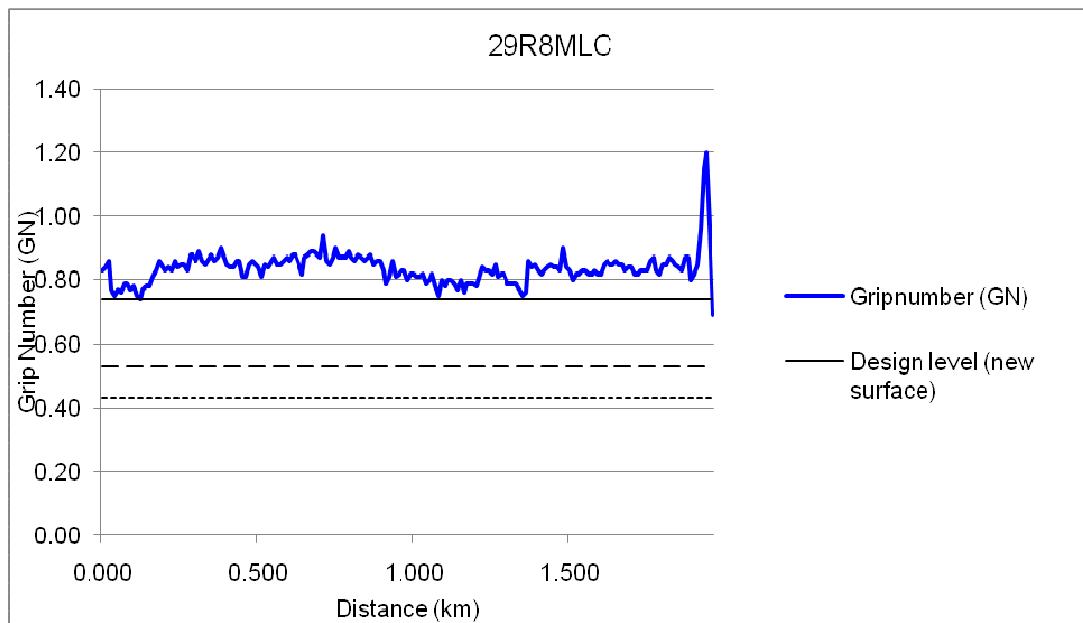
9 December 2009

Runway 29, left of the centreline. Friction measurements at 65 km/h.

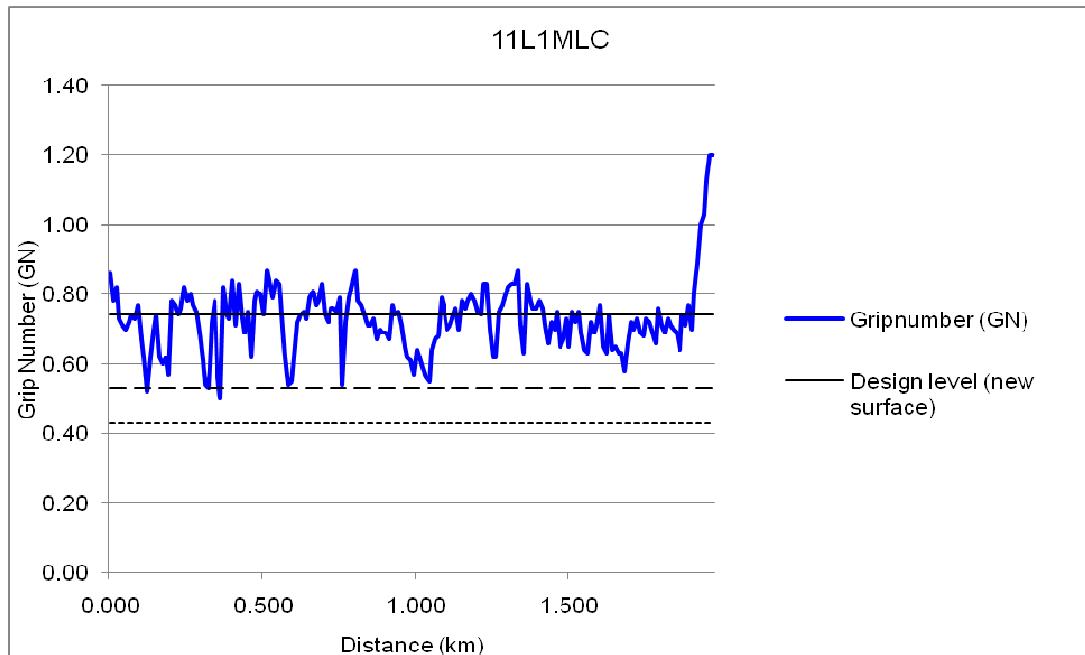
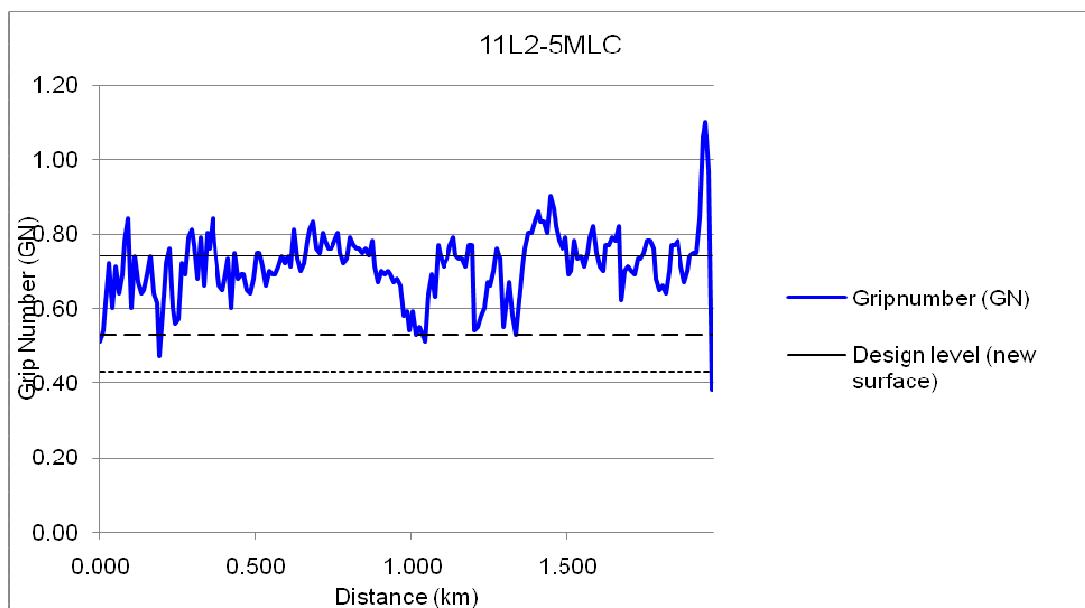
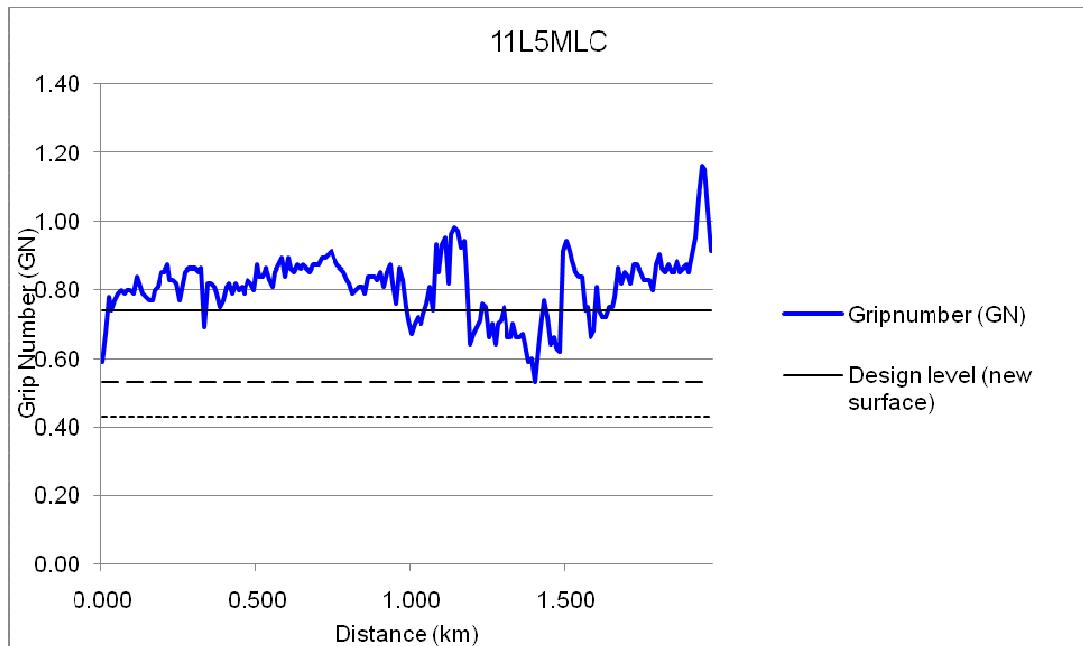
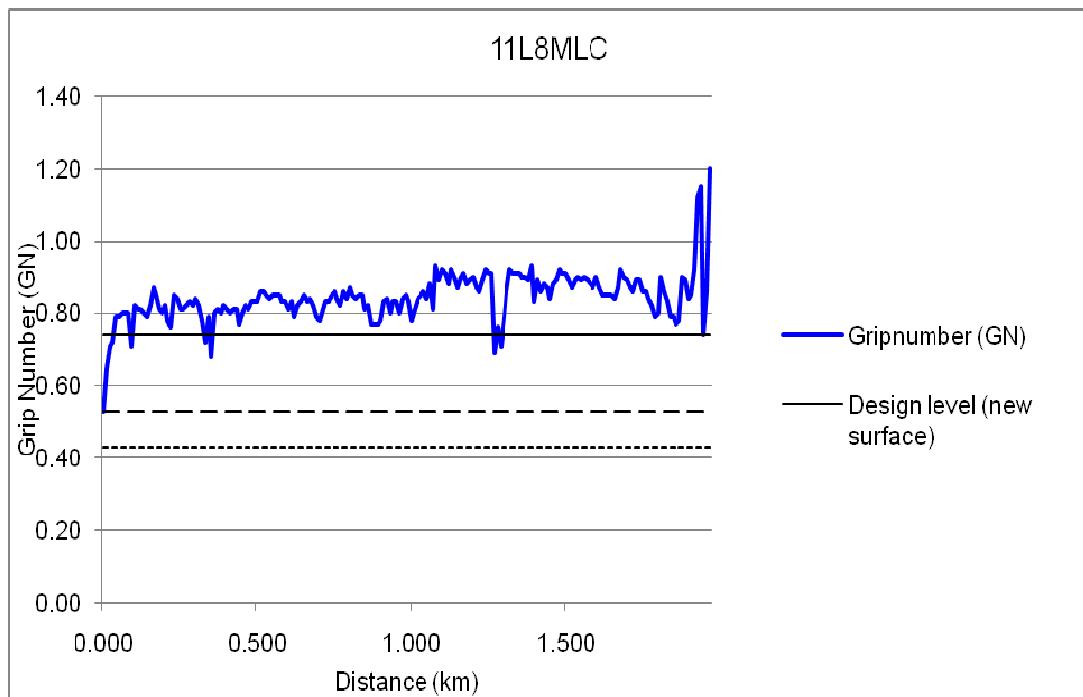
9 December 2009

Runway 11, left of the centreline. Friction measurements at 65 km/h.
