AIRCRAFT ACCIDENT REPORT AND EXECUTIVE SUMMARY

Reference:	CA18/2/3/8719								
Aircraft Registration	ZS-SJW	Date of Accident	7 December 2009		Time of Accident	0901Z							
Type of Aircraft	Embraer 135-LR (Aeroplane)			Type of Operation	Domestic Schedule								
Pilot-in-command Licence Type		Airline Transport	Age	39	Licence Valid	Yes							
Pilot-in-command Flying Experience		Total Flying Hours	11 973,5		Hours on Type	2 905,8							
Last point of departure		Cape Town International Airport (FACT), Western Cape province											
Next point of intended landing		George Airport (FAGG), Western Cape province											
Location of the accident site with reference to easily defined geographical points (GPS readings if possible)													
On the R404, a public road adjacent to the aerodrome (geographical co-ordinates: S34°00.306' E022°23.534')													
Meteorological Information	Surface wind: 090°/2-5 kt; Temperature: 20°C; Cloud base: 8 000 ft, with light rain

The crew were unable to decelerate the aircraft to a safe stop due to ineffective braking of the aircraft on a wet runway surface, resulting in an overrun.

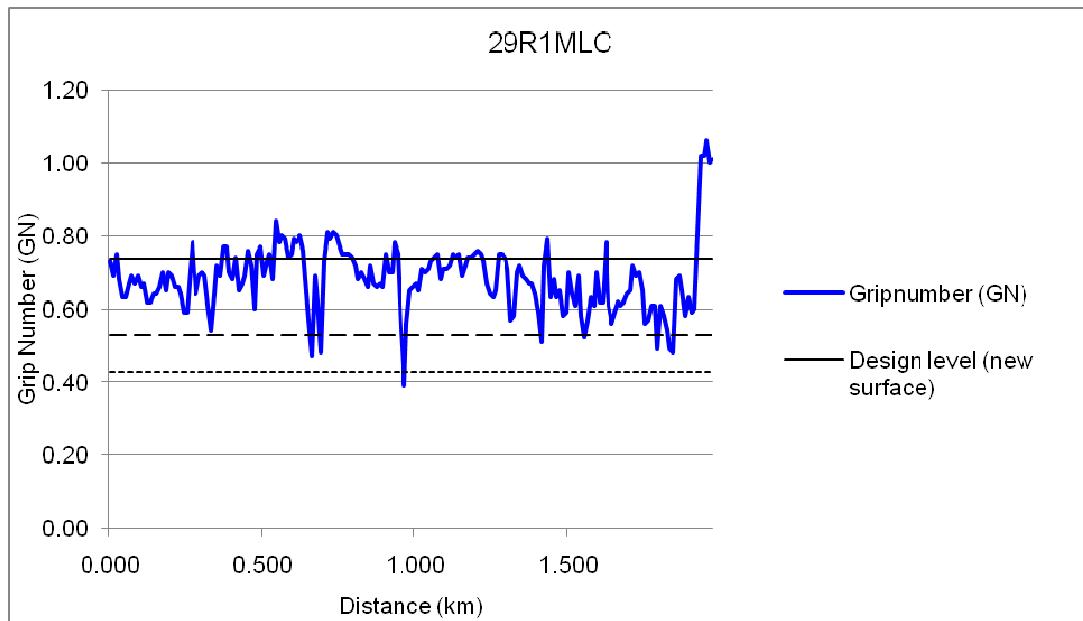
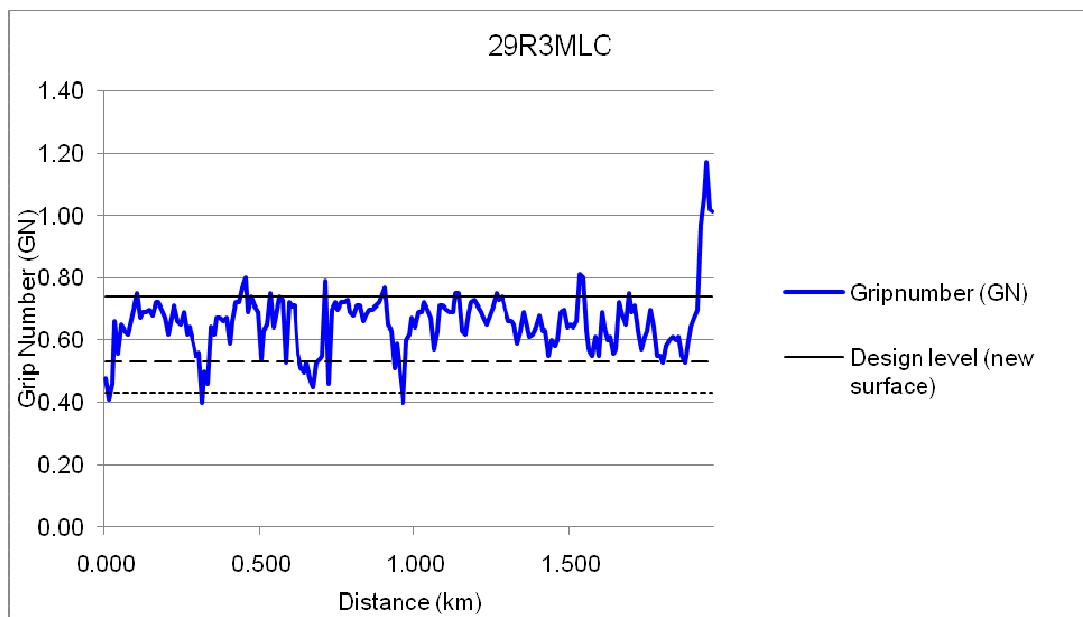
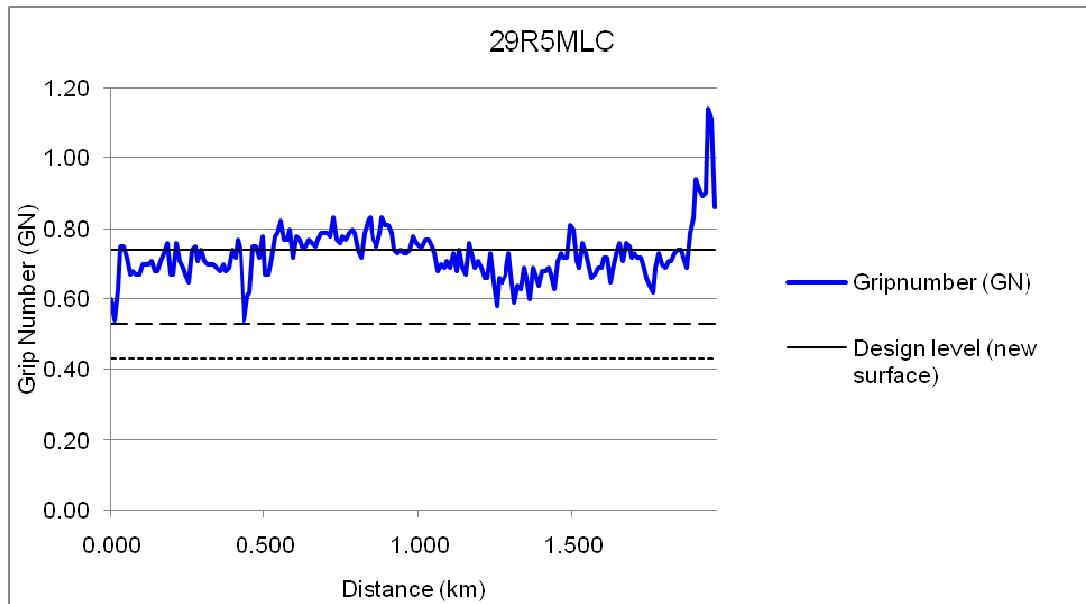
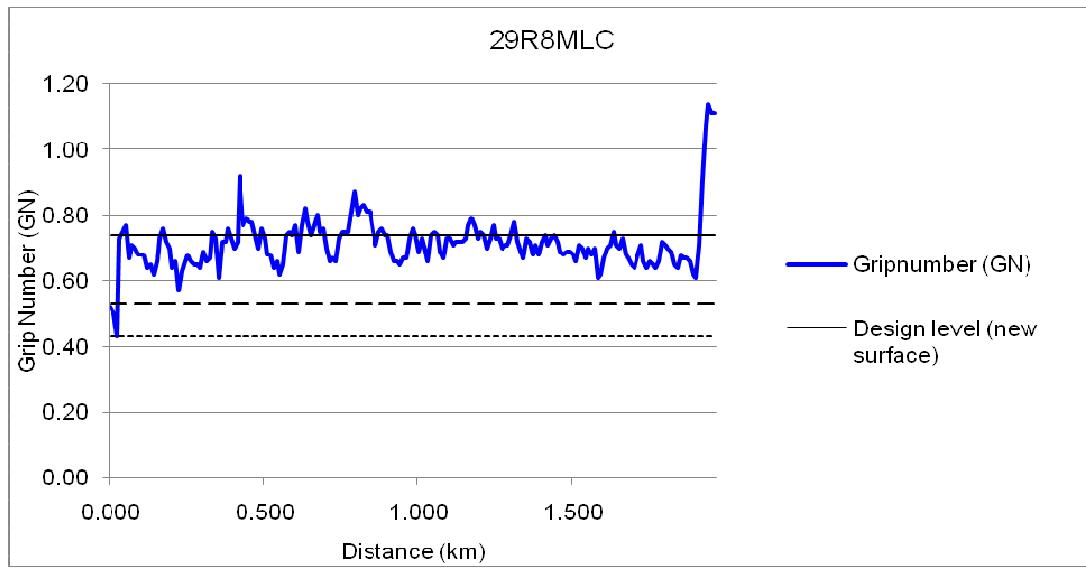
15 February 2010

Runway 29, left of the centreline. Friction measurements at 65 km/h.

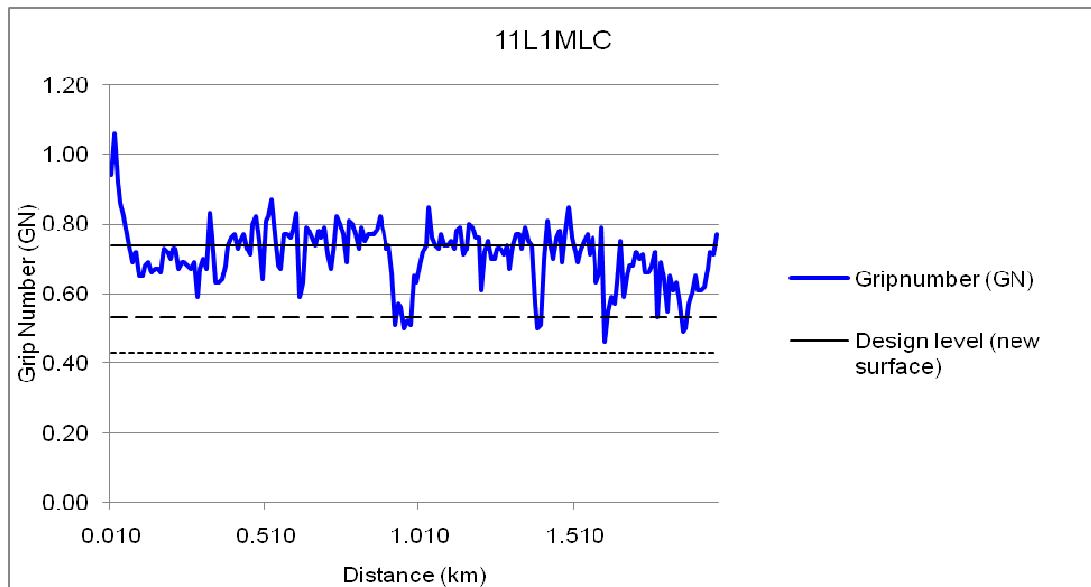
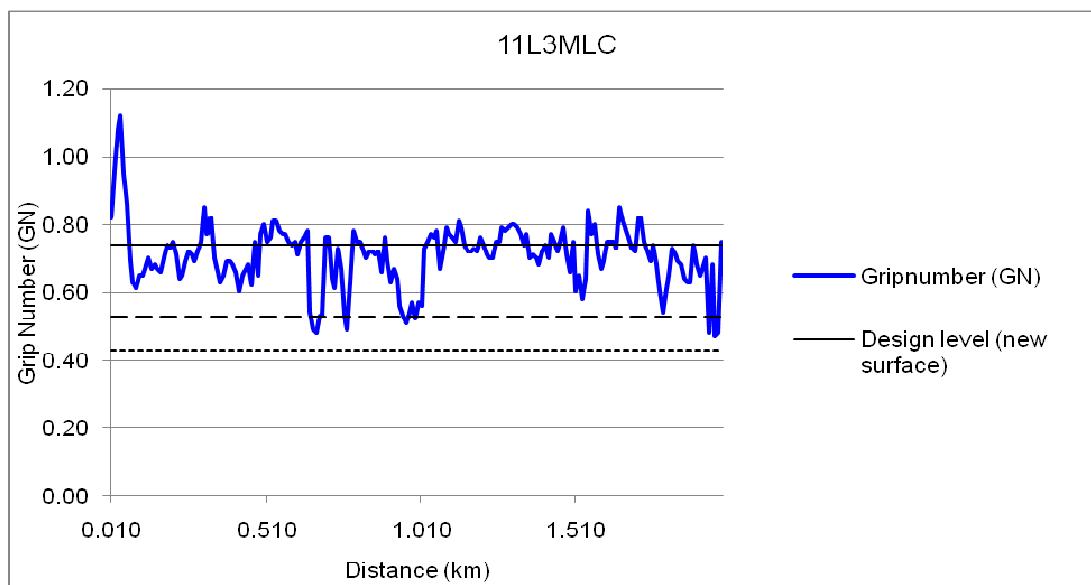
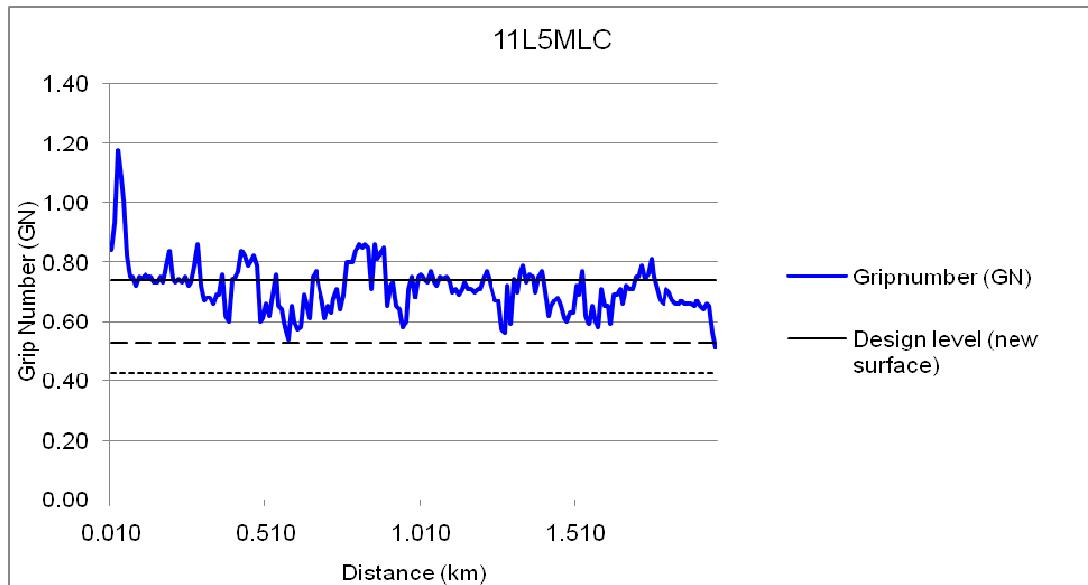
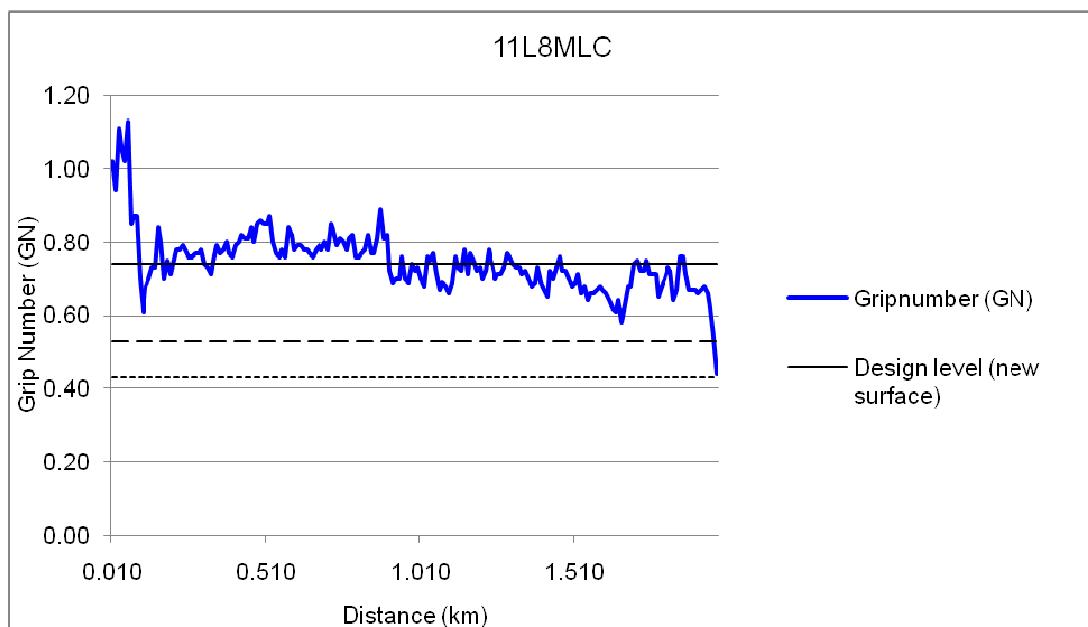
15 February 2010

Runway 11, left of the centreline. Friction measurements at 65 km/h.
