**AVIATION INVESTIGATION REPORT
A11P0149**

LOSS OF CONTROL AND COLLISION WITH GROUND

**NORTHERN THUNDERBIRD AIR INC.
BEEHCRAFT KING AIR 100, C-GXXR
VANCOUVER INTERNATIONAL AIRPORT
RICHMOND, BRITISH COLUMBIA
27 OCTOBER 2011**

Report Number A11P0149

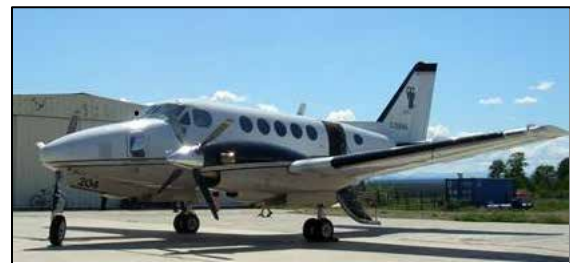
Photo 2. C-GXXR

The aircraft, C-GXXR (Photo 2), was configured to operate with 2 crew members and to carry up to 8 passengers, all facing forward. There was no partition between the passengers and the pilots. The Beechcraft King Air 100 is powered by Pratt and Whitney Canada (P&WC) engines.

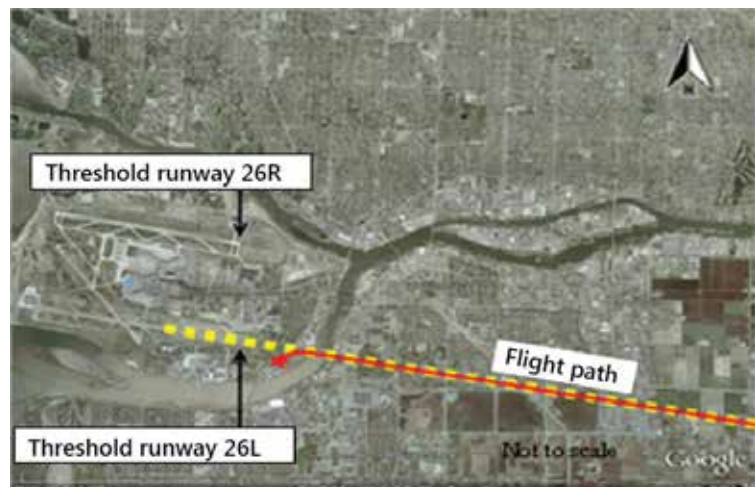
Figure 3. Flight path of NT204 (Geographic image: Google Earth)

CYVR is located in the suburbs of Vancouver, on an island in the mouth of the Fraser River, at sea level. It is a full-service international airport that supports major airlines. There are 3 runway surfaces, of which 2 are parallel. The approach was accomplished on Runway 26L (Figure 3). Other airports in the vicinity include Pitt Meadows (CYPK) and Abbotsford (CYXX), as indicated in Figure 7.

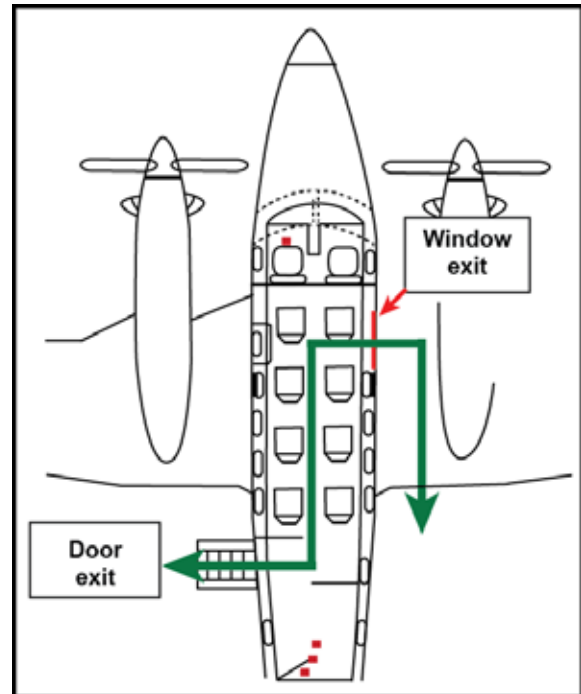
Figure 5. Seating and exits

The Beechcraft King Air 100 has 1 cabin door, located at the rear of the aircraft on the left side. One emergency exit window is located over the right wing. The cabin was configured with 8 passenger seats, all facing forward in rows, with a centre aisle. Figure 5 shows the cabin configuration and available exits. Fire was visible outside on the right, making the cabin door the only viable exit. The cabin door was opened with difficulty, as the door frame was deformed. All of the passengers and both pilots suffered injuries from the impact, and all but 1 passenger had to be assisted to exit the aircraft. The captain was not wearing a shoulder harness.

All of the persons on board sustained survivable injuries from the impact deceleration forces. The post-impact fire compromised survivability. The pilots suffered severe burns and smoke inhalation. The passenger seated closest to the cockpit suffered burns and the serious effects of smoke inhalation.

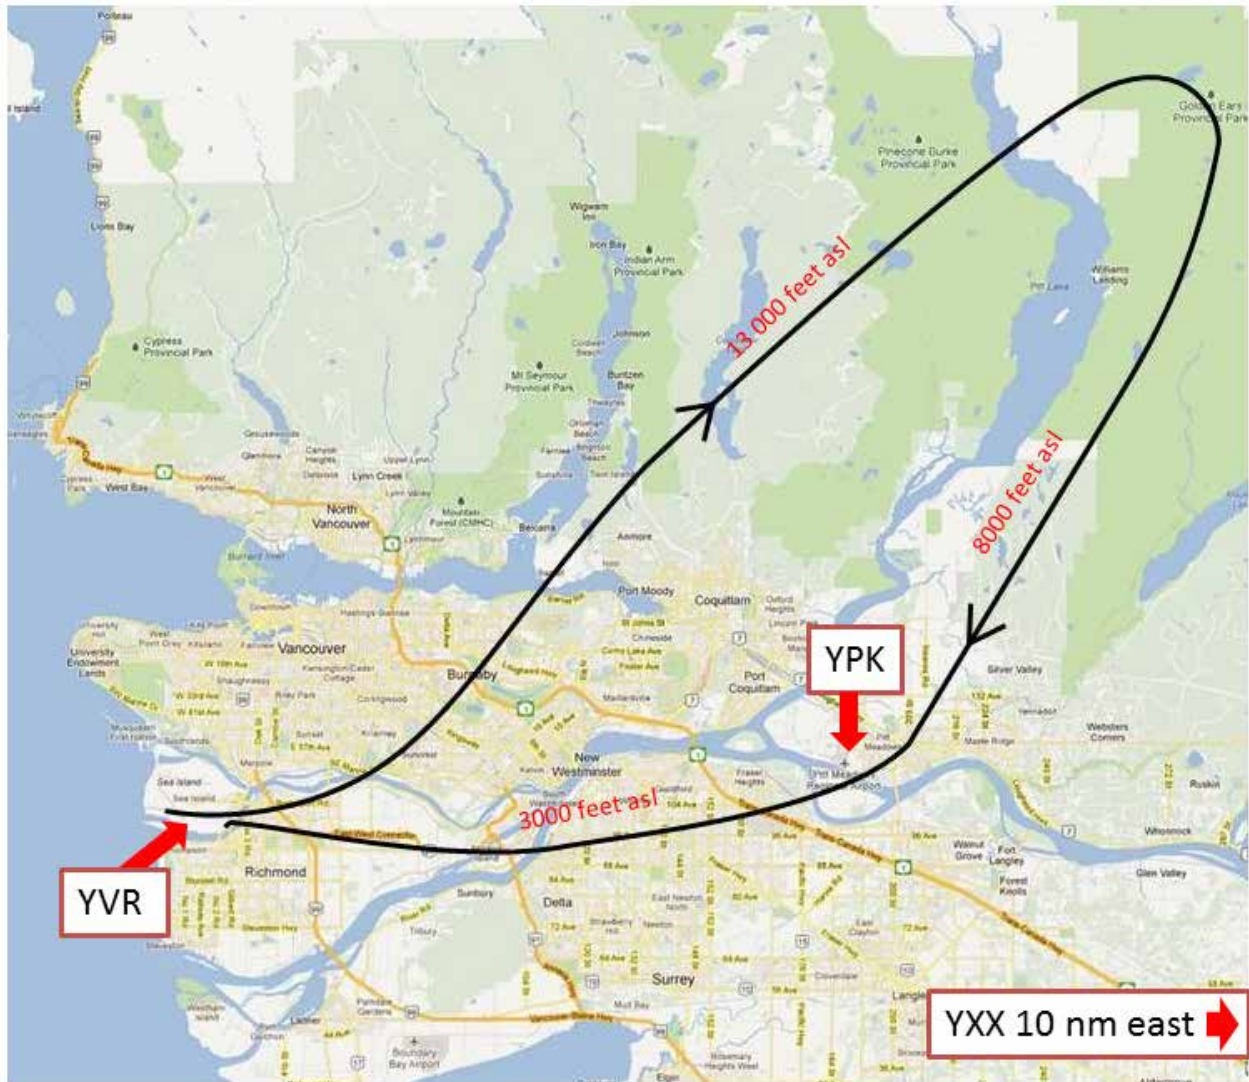
Figure 7. Flight track (Image: Vancouver Airport Authority. Modifications by TSB.)

Because the oil leak was from the engine's oil reservoir, oil pressure would not be lost immediately. If there were an indication of declining oil pressure, it would go from normal pressure to no pressure quite quickly. This situation would allow the affected engine to operate normally until several litres of oil were lost. The captain's decision to return to Vancouver International Airport (CYVR) was reasonable, given the aircraft's location (Figure 7). An emergency descent was not in order, given the problem. Using a normal descent profile from 16 000 feet, the aircraft would have had to be flown away from the closer (in horizontal distance) aerodrome, Pitt Meadows (CYPK), or in circles to get down to it. Other aerodromes were no closer in flight time, and CYVR was also the best choice considering operational needs (home base).
