Final Report No. 2140 by the Swiss Accident Investigation Board SAIB

concerning the accident involving the
Raytheon 390 aircraft, registration D-IAYL

on 19 December 2010

Bever/GR

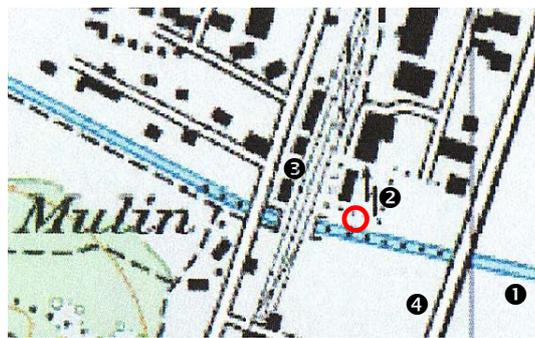
Figure 1: Map extract with the accident site

- ① Brook "Beverin", a tributary of the En
- ② Powerplant substation Bever (Repower)
- ③ RhB railway station Bever
- ④ Cantonal road Samedan-Bever

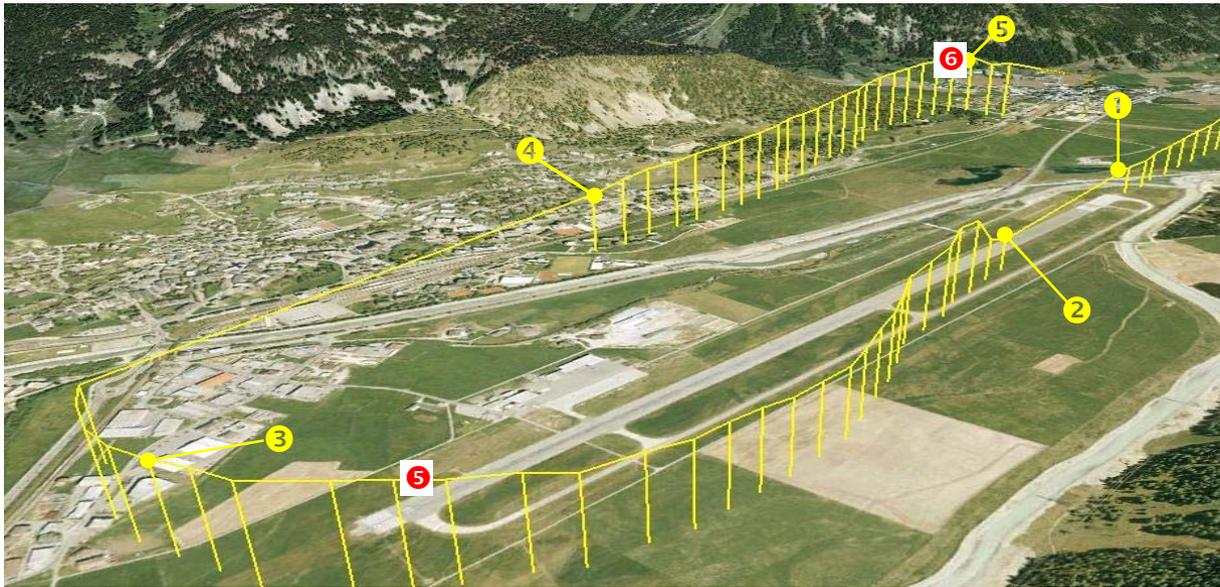
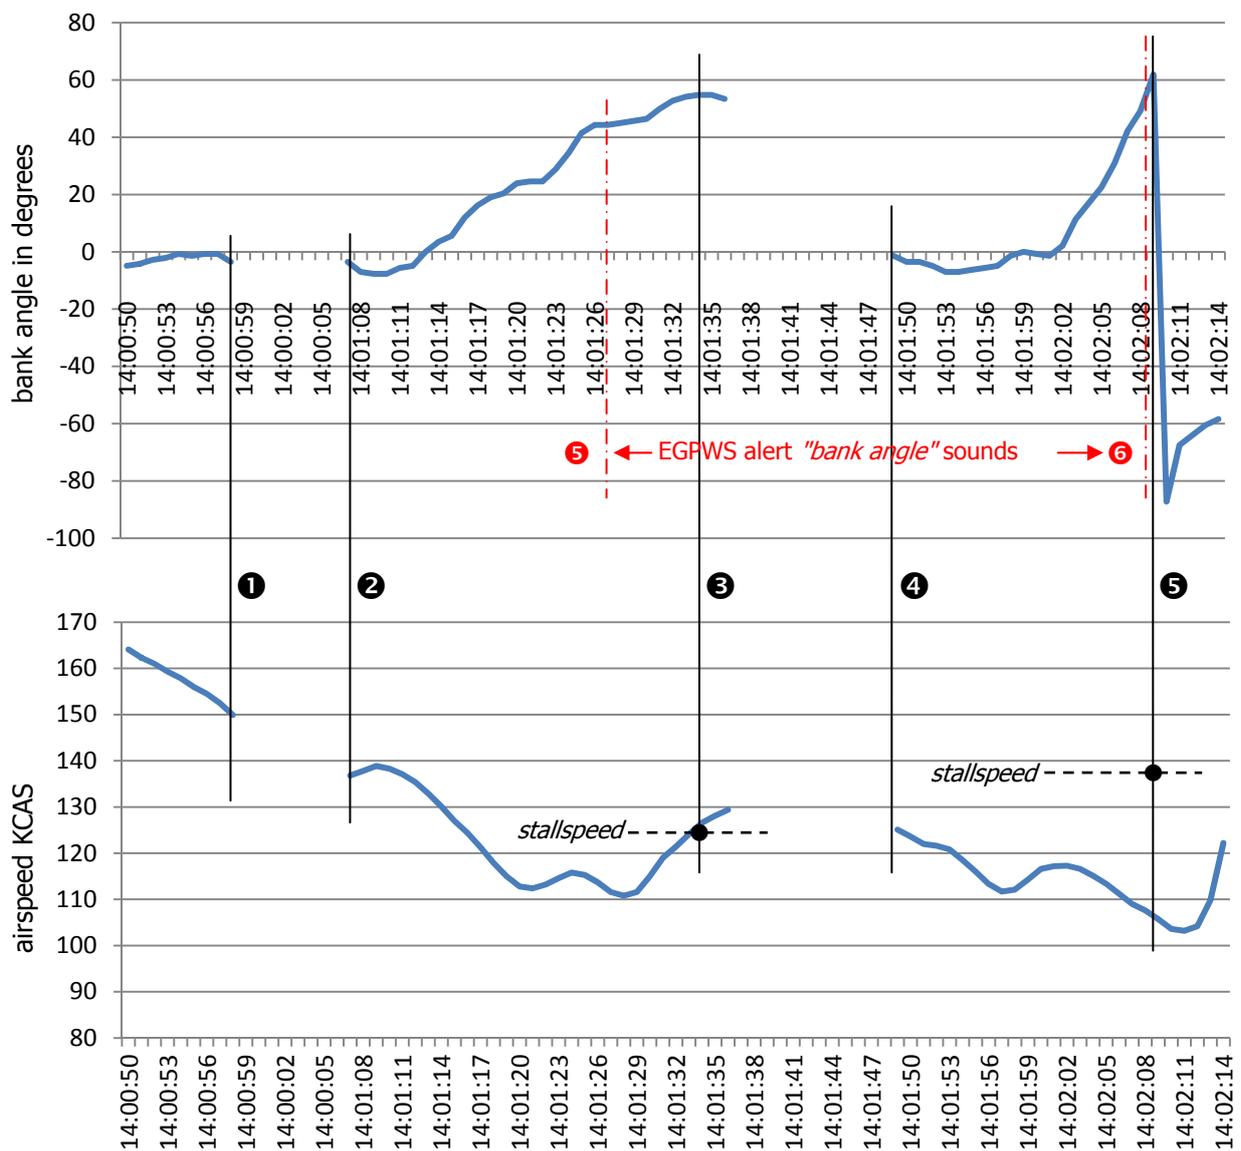
Annex 3: Flight path in the Samedan airport area

- ① EPWGS alert "*caution terrain!*" sounds (only if TERR INHIB is not deactivated)
- ② EPWGS alert "*sink rate!*" sounds
- ③ EPWGS alert "*pull up!*" sounds
- ④ EPWGS alert "*sink rate!*" sounds
- ⑤ EPWGS alert "*bank angle!*" sounds
- ⑥ EPWGS alert "*bank angle!*" sounds

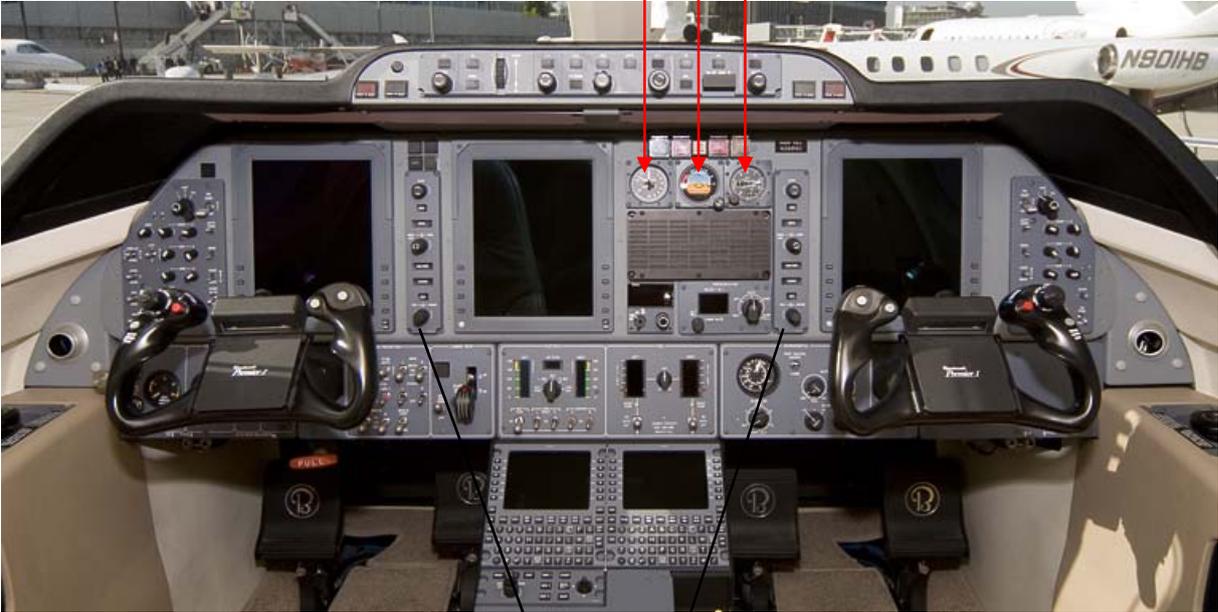
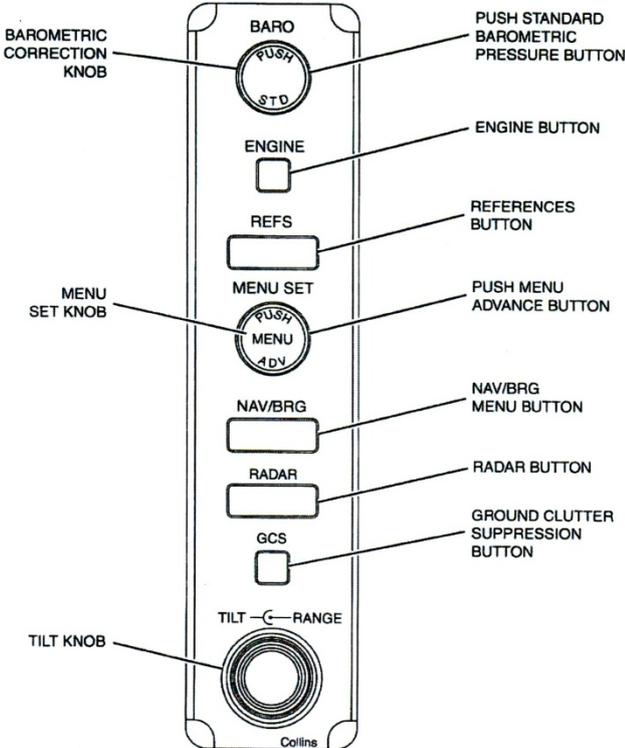
Annex 5: Cockpit layout

At the site of the accident only the standby airspeed indicator and the standby altimeter were found to be in a condition which permitted forensic investigation (cf. figures 4 and 5). Both instruments are situated in the centre of the forward panel and directly below the glareshield panel (cf. Annex 5).

standby horizon
 standby airspeed indicator standby altimeter

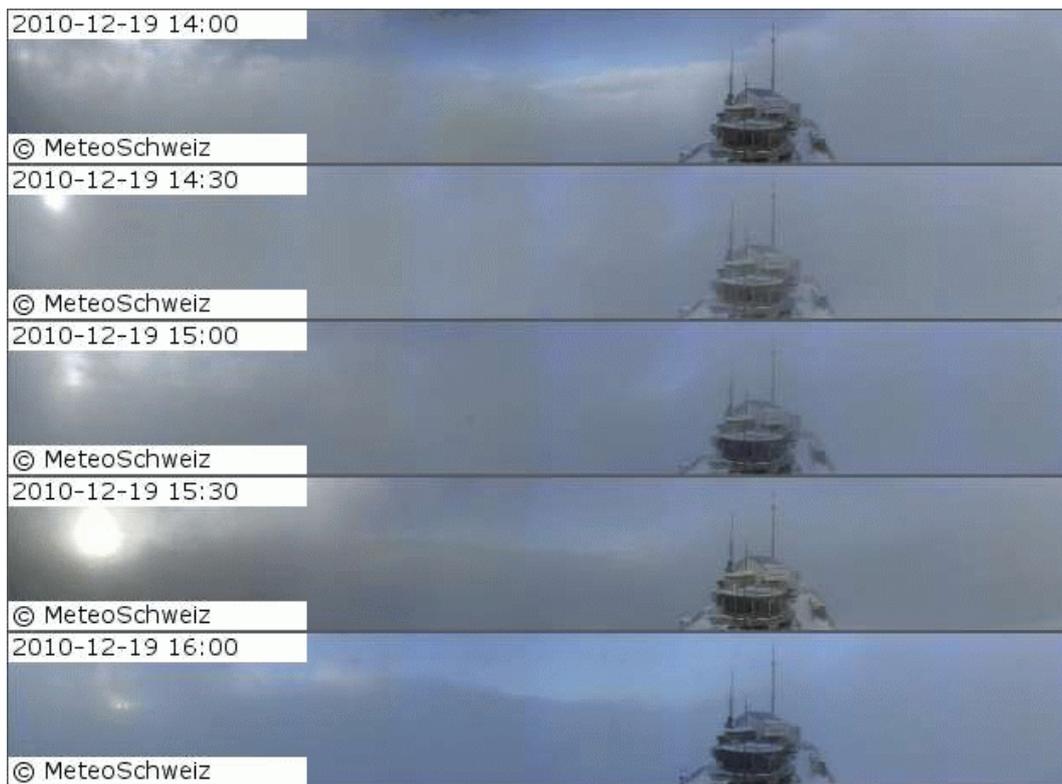
19 Dezember 2010 UTC: Thin out of cloud is clearly recognisable.

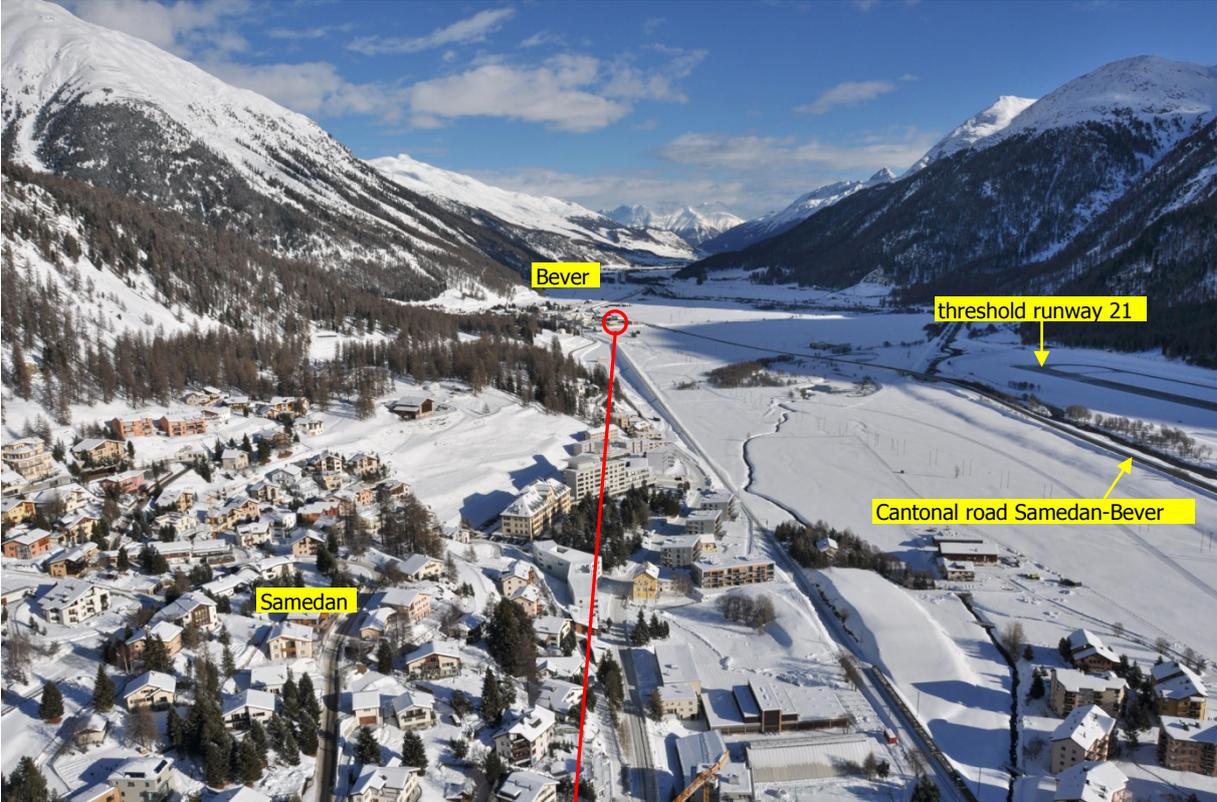
Figure 1: view direction north east

The accident site is located directly at the boundary between the river and the south fence of the Rätia Energie electricity company's Bever powerplant substation. The area was covered with snow and the river was partially frozen over (cf. Annex 11).

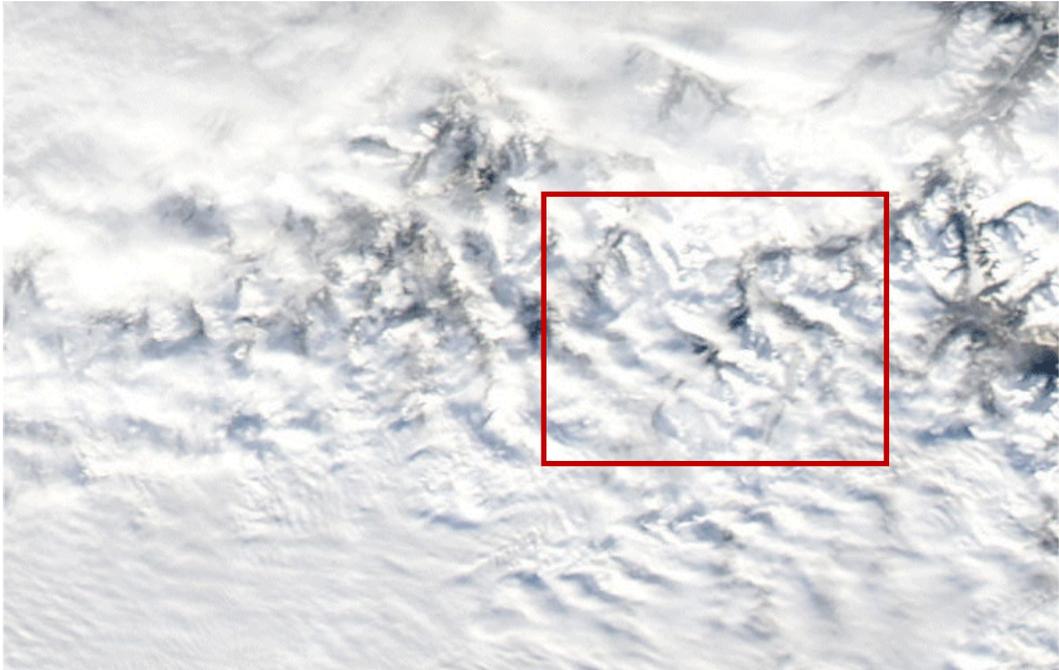
Annex 12: Weather in the Engadin

MODIS Aqua Image, taken at 12:35 UTC. Clearly visible are the mountain waves, running crossways to the wind. The cloud gaps over "Nord- und Mittelbünden" and in the lower Engadin are also visible.

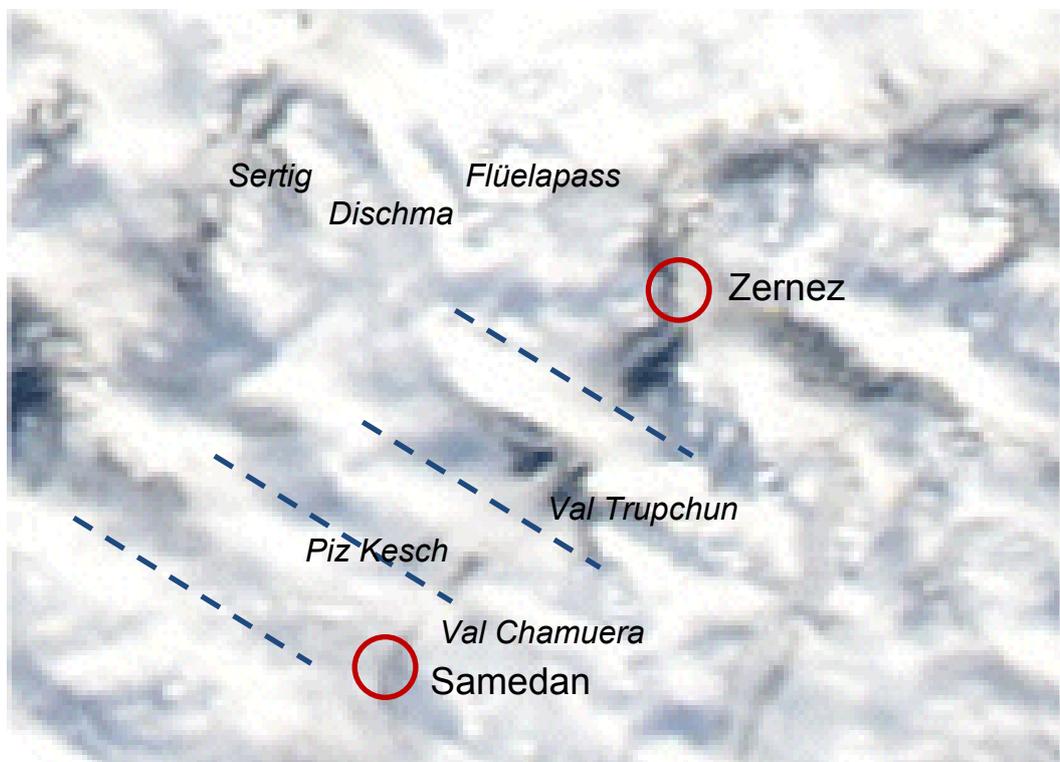
Extract of the above figure. The wave axes are drawn in blue. Snow covered mountain ridges and cloud are in part difficult to tell apart. The wave axes are much better to make out where they cross the river En valley and covering in white the dark tree-covered valleyflanks.
