Aircraft Accident Investigation Interim Report

Crash Into The Sea After An In-Flight Fire Asiana Airlines B747-400F/HL7604 130 km West Of Jeju International Airport July 28, 2011

September 17, 2012

Aircraft and Railway Accident Investigation Board

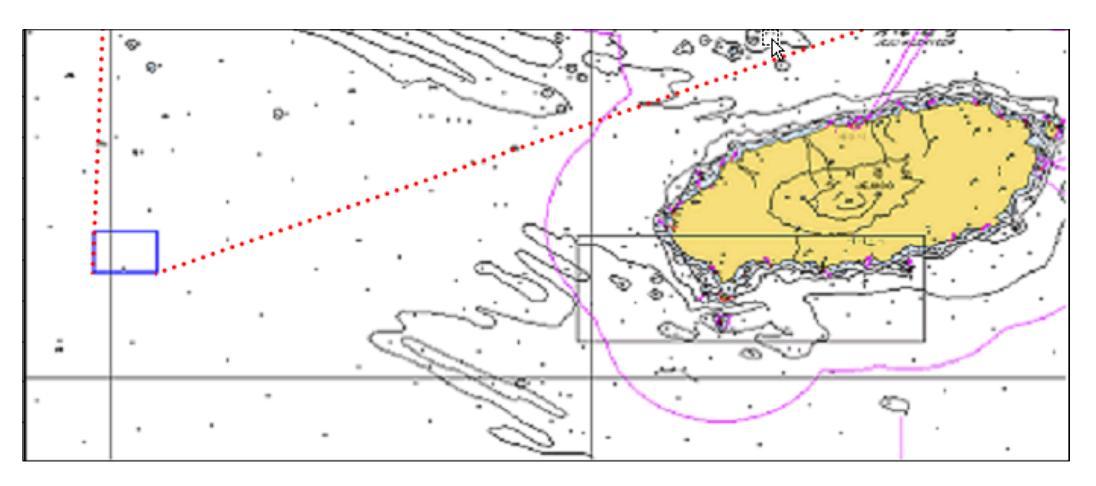
[Figure 15] Accident Site

As shown in [Figure 15], the wreckage of AAR991 was found underwater in the area inside blue rectangular enclosure.

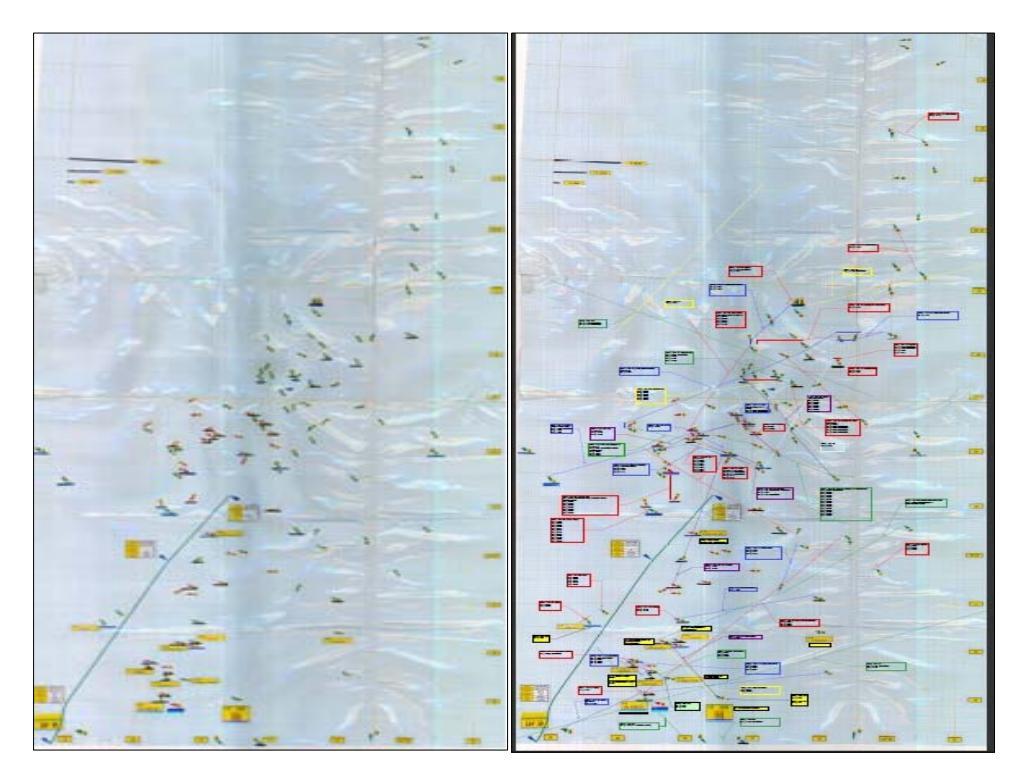
[Figure 16] Wreckage Distribution Map

As shown in [Figure 16], the wreckage was distributed in the area 3 km in width by 4 km in length in southwest-northeast direction.

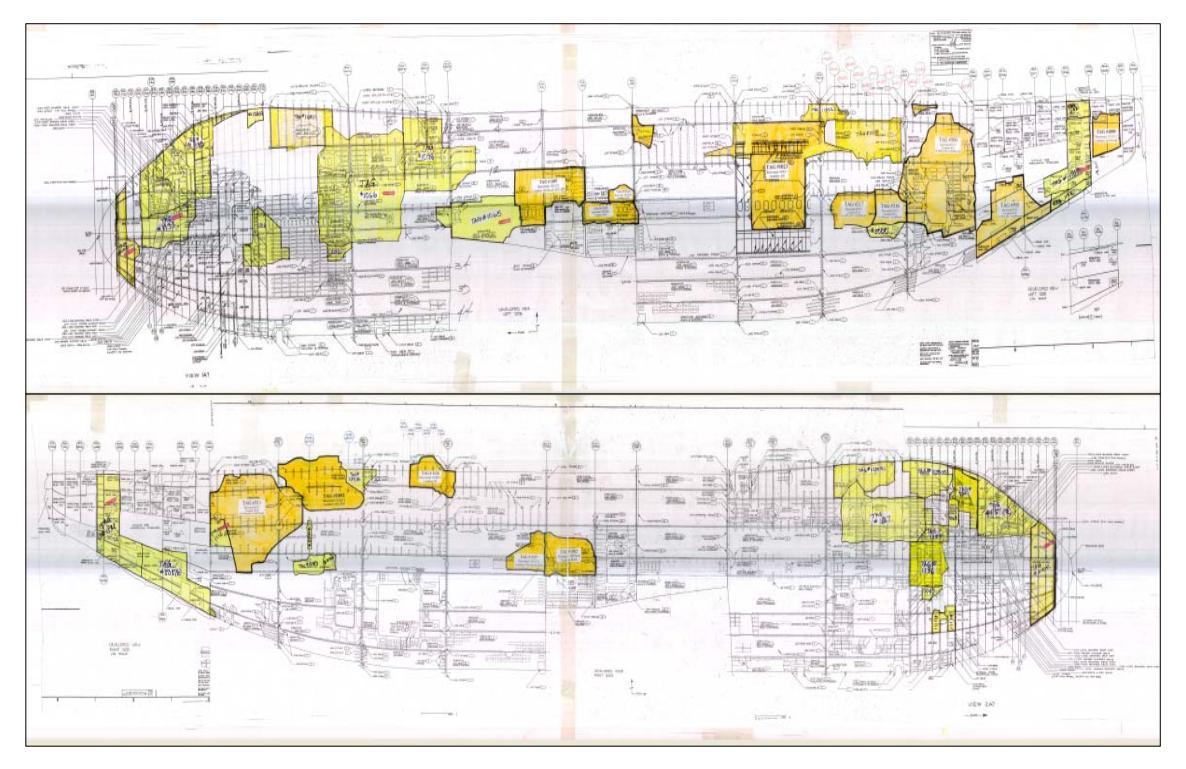
[Figure 17] Wreckage Marked on the Fuselage Diagram

The wreckage identified by the fuselage/structure group was marked on the fuselage diagram as shown in [Figure 17], and the wreckage recovered until October 30, 2011 was tagged²⁶).

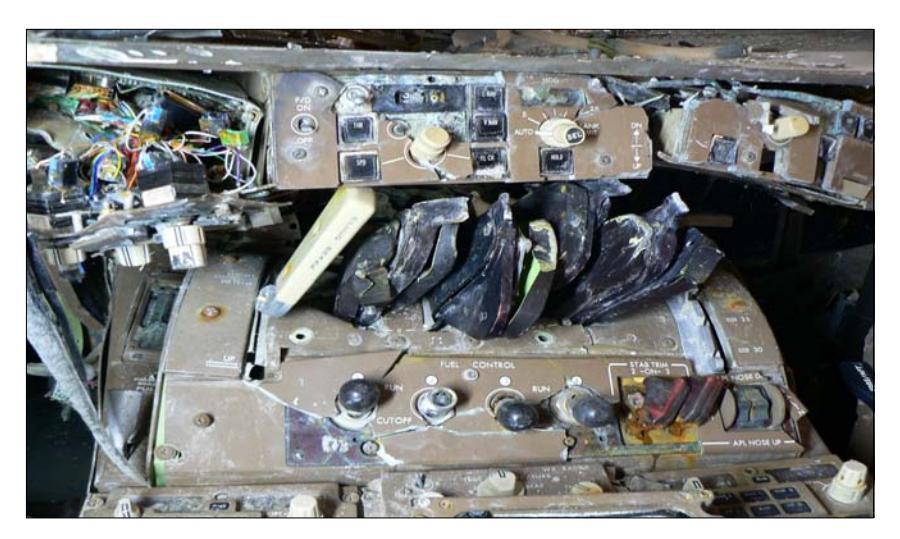
[Figure 18] Forward of the Cockpit (Throttle Quadrant and Mode Control Panel)

As shown in [Figure 18], the positions of switches and the condition of annunciator lights, circuit breakers, and various parts were examined.

Some of cockpit instruments were removed and under magnification, filaments of light bulbs were examined in order to identify whether annunciator lights had been hot at the time of impact.

The overall cockpit section was extensively pressure formed and was crushed flat.

Fuel cutoff switches #3 and #4 were found with the toggle in the OFF position, but under magnification, it was confirmed that they were OFF due to impact forces.

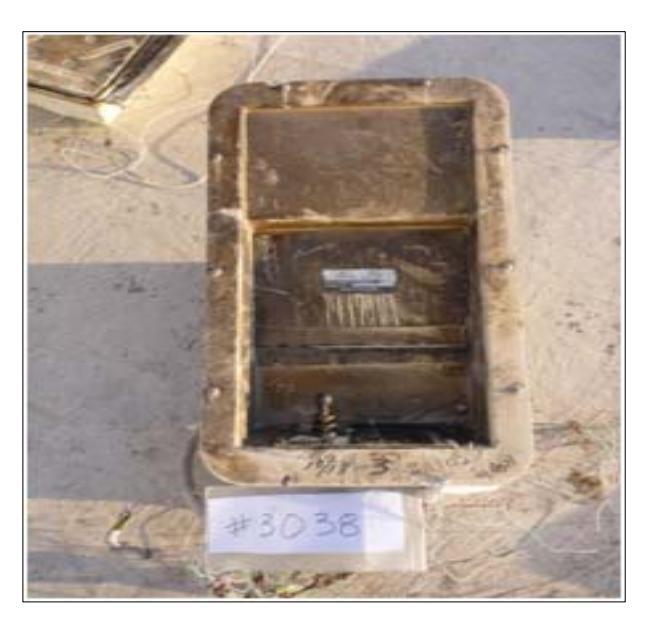
[Figure 34] Cargo Loading Control Panel

In the main cargo deck, there are multiple control panels for managing the loading of cargo pallets and containers and manipulating their positions. These control panels were found to have varying degrees of fire damage. An example of the cargo loading control panel is shown in [Figure 34].

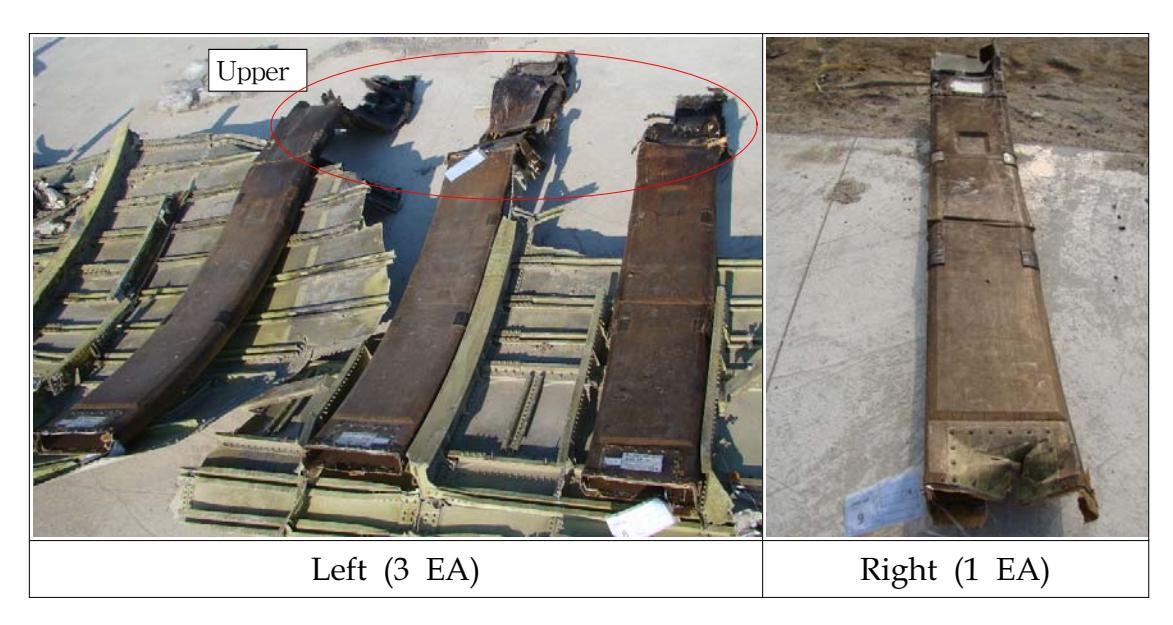
[Figure 35] Riser Ducts

Portions of four out of the six riser ducts²⁸⁾ on the aircraft were examined. As shown in [Figure 35], all of these ducts had sustained fire damage which was consistently more severe along the upper portions and tapered off towards the bottom.

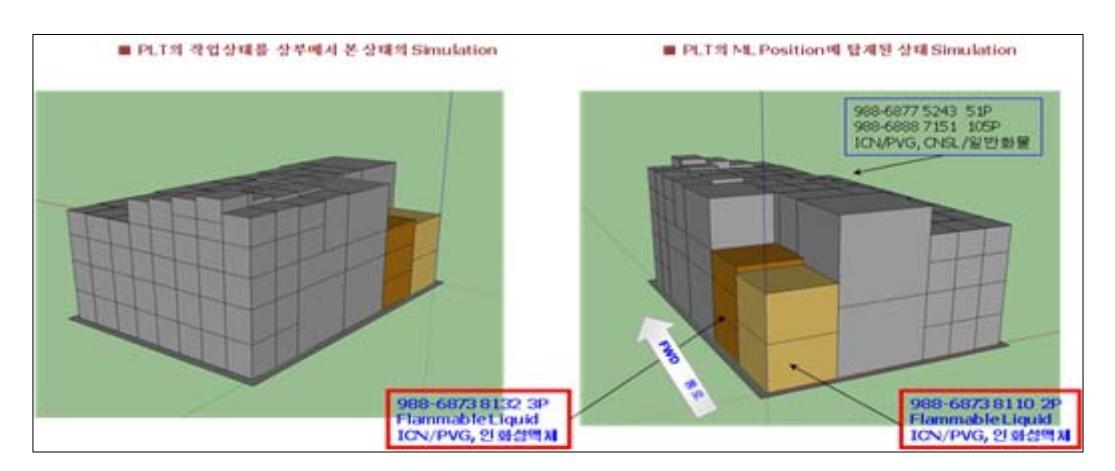
[Figure 49] Reconstruction of Loading of ML Pallet (PMC11978OZ)

Asiana Airlines reconstructed the loading configuration of the two pallets of PMC11978OZ and PMC13389OZ that had been loaded respectively at ULD positions ML and PR of the accident aircraft as shown in [Figure 49] and [Figure 50] below. The reconstruction is based on Asiana cargo handler's recollection of package positioning on the pallets.

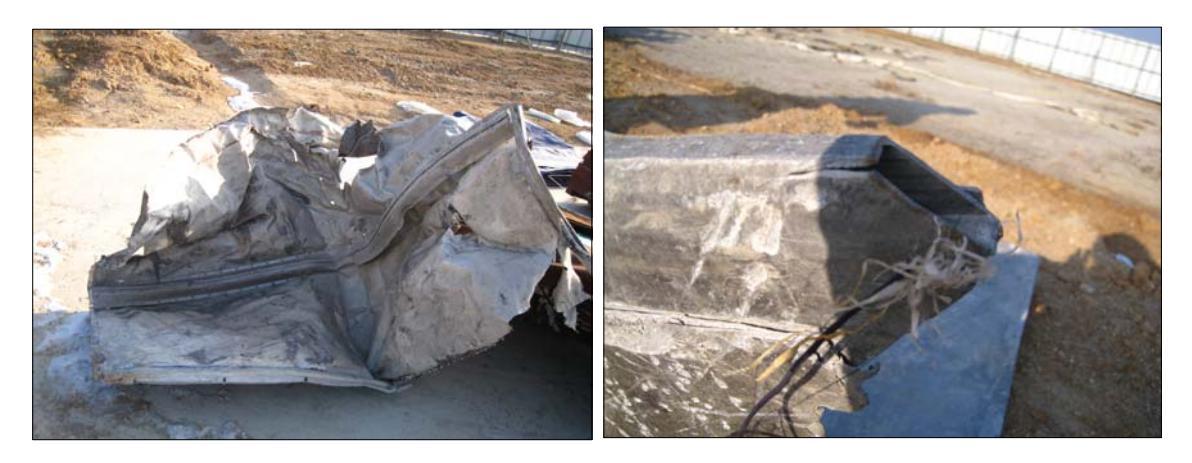
[Figure 51] Inside and Outside of the ULD Container at Position LL

The ULD container at position LL of the main cargo deck was recovered. No traces of fire damage was found on the inside of the wreckage as shown in [Figure 51], but the outside of the container was heavily covered in soot.

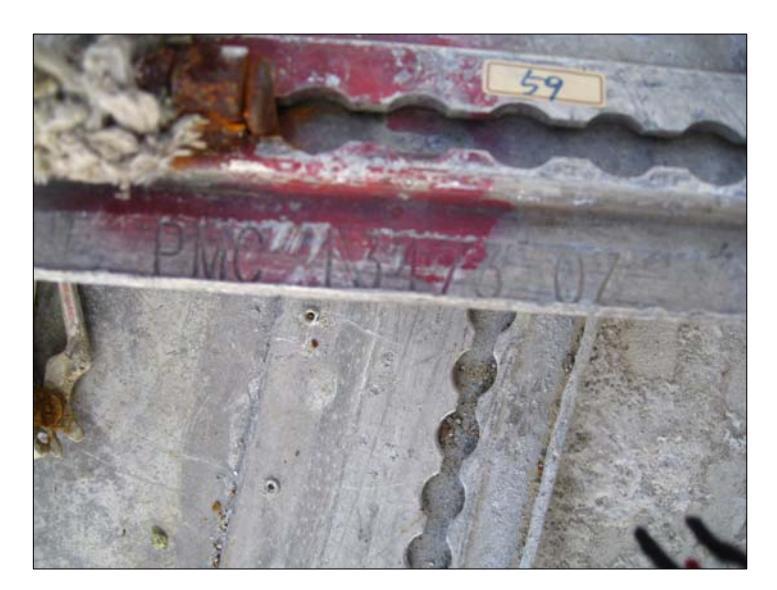
[Figure 52] Rail Sample Marked with Serial Number

Edge rails of cargo pallets were found separated from the pallets as shown in [Table 26], and the serial number of a certain rail could be confirmed as shown in [Figure 52].
