FINAL
KNKT.11.05.10.04

Aircraft Accident Investigation Report

**PT. Merpati Nusantara Airlines
Xi 'An Aircraft Industry MA60; PK-MZK
Utarom Airport, Kaimana - Papua Barat
Republic of Indonesia**

07 May 2011

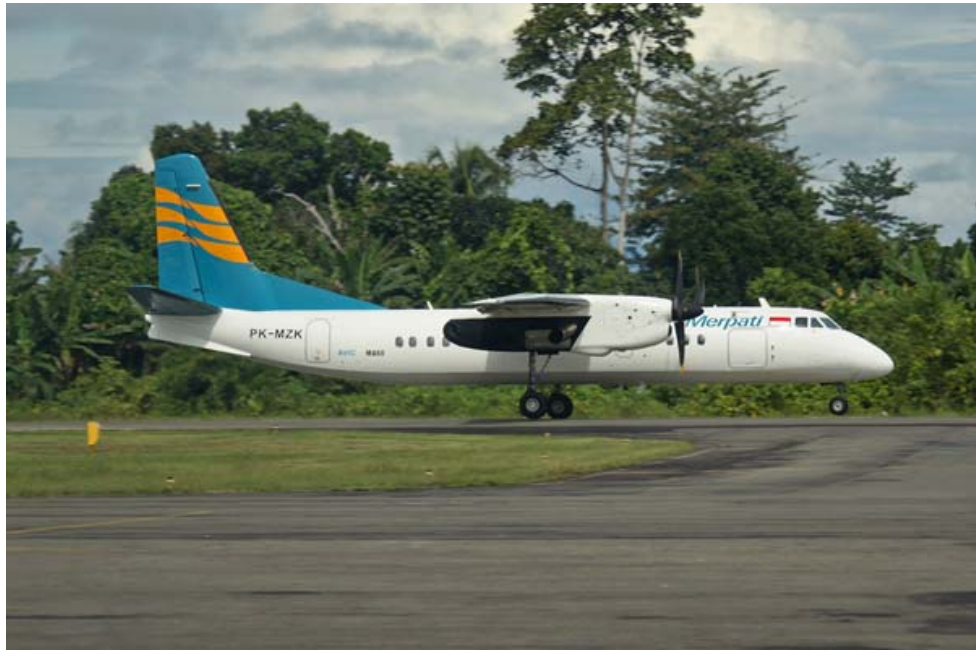
Figure 1: The Xi'An MA60 aircraft registration PK-MZK

On 7 May 2011, a Xi 'An MA60 aircraft, registered PK-MZK, was being operated by PT. Merpati Nusantara Airline as a scheduled passenger flight MZ 8968, from Domine Eduard Osok Airport, Sorong, Papua Barat to Utarom Airport (WASK), Kaimana, Papua Barat (Figure 1).

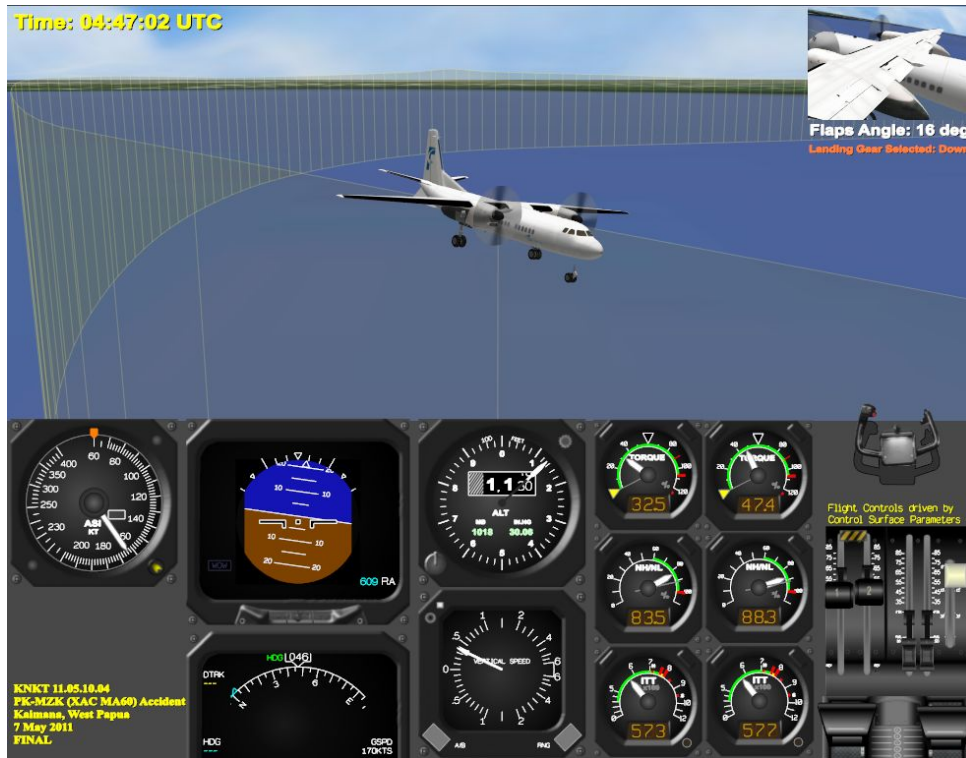
Figure 4: Screenshot of flight animation

An animated reconstruction of the FDR parameters and flight path was produced by NTSC recorder specialists at the NTSC flight recorder lab using Insight Animation and Google Earth images. The audio from the CVR was integrated into the accident flight animation to assist the investigation team.

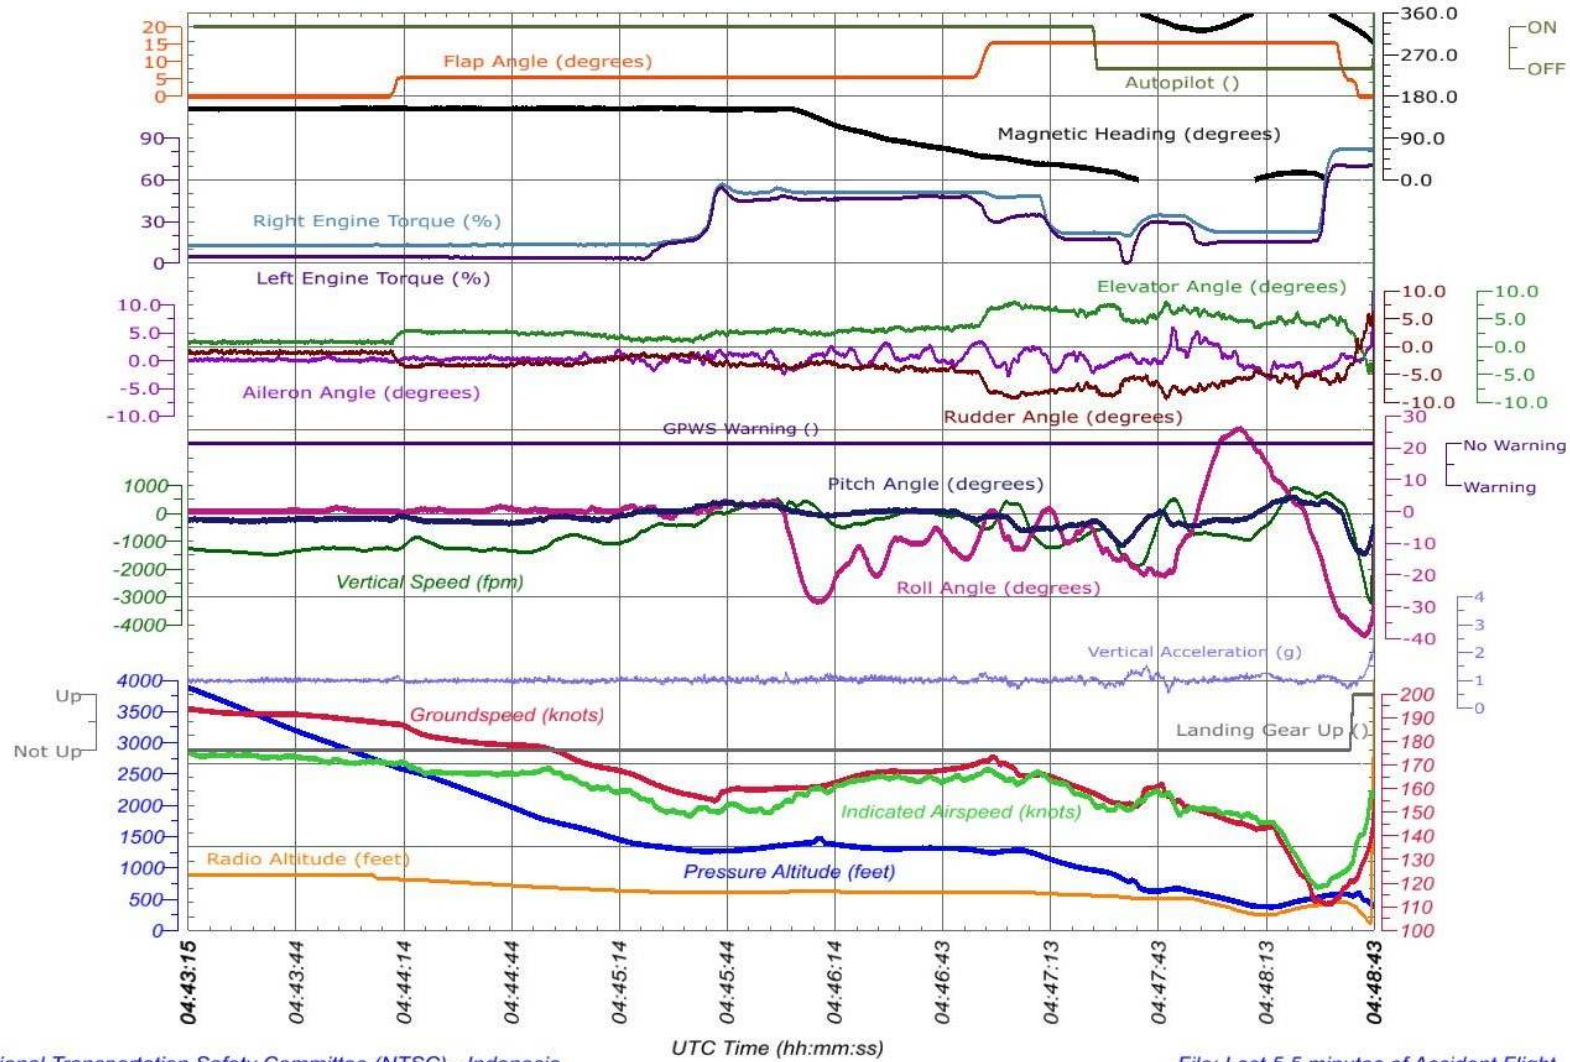
File: Last 5.5 minutes of Accident Flight

UTC Time	CVR	FDR
	The PIC asked about the conditions on final to runway 01, Kaimana AFIS informed them that the visibility in that direction was about 2 km.	
0440.08	The PIC ordered the SIC to reduce power.	
0441.53	The PIC ordered the SIC to reduce power further. The PIC then asked about the rain, and Kaimana AFIS informed the crew that it was still raining heavily.	
0443.46	The PIC asked if the runway 01 could be seen from the tower and the AFIS replied that the runway 01 could be seen from the tower.	
0444.01	The SIC asked for further descent and the PIC agreed.	
0444.08	The PIC continued the approach, and ordered the SIC to descend to circuit altitude and selected the flap.	
0445.32	The Flight Attendant reported "Cabin ready".	
0445.38	The PIC ordered the SIC to increase the engine power.	
0445.46	The PIC asked to select the landing gear to down.	
0445.49		L/G down, 1274 feet pressure altitude, 151 knots airspeed.

0445.58	The SIC asked the PIC to turn and the PIC agreed. The SIC stated that they were too far, the PIC replied that they were looking for clear area and not the matter of distance.	
0446.16	The PIC stated that approach could not be accomplished.	1357 feet pressure altitude.
0446.22	The PIC asked Kaimana AFIS the condition of the rain, and was answered that it was still heavy rain and final 01 was still insight from tower.	
0446.43	The SIC said that he could see the island.	
0446.55	The PIC said the flap was selected to 25. (Note that the MA 60 does not have flap position 25)	Flap travelled to 15.
0447.07	The PIC ordered the SIC to reduce the power.	
0447.26		Autopilot disengaged, 960 feet pressure
