Accident Investigation Board Denmark

FINAL REPORT

Accident to De Havilland DHC 8-106 Registration TF-JMB Nuuk Airport (BGGH), Greenland The 4th of March 2011

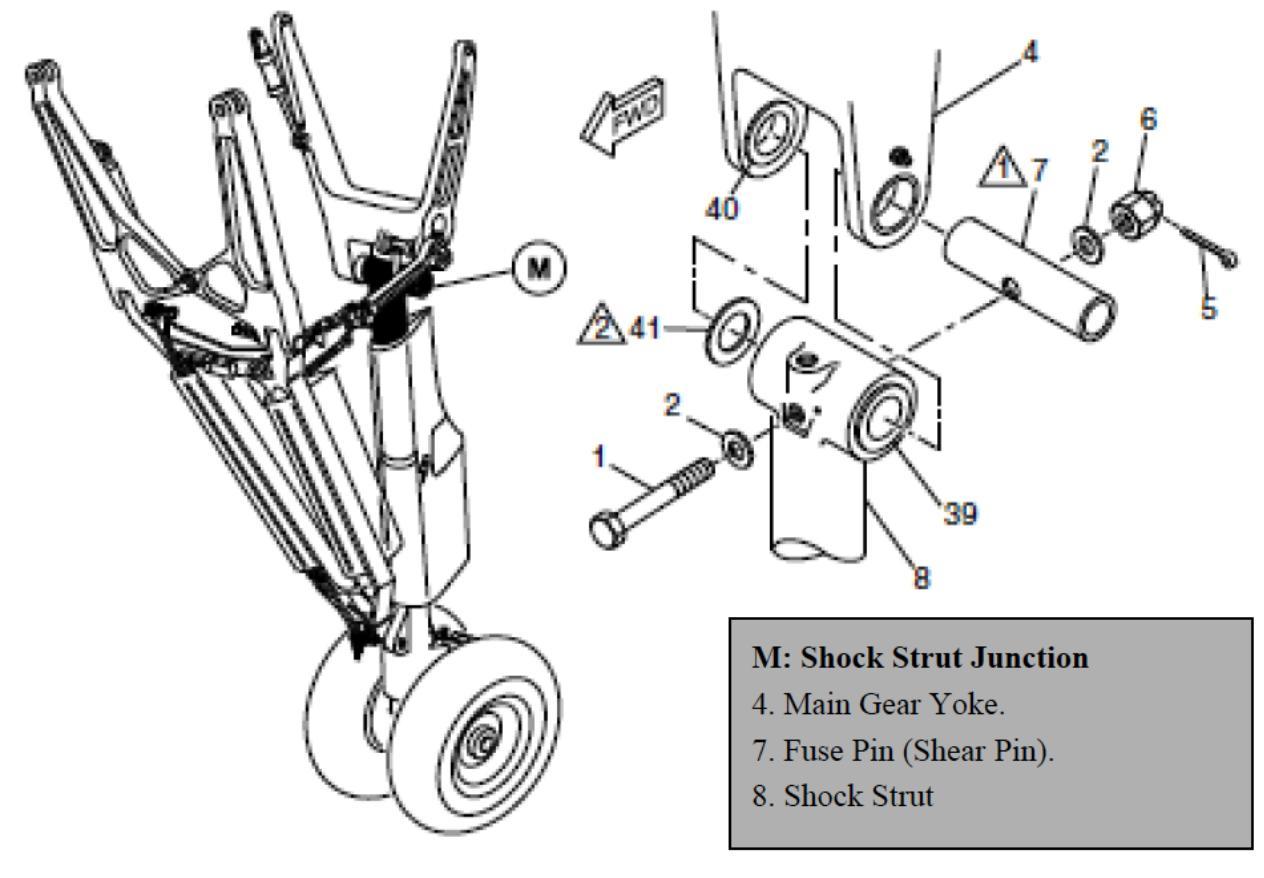
1.6.3.3 Main landing gear structural fuse pin p/n 10150-5

To prevent the gear from rupturing the fuel tanks inside the wing box during a rough landing, a fuse pin (shear pin) was installed at each main landing gear yoke to shock strut junction. This was to comply with JAR 25.721(a) and JAR 25.963(d). The purpose of those JAR requirements was to demonstrate adequate airframe strength (especially of the wing in the fuel tank zones) up until the instant where breakage of the fuse pin occurs.

The structural fuse pin was designed to shear if the aircraft touched down in level attitude at a rate of decent of more than 894 to 942 feet per minute - or if - the aircraft touched down in a tail down attitude at a rate of decent of more than 996 to 1029 feet per minute.

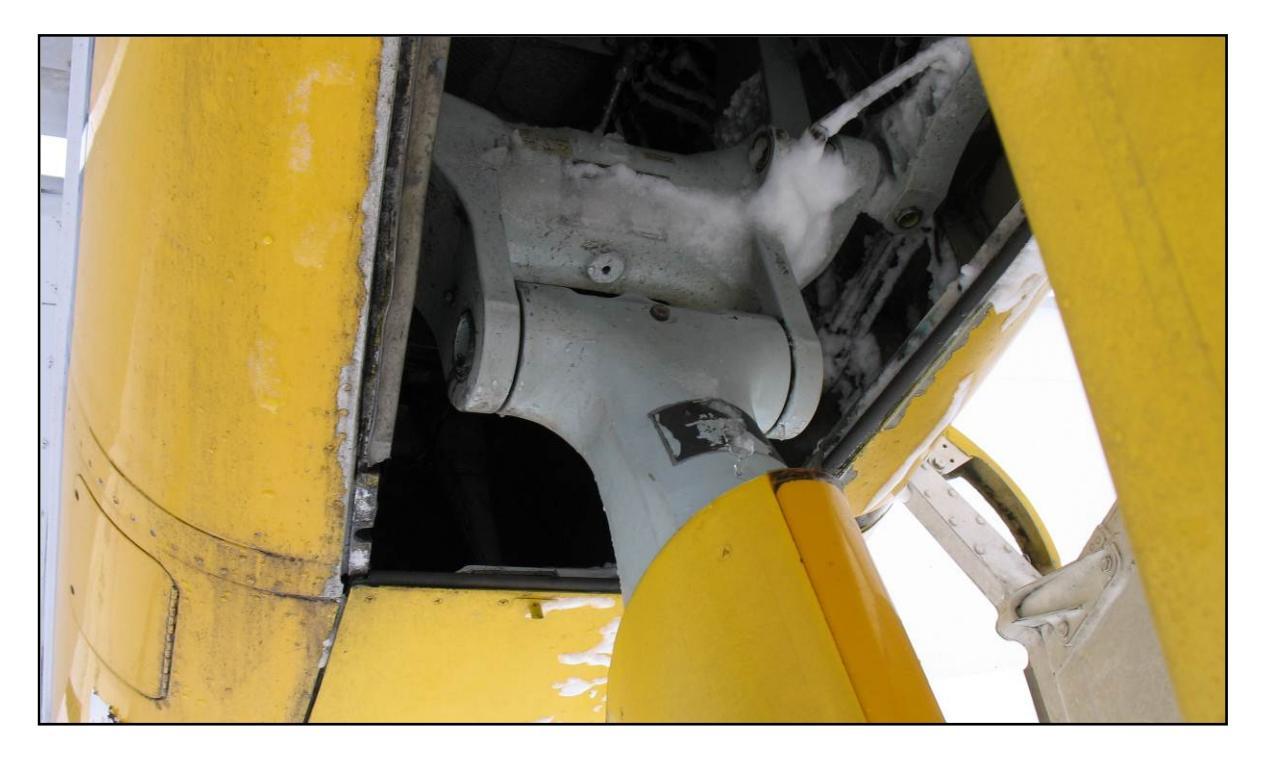
1.12.2 Fuse pin analysis

The mid-section of the fuse pin, (fig. 1 with the bolt) was found inside the head of shock strut to yoke.

The head of the bolt indicates the forward direction (flight direction). The two ends (L & R) of the fuse pin were found inside yoke junction to shock strut.

A hint of inflection on the upper side of the fuse pin can be seen, fig 1. The remaining of the fracture in the nature of a clean shear - see figure 1, 2 and 3.

The surface of the fractures from those pieces found in the gear yoke, showed marks coming from vertical upward force. This force triggered the fracture. See fig. 2 and 3.

Fractures in the fuse pin were caused by shear (shearing).

It predominantly was a vertical-shear leading to the fractures.

There was no evidence of fault or pre-existing cracks in the fuse pin.

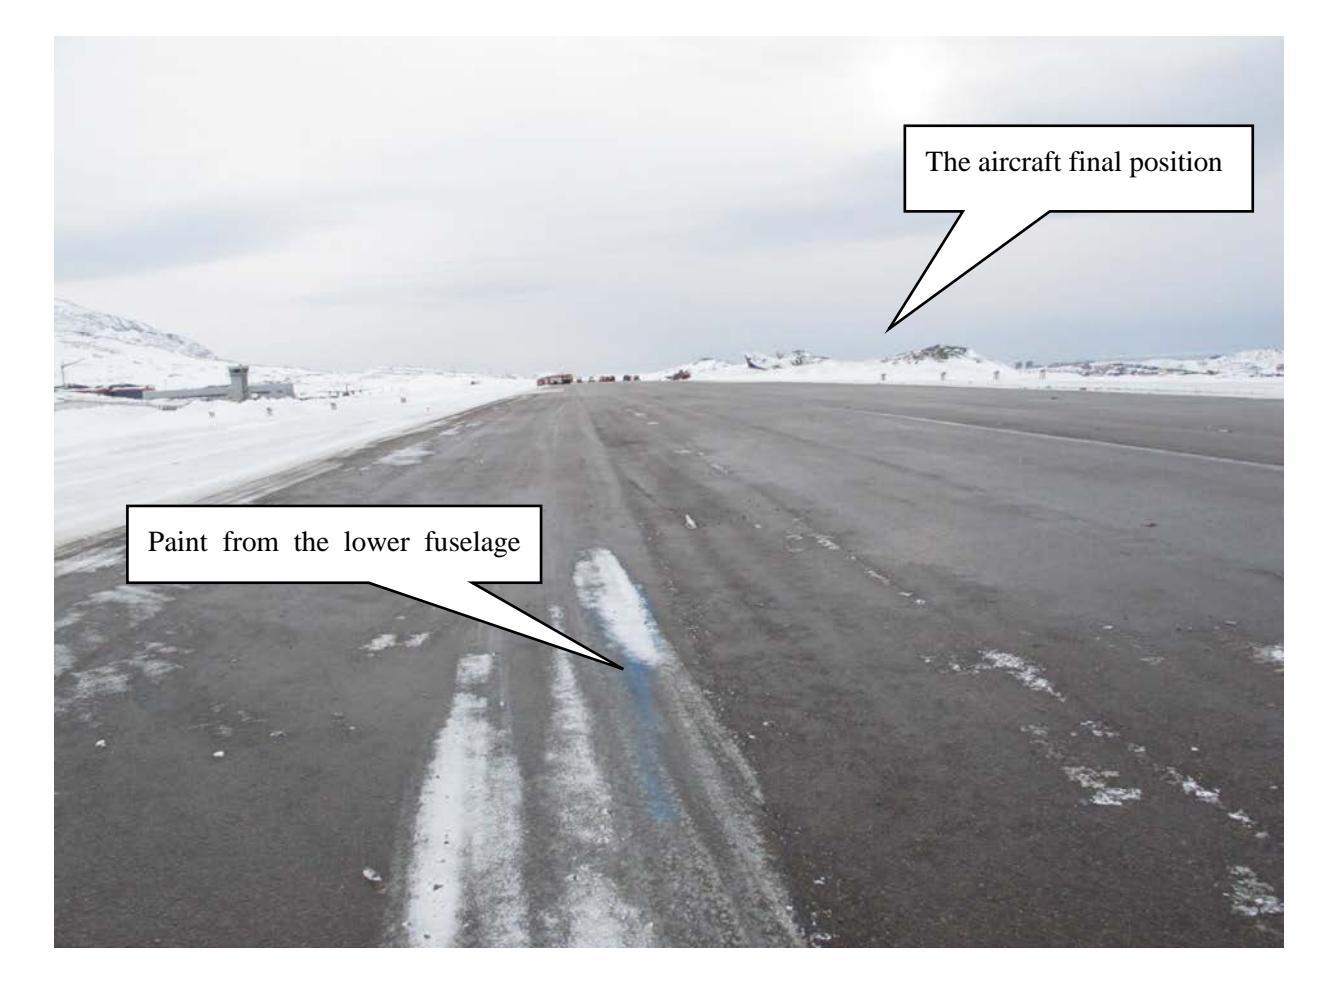
1.12.3 The touchdown

The aircraft touched down on runway 23 at time 16:09 hrs.

At touchdown the right MLG fuse pin sheared; consequently the right MLG collapsed and the fuselage made contact with the runway.

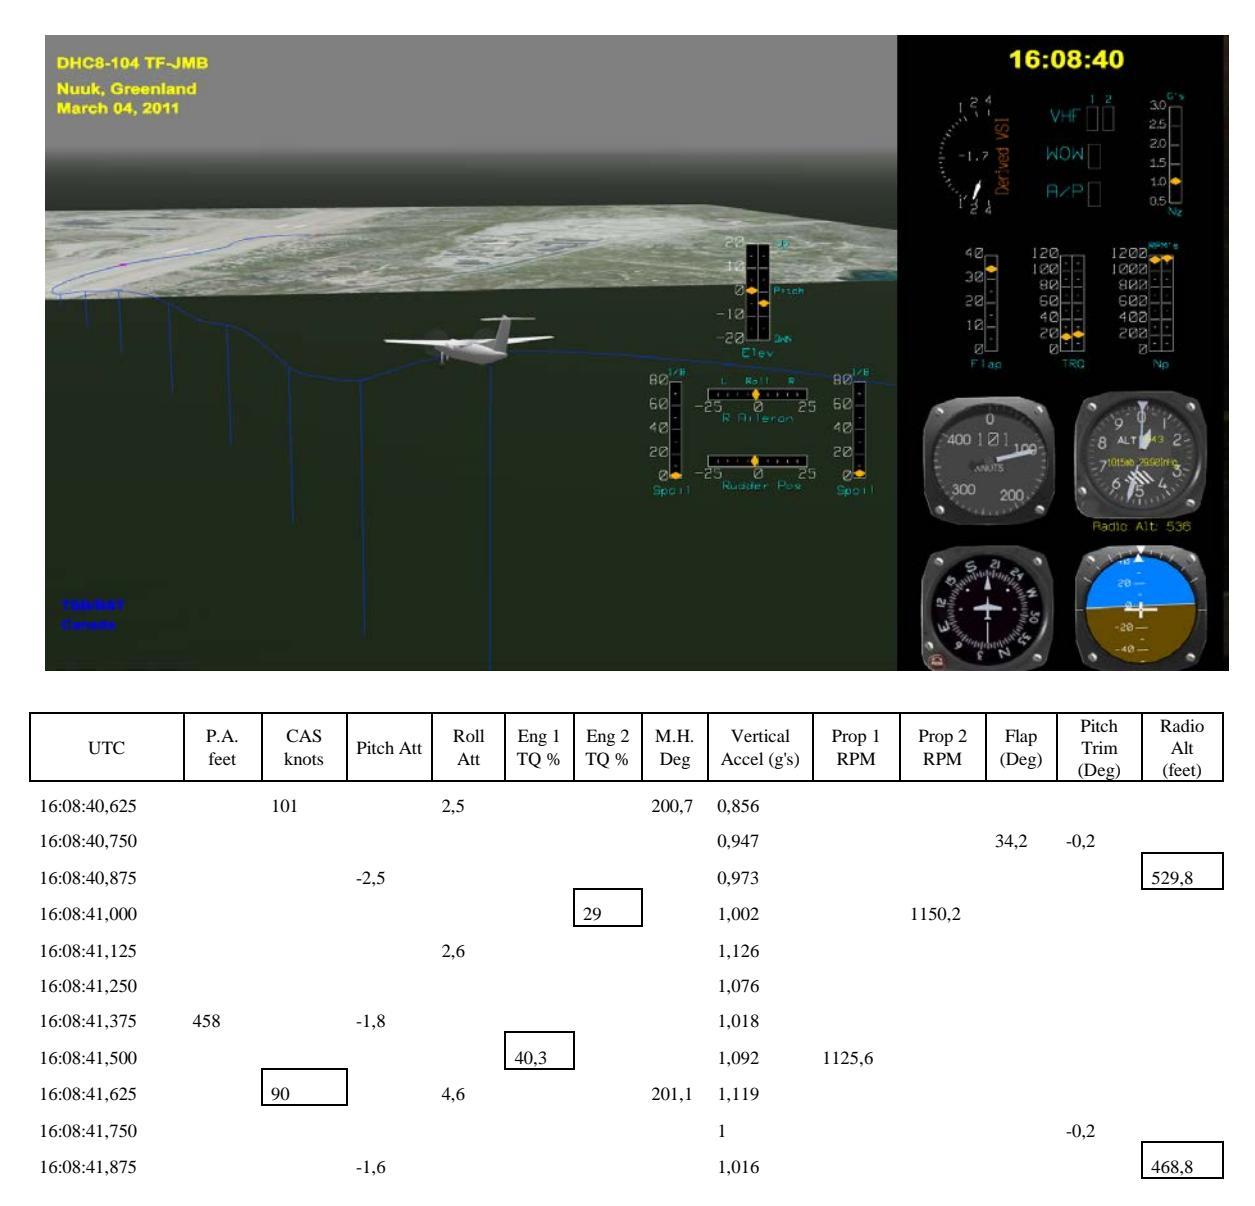
Time 16:08:40 - approximately 530 feet RA - airspeed 17 knots below Vtgt

The aircraft continued on a track towards the landing threshold runway 23 at an angle of 25° to 35°.

As the airspeed momentarily decreased to 90 knots, the engine torque increased from slightly above idle to 30% - 40%.

The Vtgt was 107 knots, and the actual CAS momentarily decreased to 90 knots.

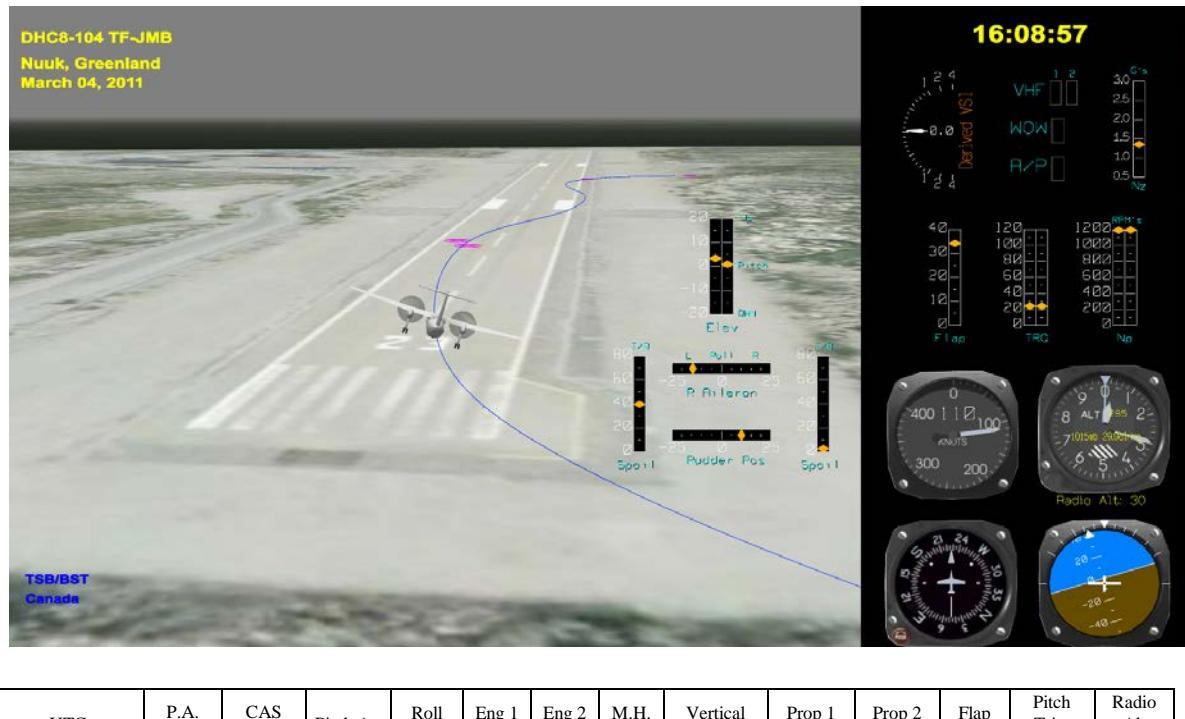
Time 16:08:57 - 30 feet above the runway – banking 18° to the right

The aircraft had passed the runway threshold and descended through 30 feet above runway 23.

The aircraft was banking up to 18.3° to the right but it was drifting to the left. The aircraft overshot the runway centerline to the left. The engine torque was around 24% and was about to be reduced. The RA decreased from 37.8 feet to 24.4 feet or 13.4 feet in one second (804 fpm).

The pitch attitude decreased from the previous -3° to -4° (nose down) to -5.8° (nose down).

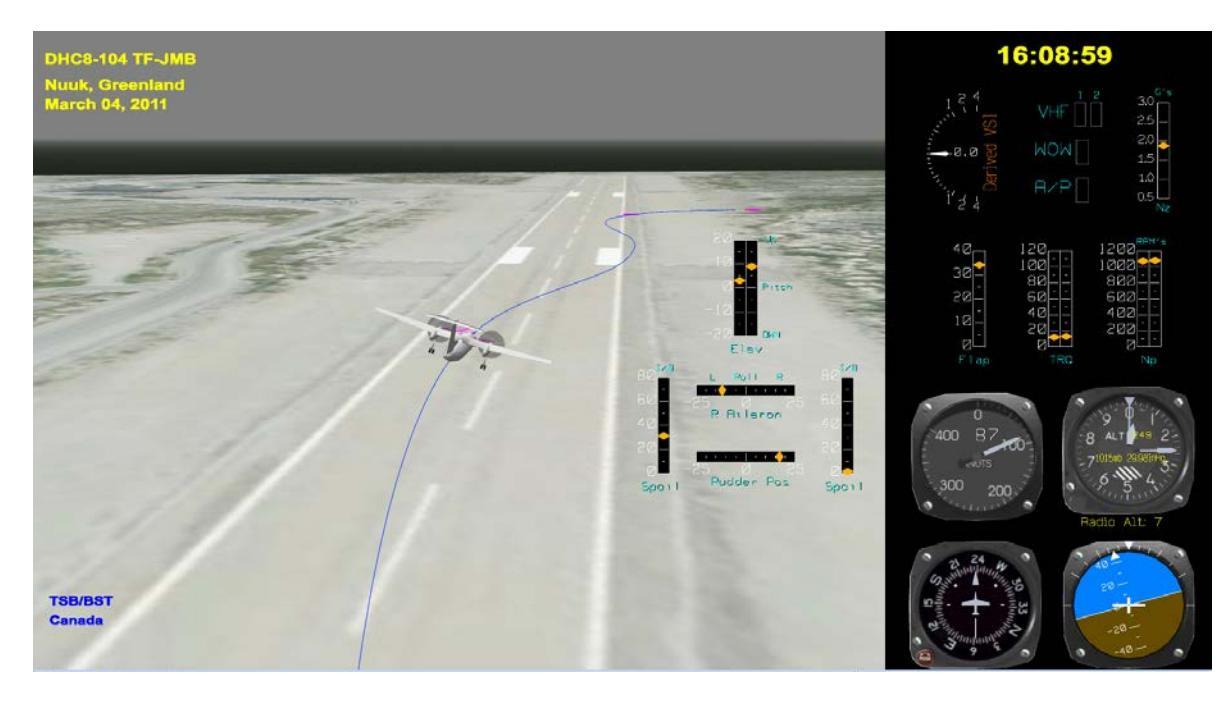
Time 16:08:59 – the flare

The aircraft was in the landing flare. The aircraft was still banking up to 17.9° to the right and the drift to the left had stopped. The aircraft was left of the runway centerline.
