No. 3

KLM Royal Dutch Airlines, Lockheed Super Constellation, crashed in
the estuary of the River Shannon, Ireland, on 5 September 1954.
Department of Industry and Commerce, Ireland,
Accident Investigation Report, released
31 January 1955.

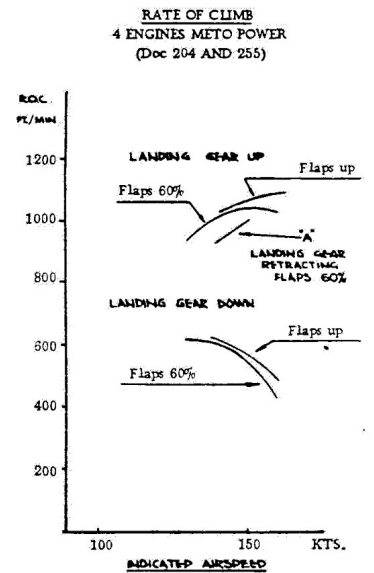
FIGURE 2
TIME HISTORY
AND
INSTRUMENT INDICATIONS

During the first 25 seconds after leaving the ground the climb was normal. During this period take-off power was reduced to METO power (maximum except take-off power) after approximately 15 to 20 seconds. At the end of this period a height was reached of approximately 40 metres. At that moment the captain considered the undercarriage to be fully retracted, and he gave the order to retract the wing flaps which at the time were in the take-off position. During this manoeuvre the take-off condition began to develop unfavourably. After the aircraft had reached a height of 50 metres (according to the indication of the altimeter 80 metres), the flight path gradually changed from a climb into a descent. The descent continued during the later part of the flight, for a period of approximately 10 seconds.
