No. 50

BEA, Viscount 701, G-ANHC and Italian Air Force, F-86E collided over Nettuno, Italy on 22 October 1958. Report released by the Ministry of Defence-Aviation, Republic of Italy - April 1959

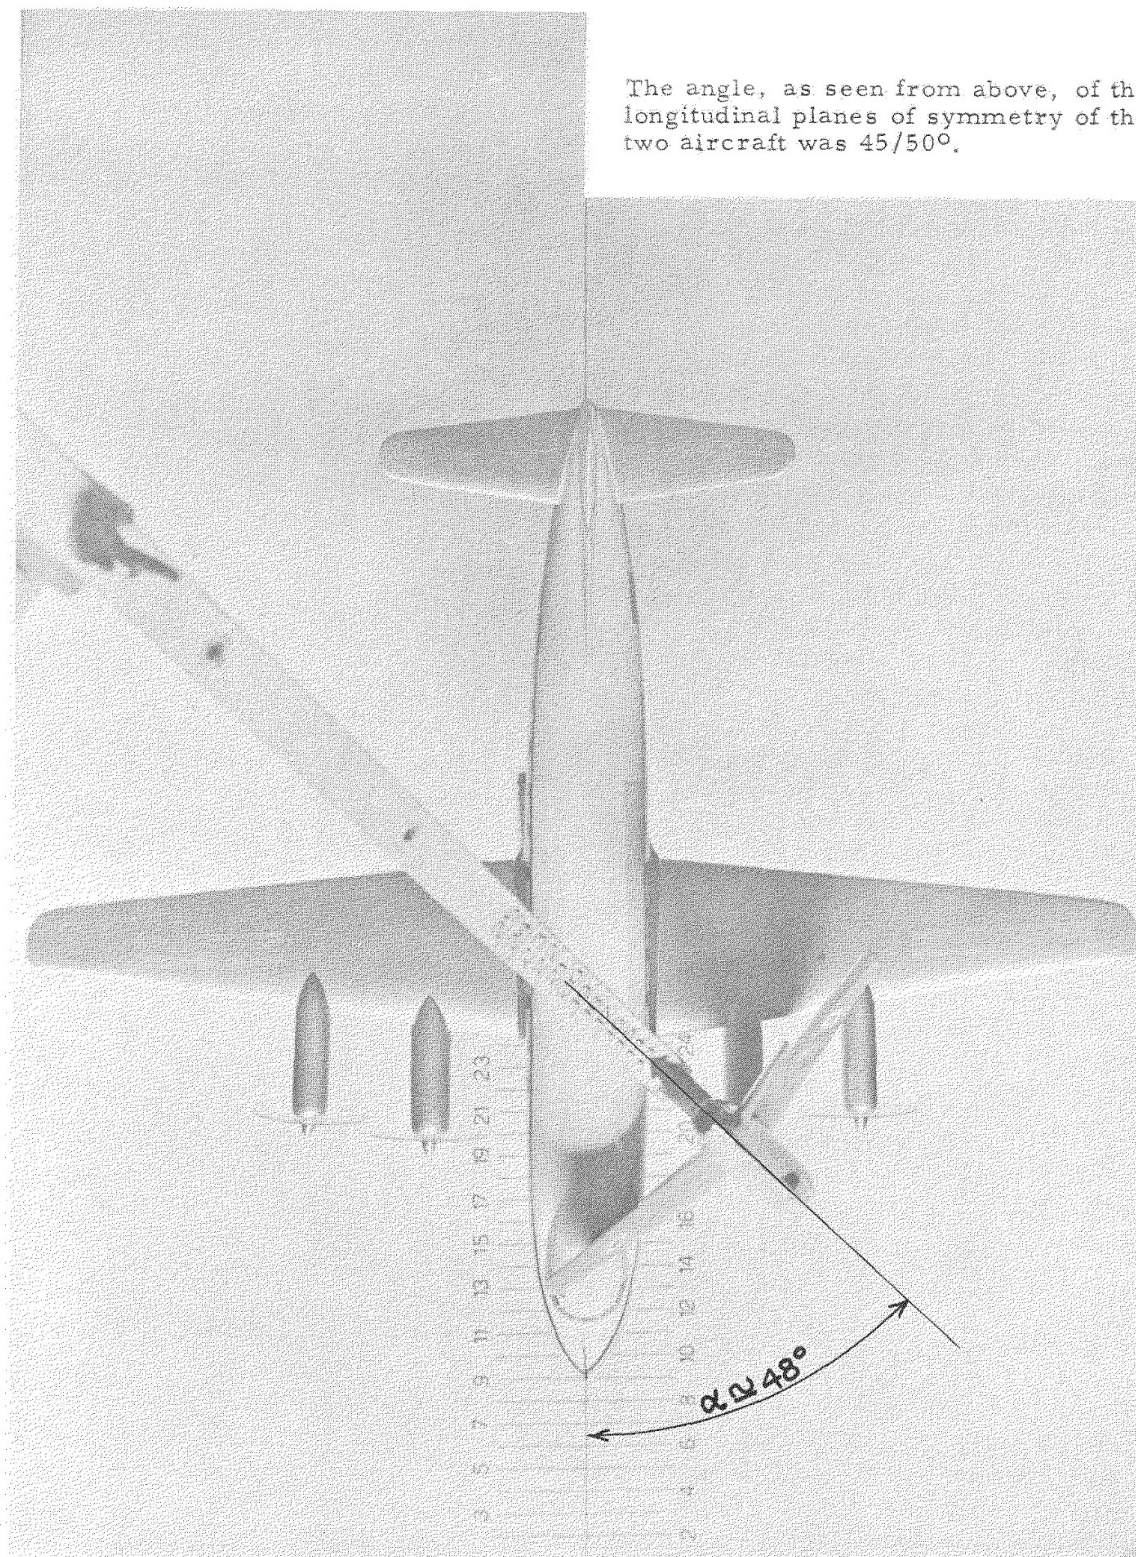
FIGURE 30

The angle, as seen from above, of the longitudinal planes of symmetry of the two aircraft was  $45/50^{\circ}$ . (See Figure 30)

The angle, as seen from above, of the longitudinal planes of symmetry of the two aircraft was 45/50°.
