AIRCRAFT ACCIDENT REPORT 2/90

Air Accidents Investigation Branch

Report on the accident to
Boeing 747-121, N739PA at
Lockerbie, Dumfriesshire, Scotland
on 21 December 1988

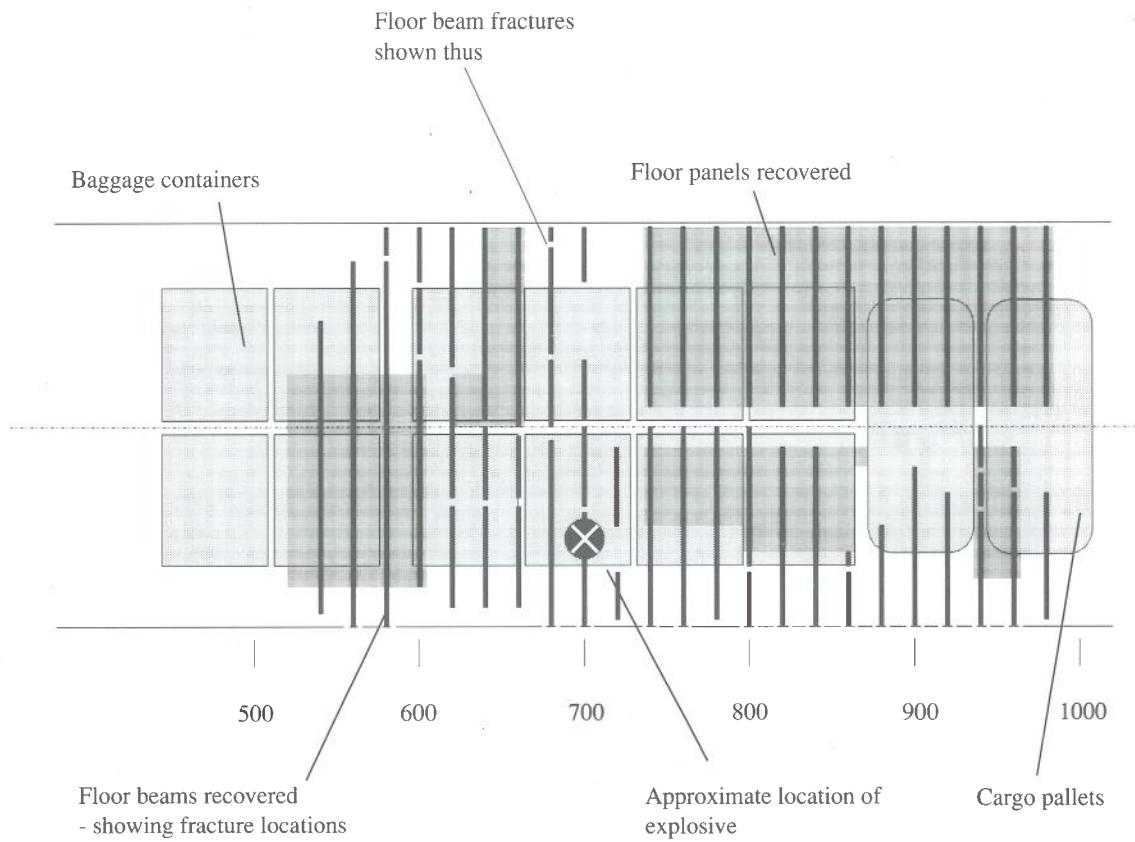
Figure B-17

Plot of floor damage in area of explosion

(structure & floor panel details based on those items recovered, identified, and incorporated into the three-dimensional reconstruction)

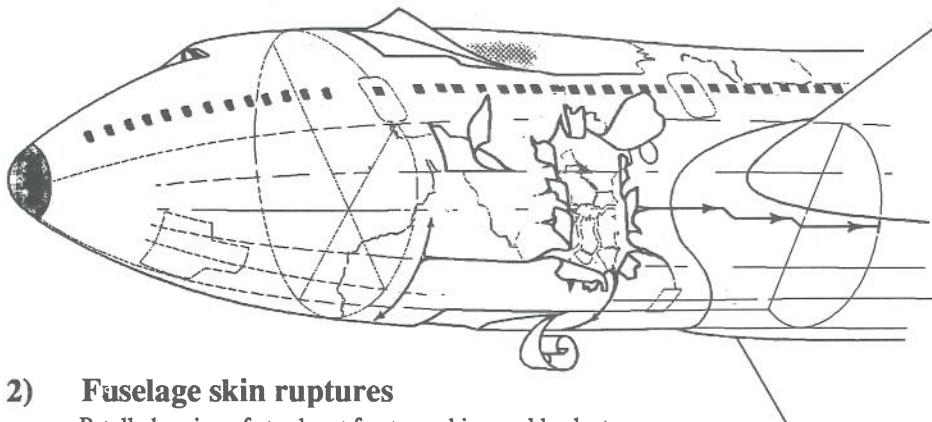
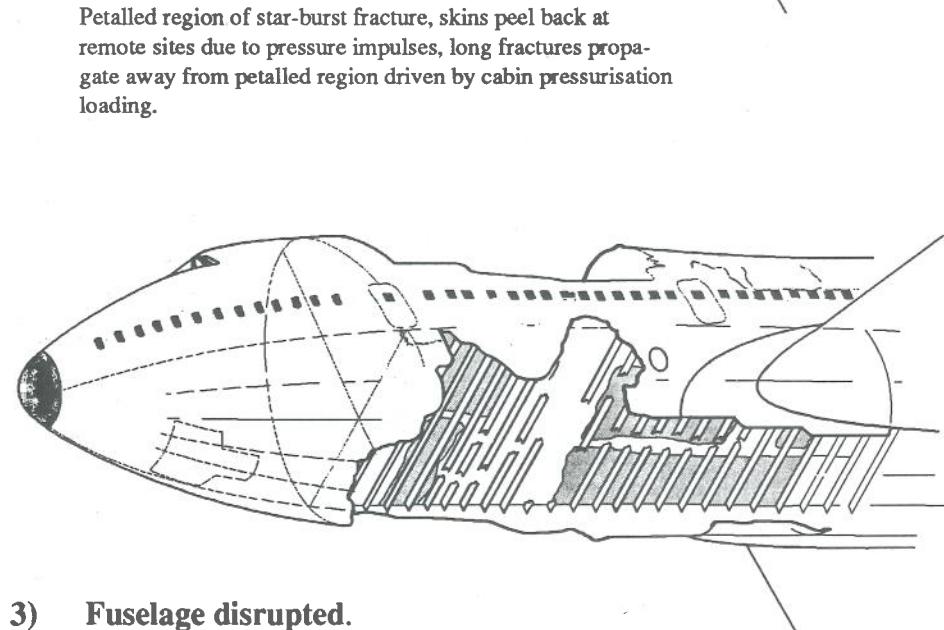
Figure B-24

1) Device detonates

2) Fuselage skin ruptures

3) Fuselage disrupted.

Fuselage Initial Damage Sequence (schematic representation)

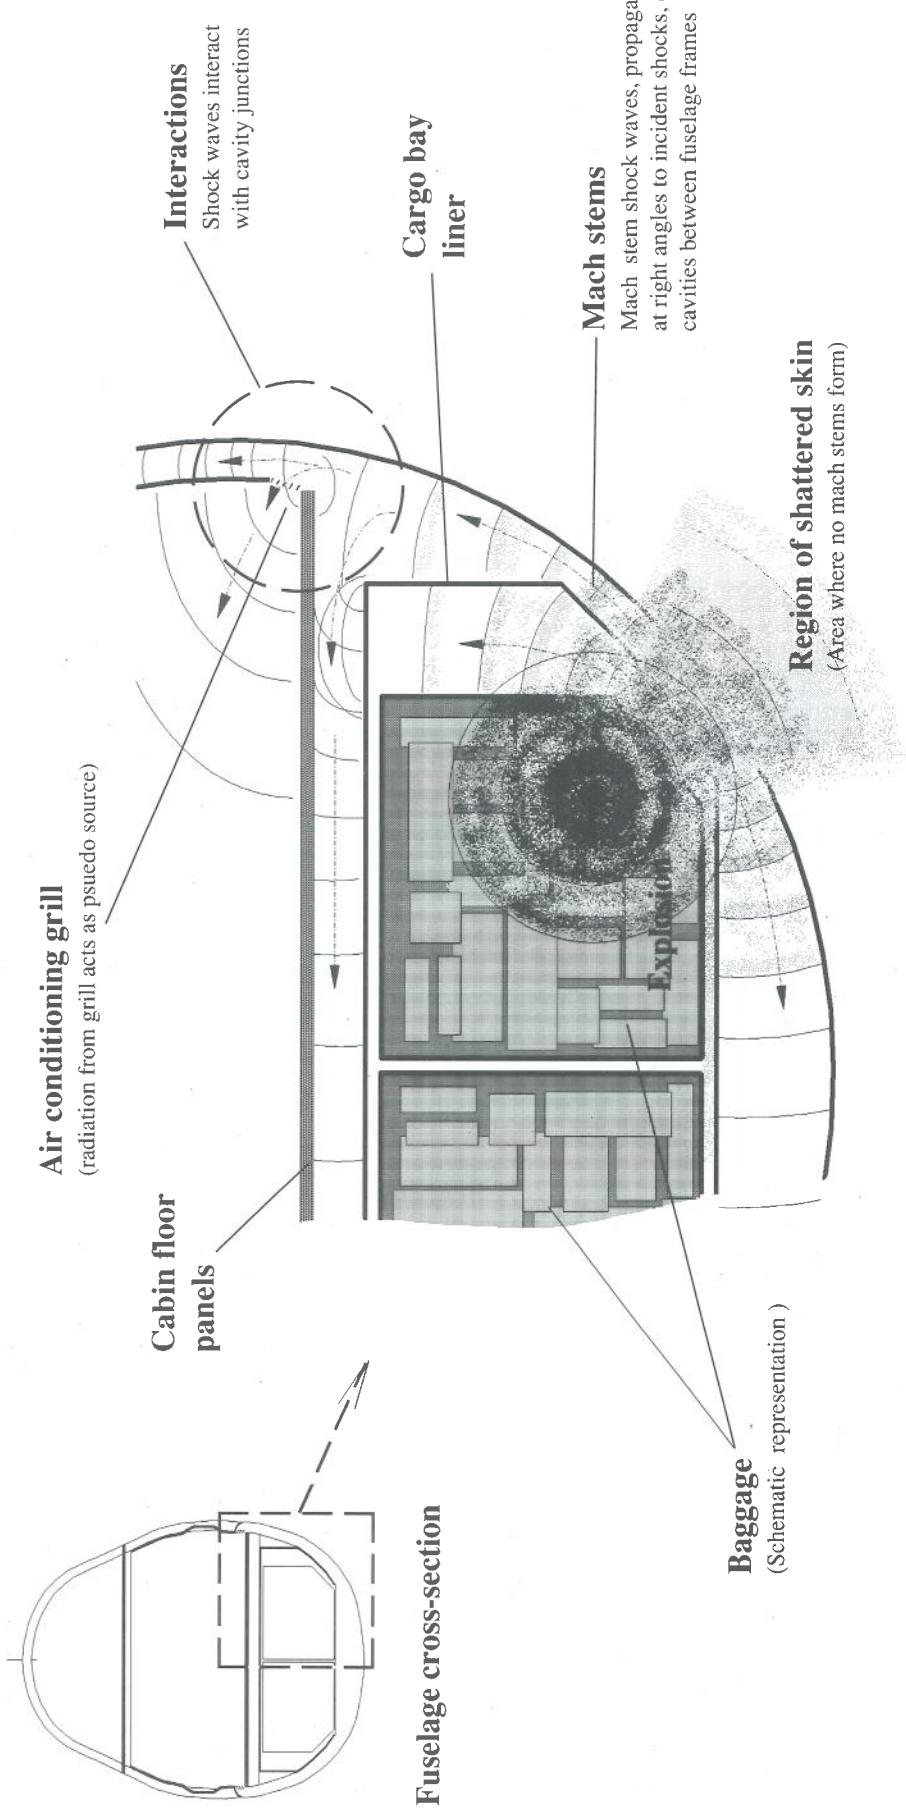
Figure B-25

Incident Shock & Regions of Mach Stem Propagation
(schematic representation)

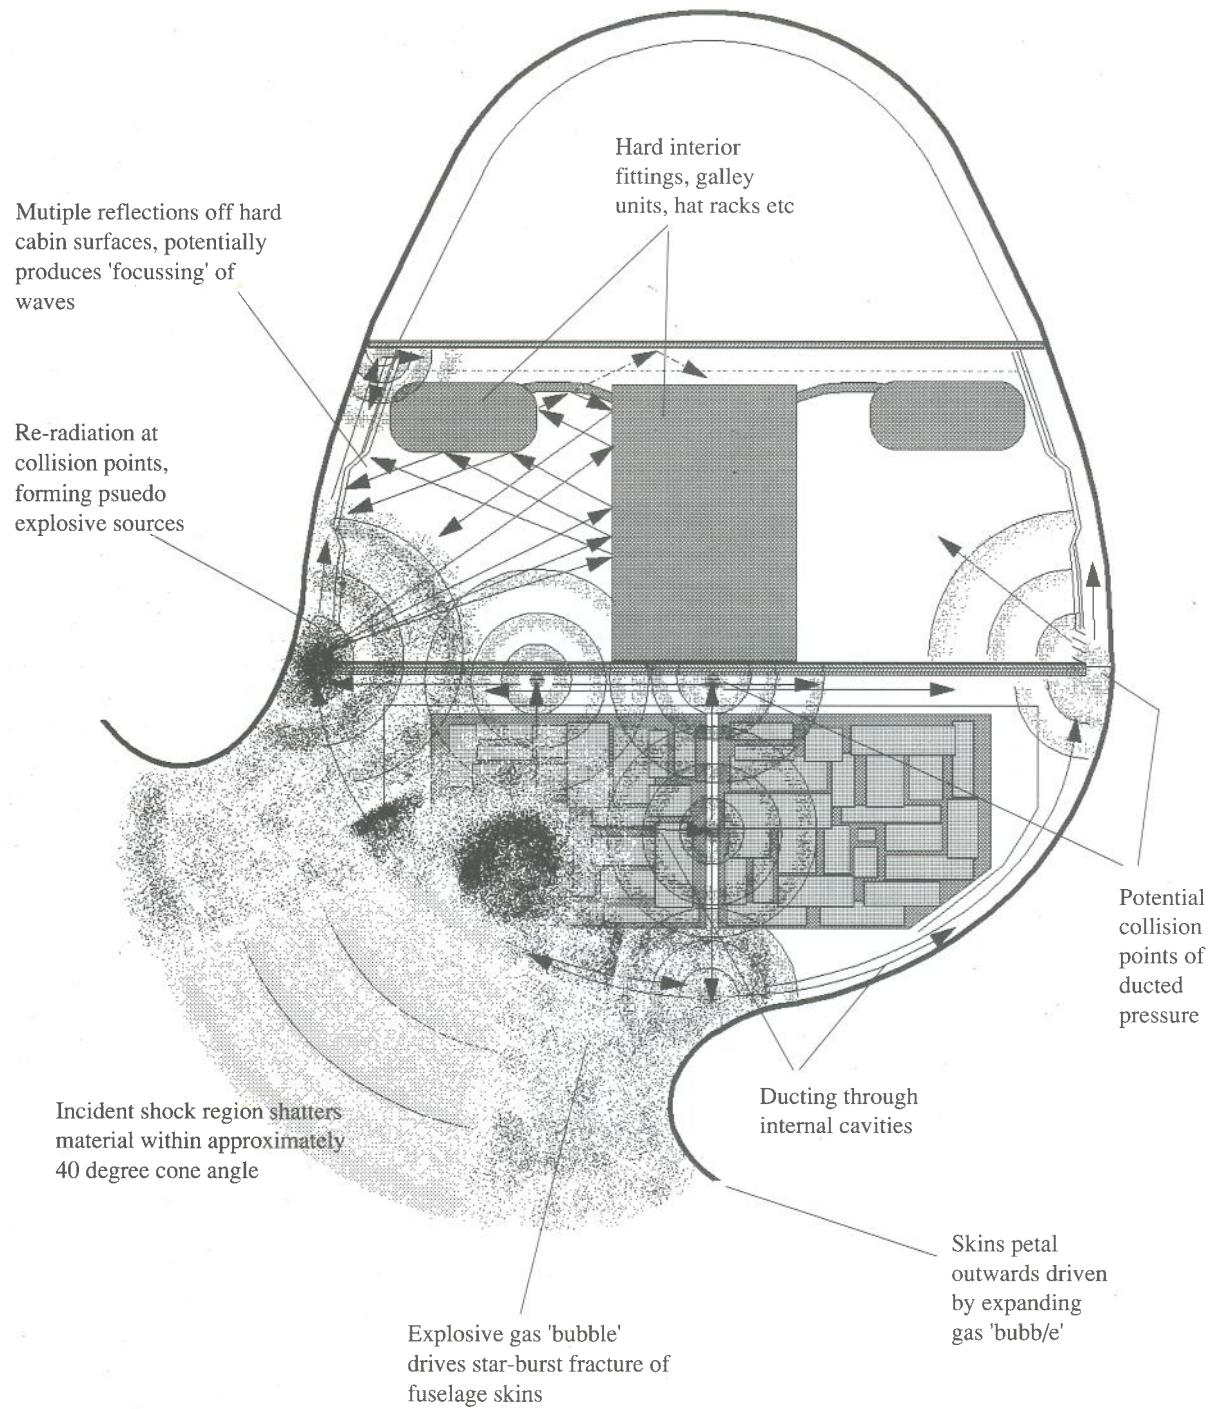
Figure B-26

Potential Shock and Explosive Gas Propagation Paths
(schematic representation)

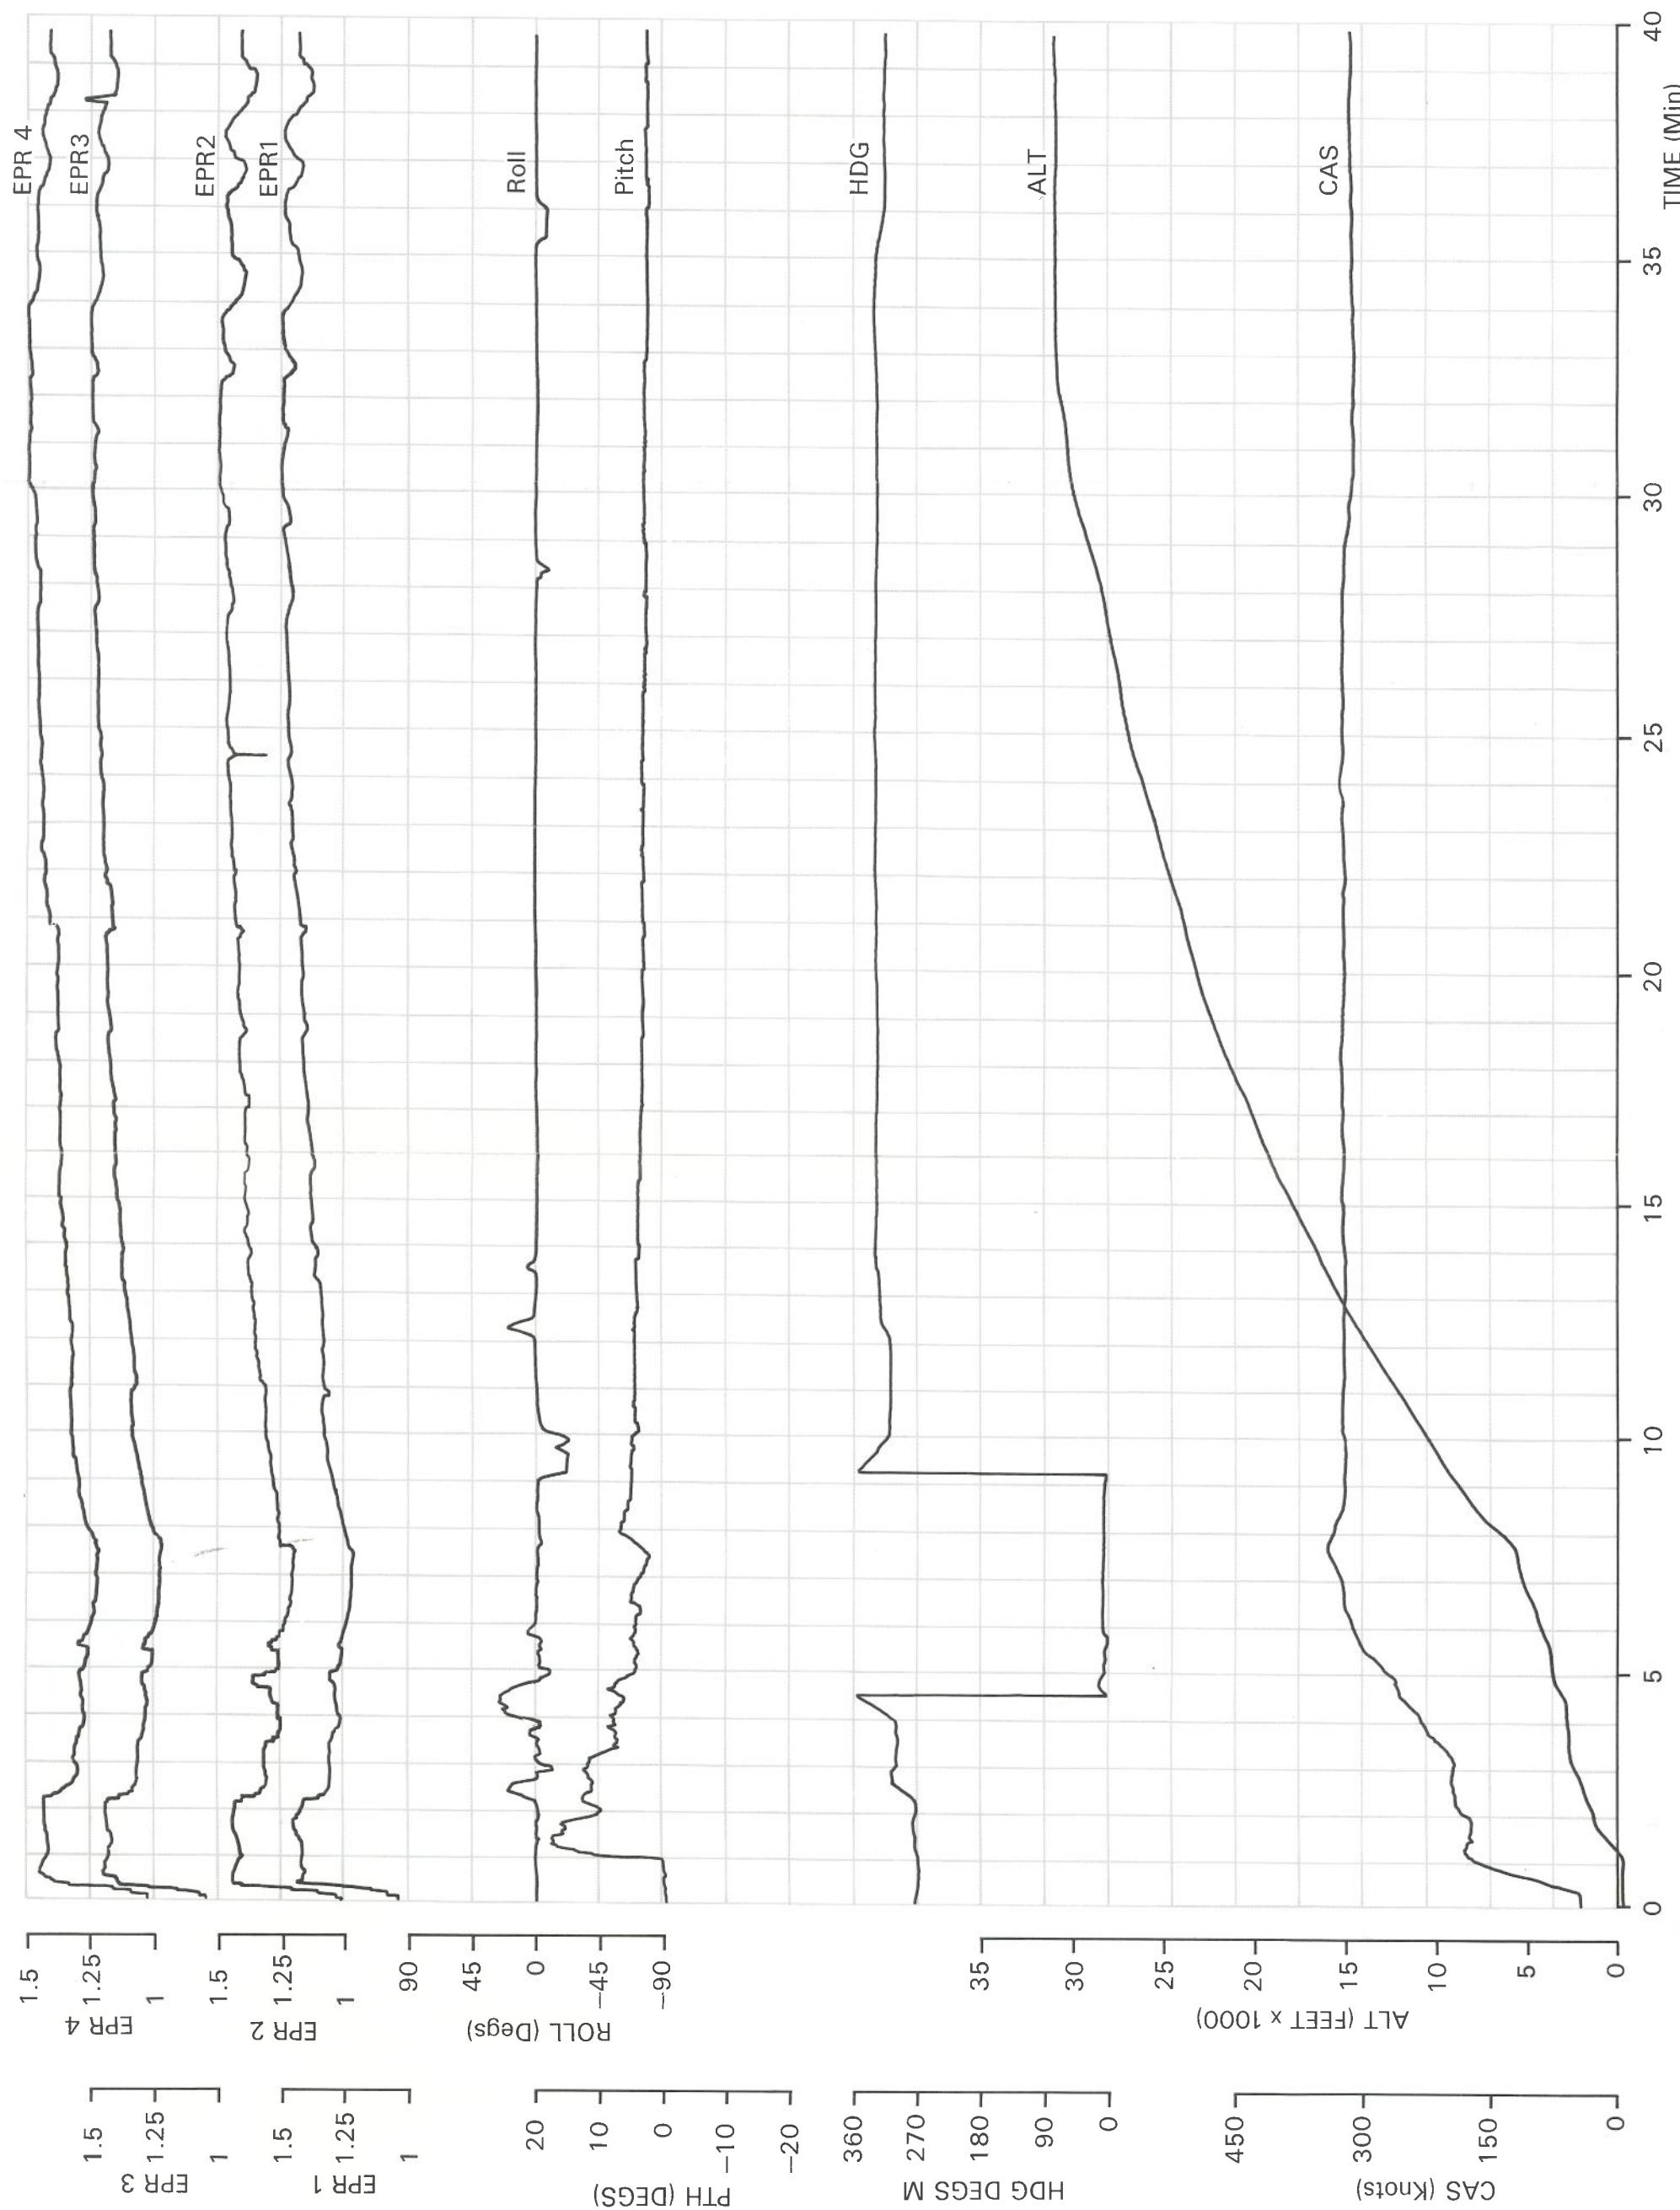
Figure C-1

The 25 hour duration of the DFDR was satisfactorily replayed. Data relating to the accident flight was recorded on track 2. The only significant defect in the recording system was that normal acceleration was inoperative. There was one area on the tape, 2 minutes from the end, where data synchronisation was lost for 1 second.

Selected DFDR parameters of final flight of N739PA

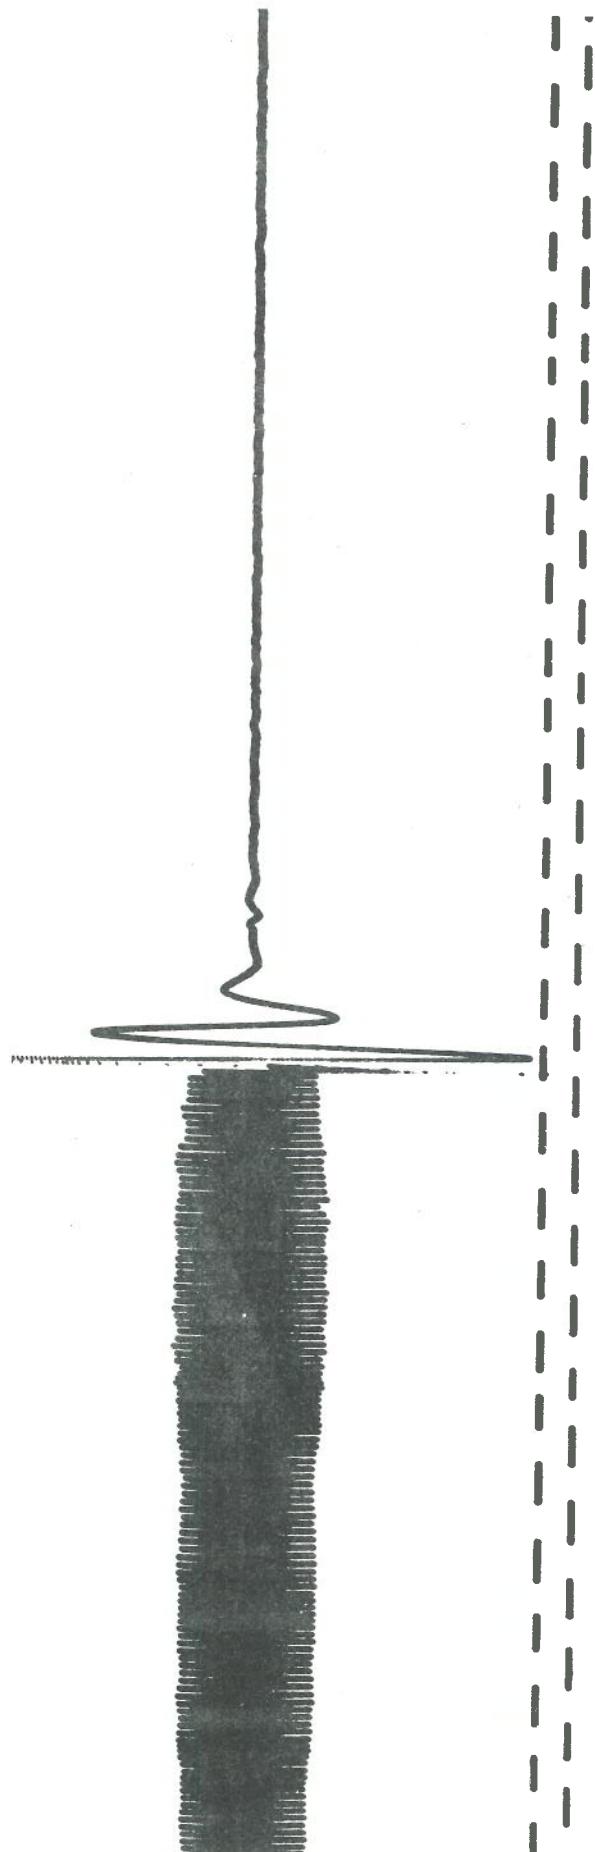
Figure C-2

To determine the mechanism that stopped the recorder a bench test rig was constructed utilizing an A100 CVR and an A152 CAM. Figures C-2 to C-5 show the effect of shorting, earthing or disconnecting the CAM signal wires. Figure C-8 shows the CAM channel signal response to the event which occurred on Flight PA103. From this it can be seen that there are no characteristic transients similar to those caused by shorting or earthing the CAM signal wires. Neither does the signal stop cleanly and quickly as shown in Figure C-5, indicating that the CAM signal wires were not interrupted. The UV trace shows the recorded signal decaying in a manner similar to that shown in Figure C-6, which demonstrates the effect of disconnecting electrical power from the recorder. The tests were

The effect on the recorded signal of shorting
the signal wires to the CAM

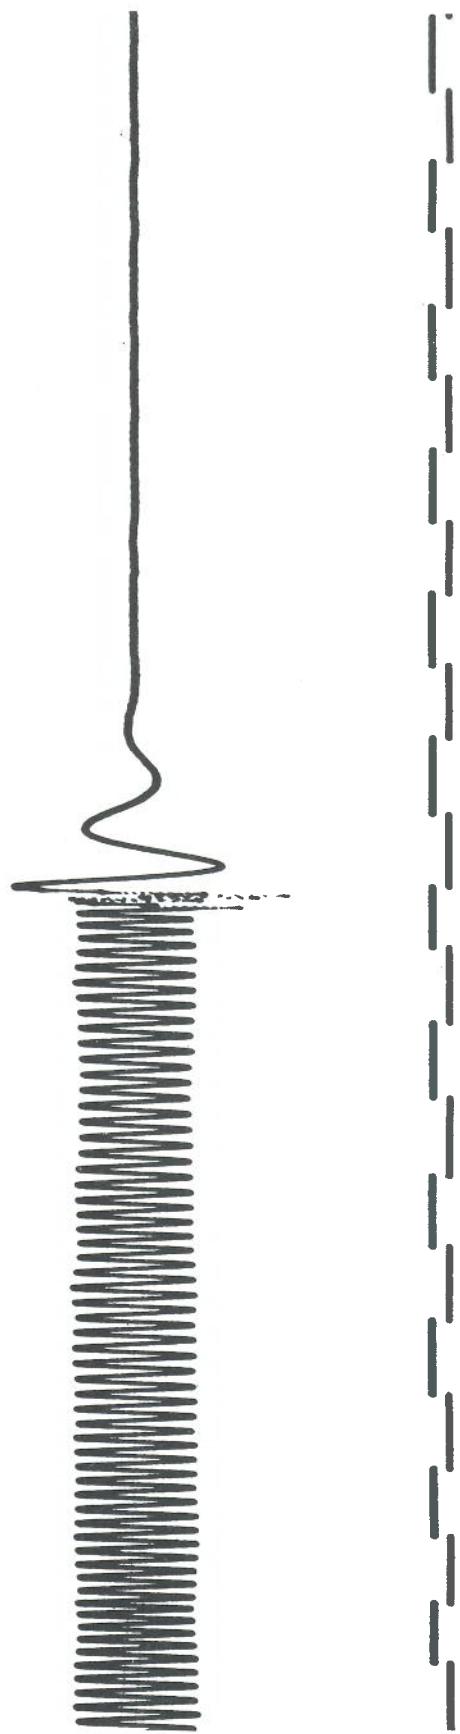
Figure C-3

The effect on the recorded signal of earthing
the hi wire to the CAM

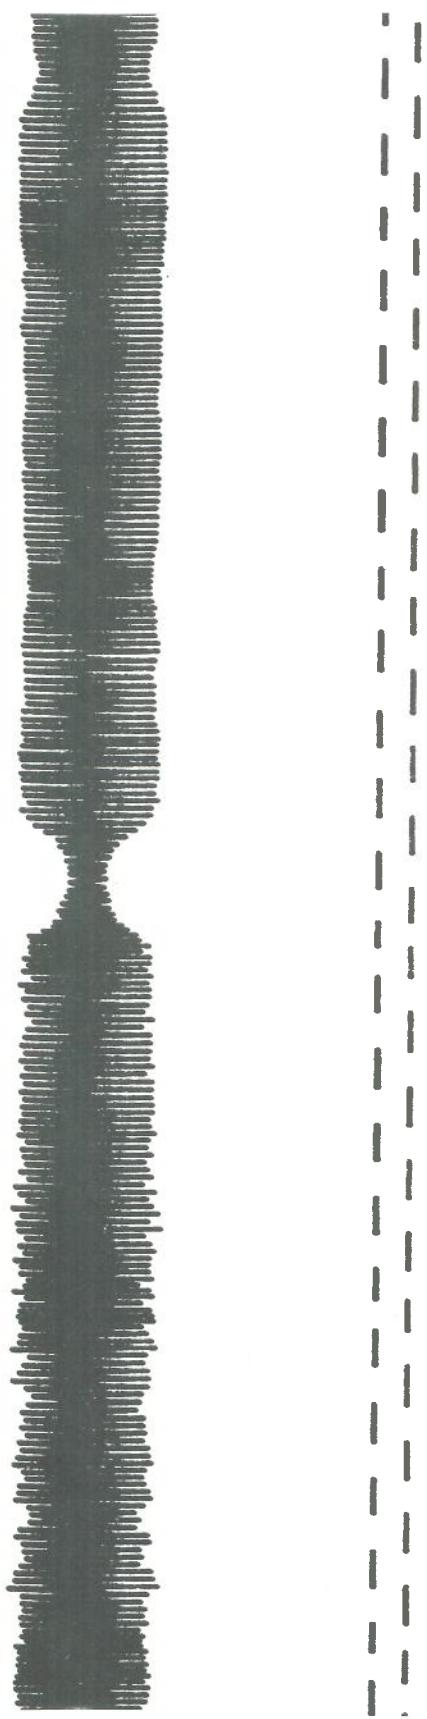
Figure C-4

The effect on the recorded signal of earthing
the lo wire to the CAM

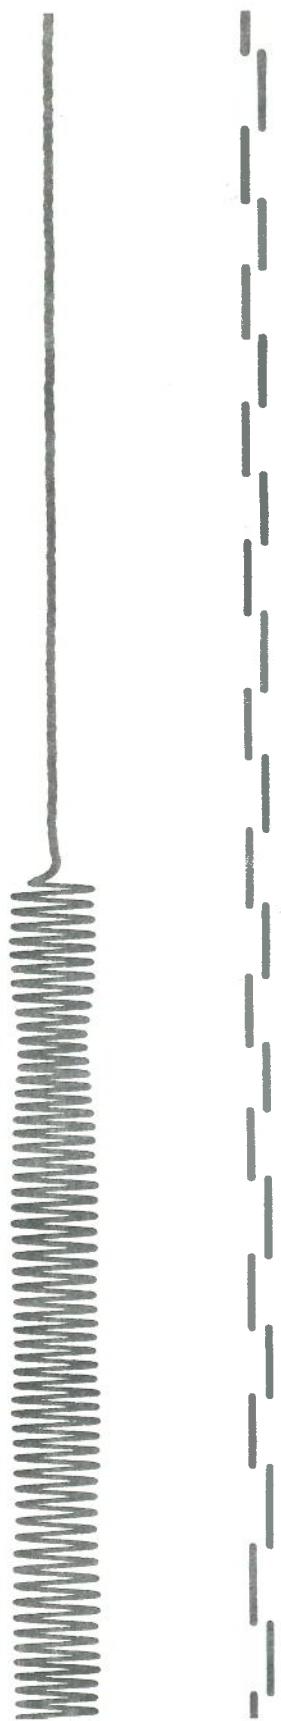
Figure C-5

The effect on the recorded signal of disconnecting
the CAM signal wires

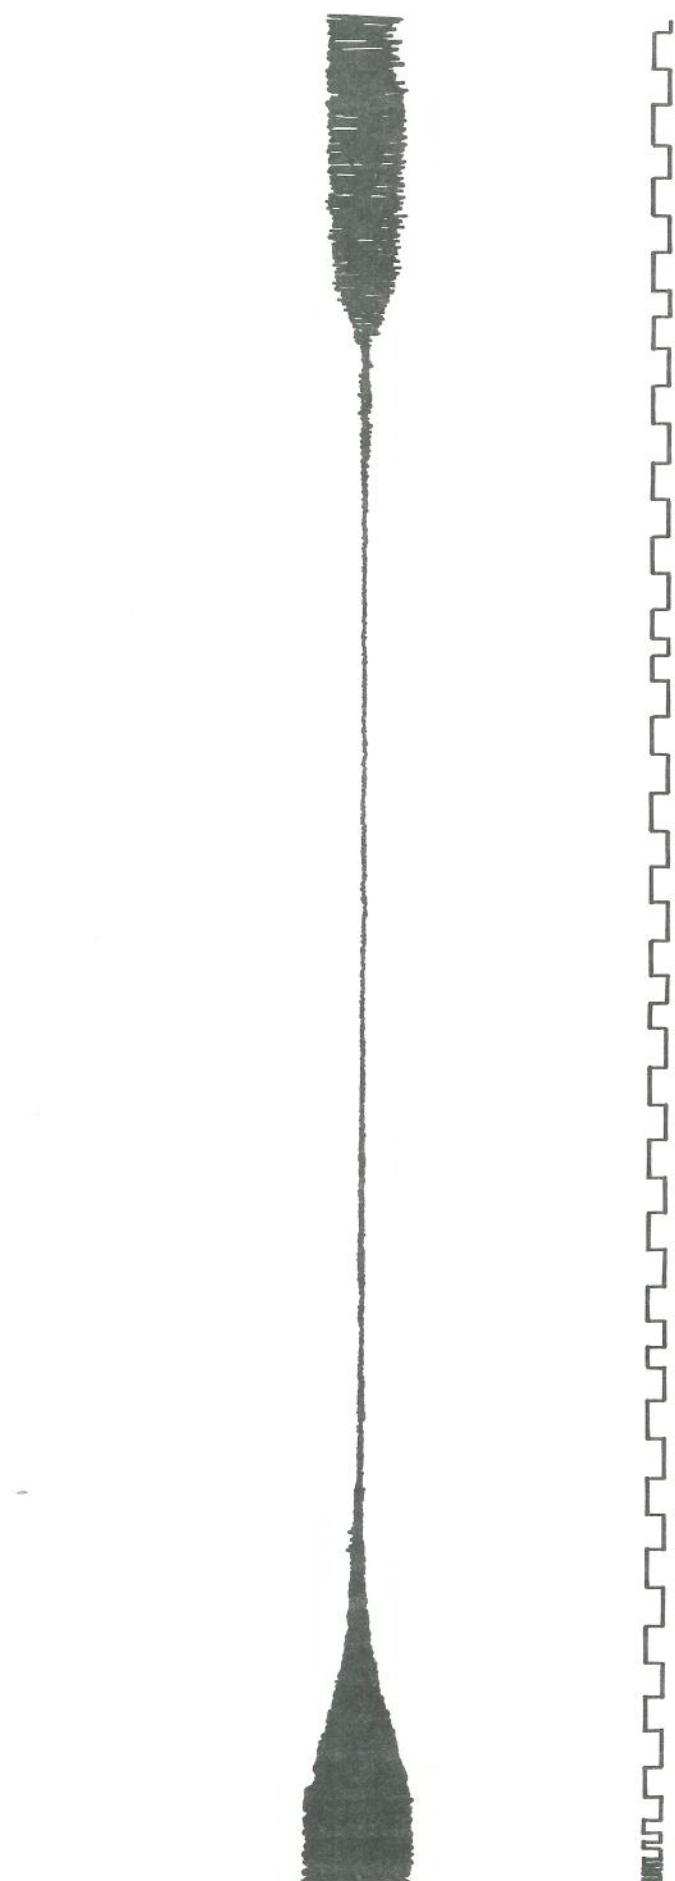
Figure C-6

Both methods of signal representation were used to determine the manner by which the recorder stopped. There was no gap between the most recently recorded data and the 25 hour old data. This showed that the recorder stopped while there was an incoming data stream from the FDAU. The recorder, therefore, stopped because its electrical supply was disconnected. The tape signal was examined for any transients or noise signals that would have indicated the presence of electrical disturbances prior to the recorder stopping. None was found and this indicated that there had been a quick clean break of the electrical supply.

The effect on the recorded CAM signal of disconnecting
the CVR power supply

In order to respond to events that result in the almost immediate loss of the aircraft's electrical power supply it was therefore recommended during the investigation that the regulatory authorities consider requiring CVR systems to contain a short duration (i.e. no greater than 1 minute) back-up power supply.

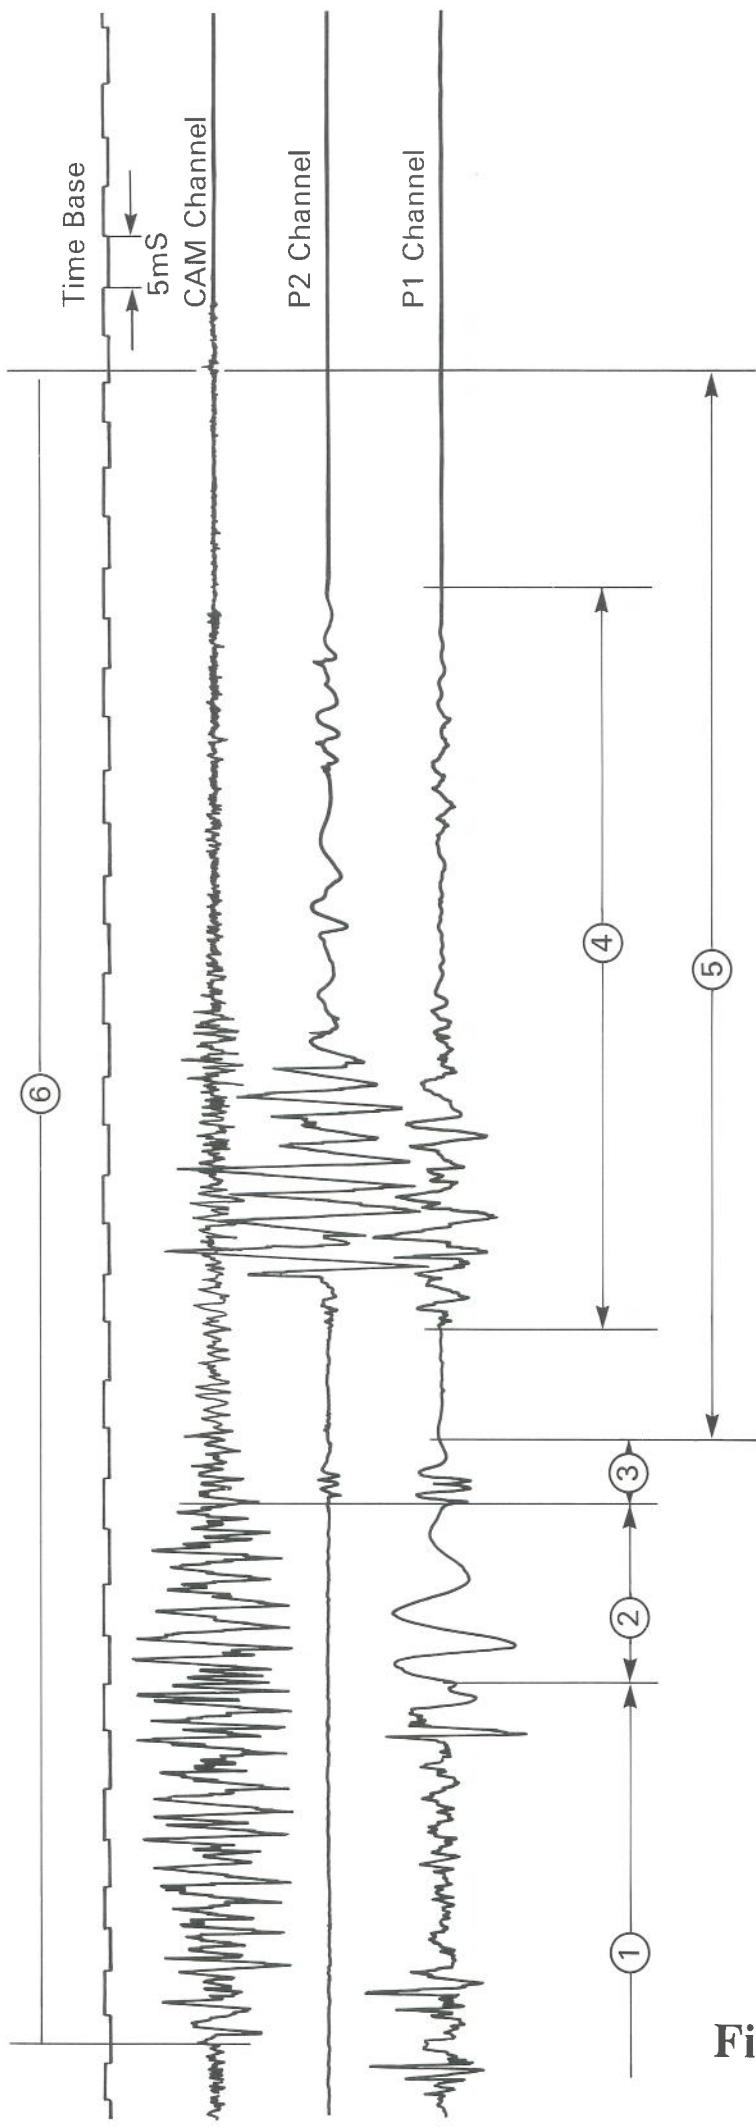
Figure C-8 is an expanded UV trace of the final milliseconds of the CVR record. Three tracks have been used, the flight engineer's RTF channel which contained similar information to the P2's channel has been replaced with a timing signal. Individual sections of interest are identified by number. On the bottom trace, the P1 RTF track, section 1 is part of the Shanwick transatlantic clearance. During this section the loud sound on the CAM channel is evident.

The CAM unit is of the old type which has a frequency response of 350 to 3500 Hz. The useable duration of the signal is probably confined to the first 60 milliseconds of the final 170 milliseconds and even during this period the AGC is limiting the signal. In the remaining time the sound is being distorted because power to the recorder has been disconnected. The ambient cockpit noise may have been high enough to have caused the AGC to have been active prior to the event and in this event the full volume of the sound would not be audible. Distortion from the incomplete erasure of the last recording may form part of the recorded signal.

The end of the recorded signals from the CVR of the final flight of N739PA

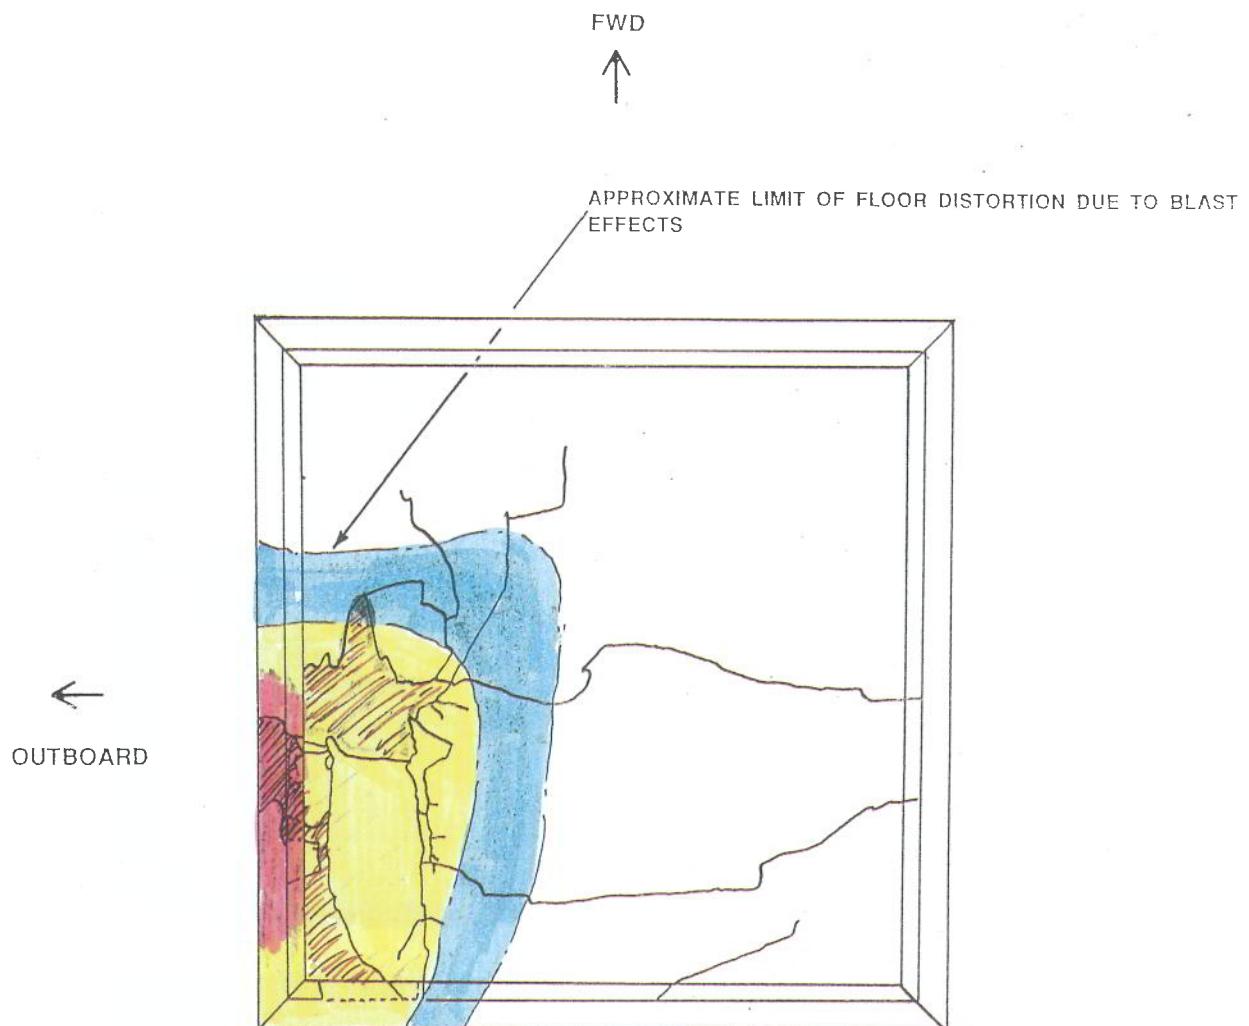
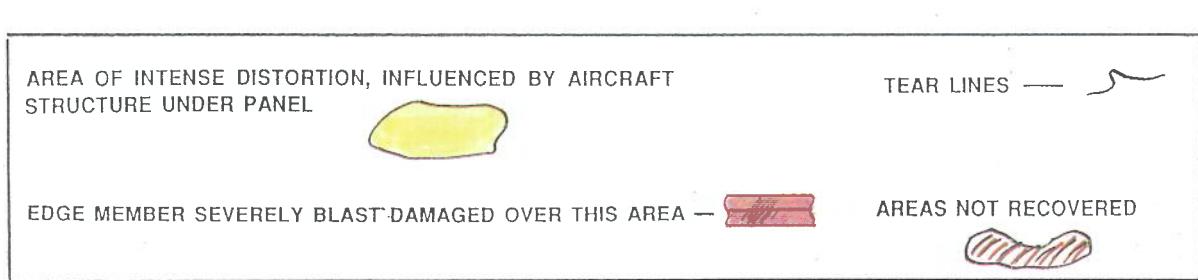
Figure F-4

BAGGAGE CONTAINER FLOOR DAMAGE DIAGRAM

N739PA - FLOOR PANEL MAP FROM CONTAINER

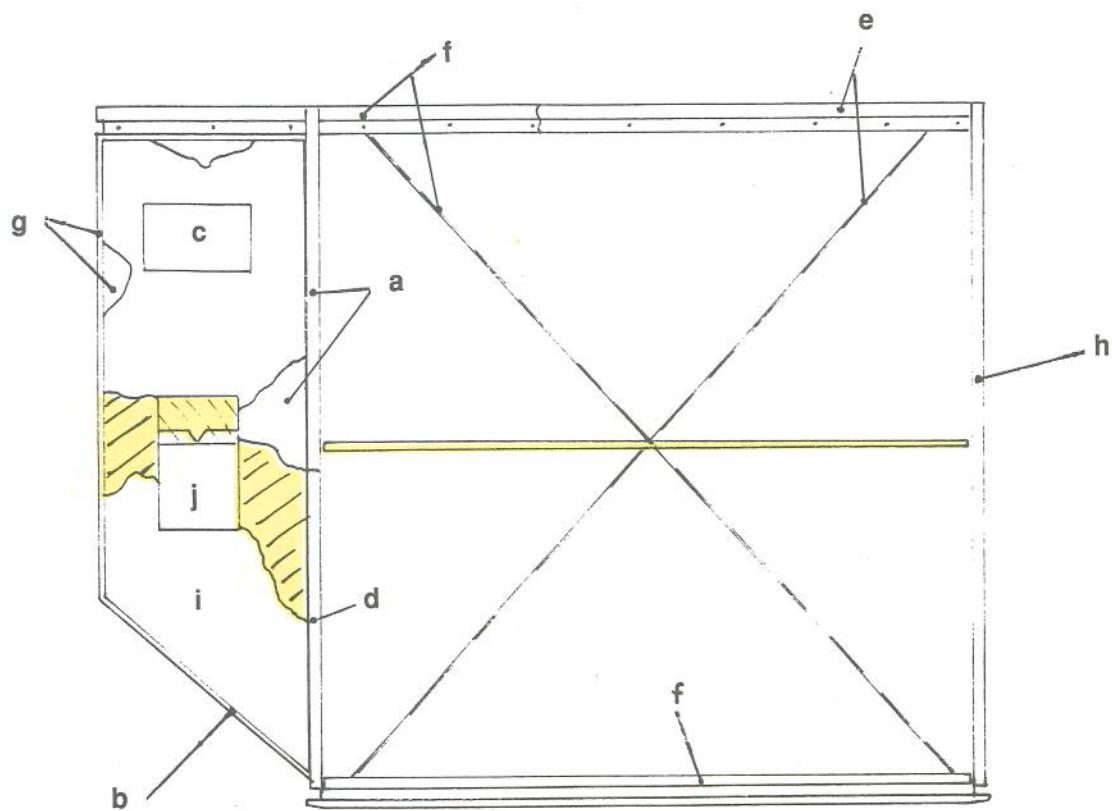
Figure F-5

- a Curtain aperture left side vertical edge member, upper half
- b Sloping face edge member
- c Container manufacturer's data plate containing burnt piece of material which itself contained a fragment of circuit board
- d Curtain aperture left side vertical edge member, lower half
- e Upper edge member, right half, attached to roof edge member and one curtain bar
- f Upper edge member, left half, attached to roof edge member, cutrain wire and lower curtain bar
- g Left edge vertical member
- h Curtain aperture right side vertical member
- i Left side lower skin section adjoining sloping face
- j Soot stained plastic sheet

Aft face of container AVE 4041 PA, view looking forward

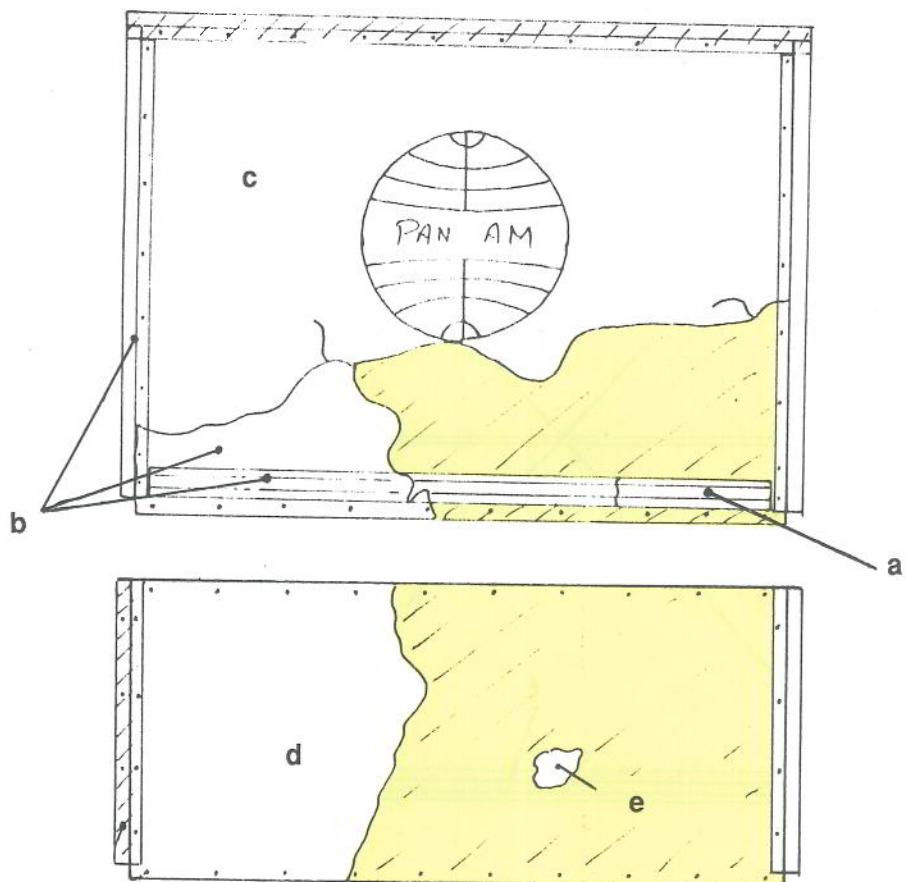
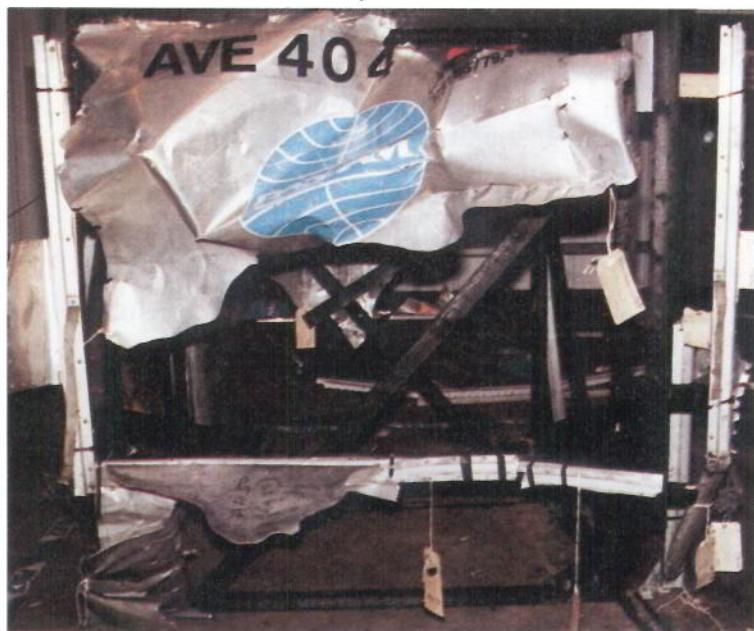
Figure F-6

- a** Stiffener section from base of vertical face
- b** Vertical face forward edge member, lower stiffener section and skin fragment
- c** Distorted upper section of vertical face skin
- d** Forward section of sloping face skin, severely distorted
- e** Fragment of container skin, provisionally thought to be part of sloping face skin.

Outboard faces of AVE 4041

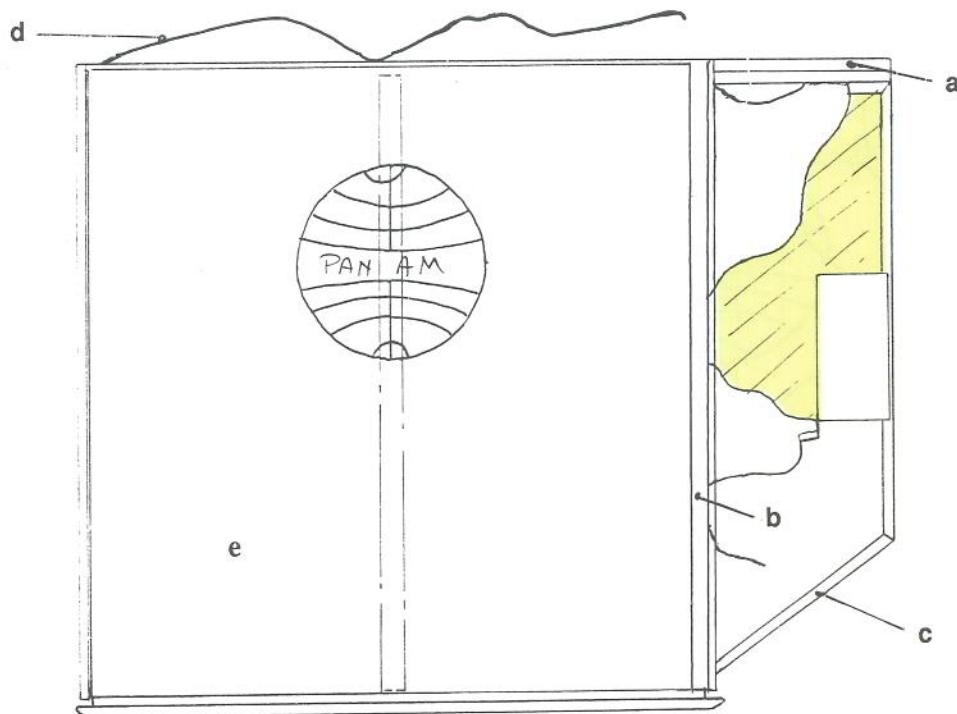
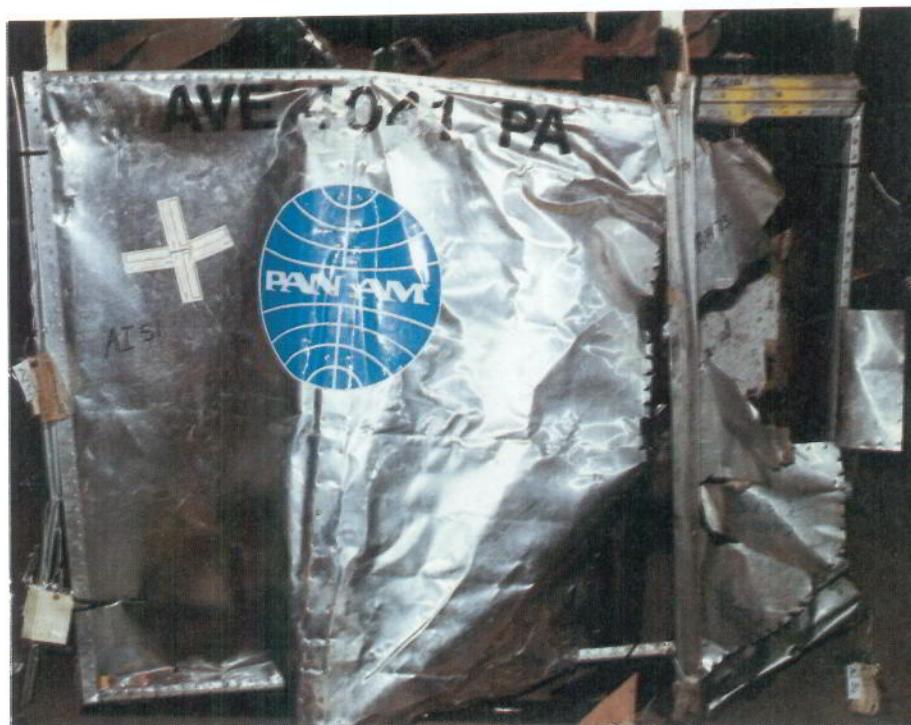
Outboard section of roof edge member

- b Forward face outboard skin, attached to vertical edge member
- c Forward edge member of sloping face
- d Roof skin panel, complete except for aft outboard corner
- e Forward face panel, complete with top, left and lower edge members

Forward face of AVE 4041 PA
Figure F-7

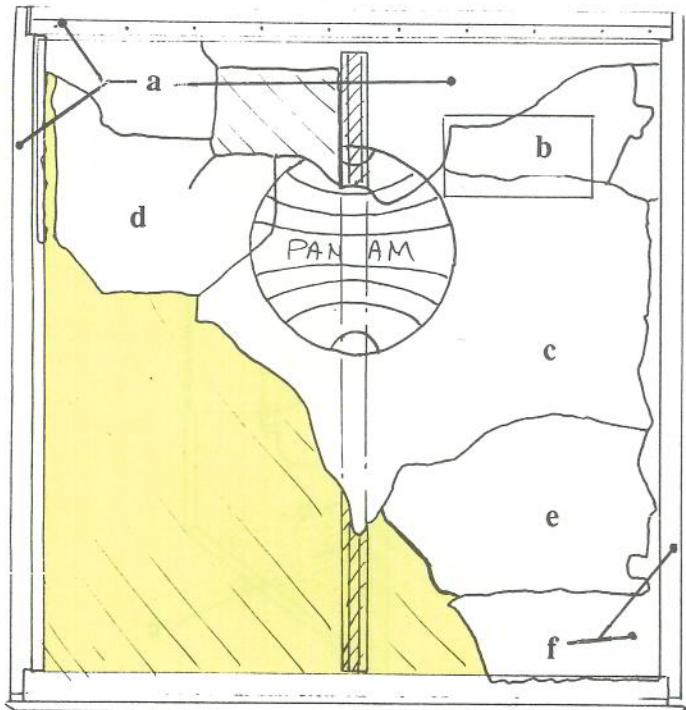
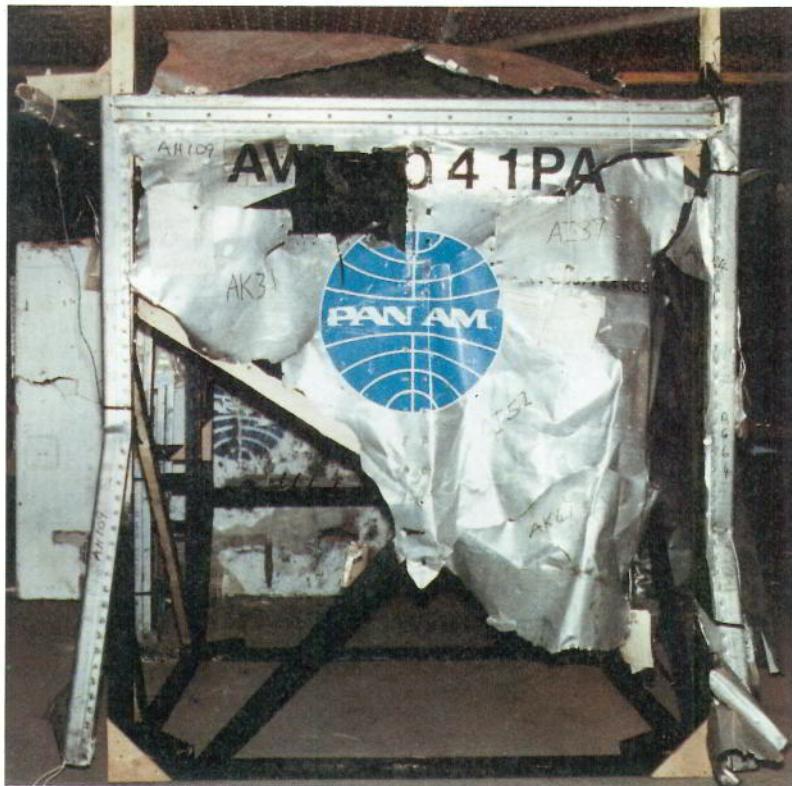
Figure F-8

- a** Aft, top and roof edge members including upper section of skin
- b** Repair patch from upper right side
- c** Mid section of skin including stiffener section
- d** Upper skin section
- e** Lower skin section
- f** Right side vertical edge member attached to lower piece of skin

Inboard face of container AVE 4041 PA
