AIRCRAFT ACCIDENT REPORT 2/90

Air Accidents Investigation Branch

Report on the accident to
Boeing 747-121, N739PA at
Lockerbie, Dumfriesshire, Scotland
on 21 December 1988

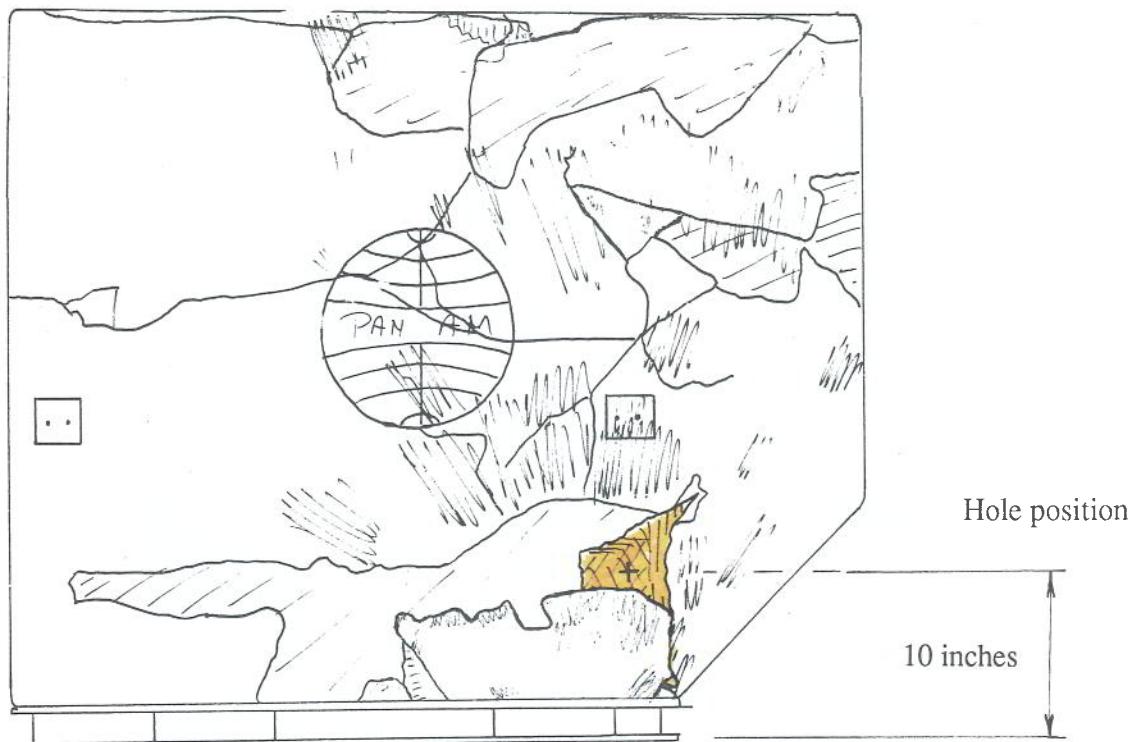
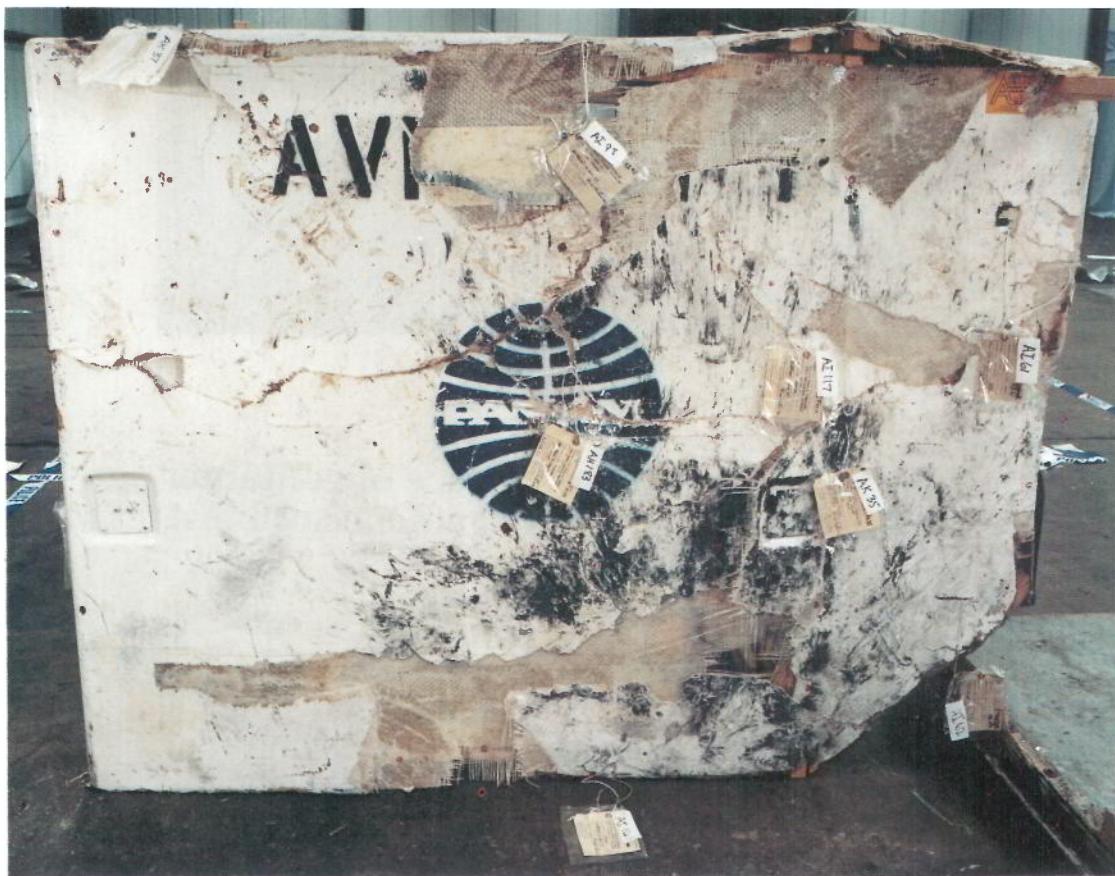
Figure F-10

**Detail of items from aft face of container
AVE 4041 PA showing evidence of blast
damage**

**Forward face of container AVN 7511 PA,
view looking aft**
