AVIATION INVESTIGATION REPORT

A15Q0120

Loss of control and collision with terrain

Air Saguenay (1980) inc.
de Havilland DHC-2 Mk. 1 (Beaver), C-FKRJ
Tadoussac, Quebec, 7 nm N
23 August 2015

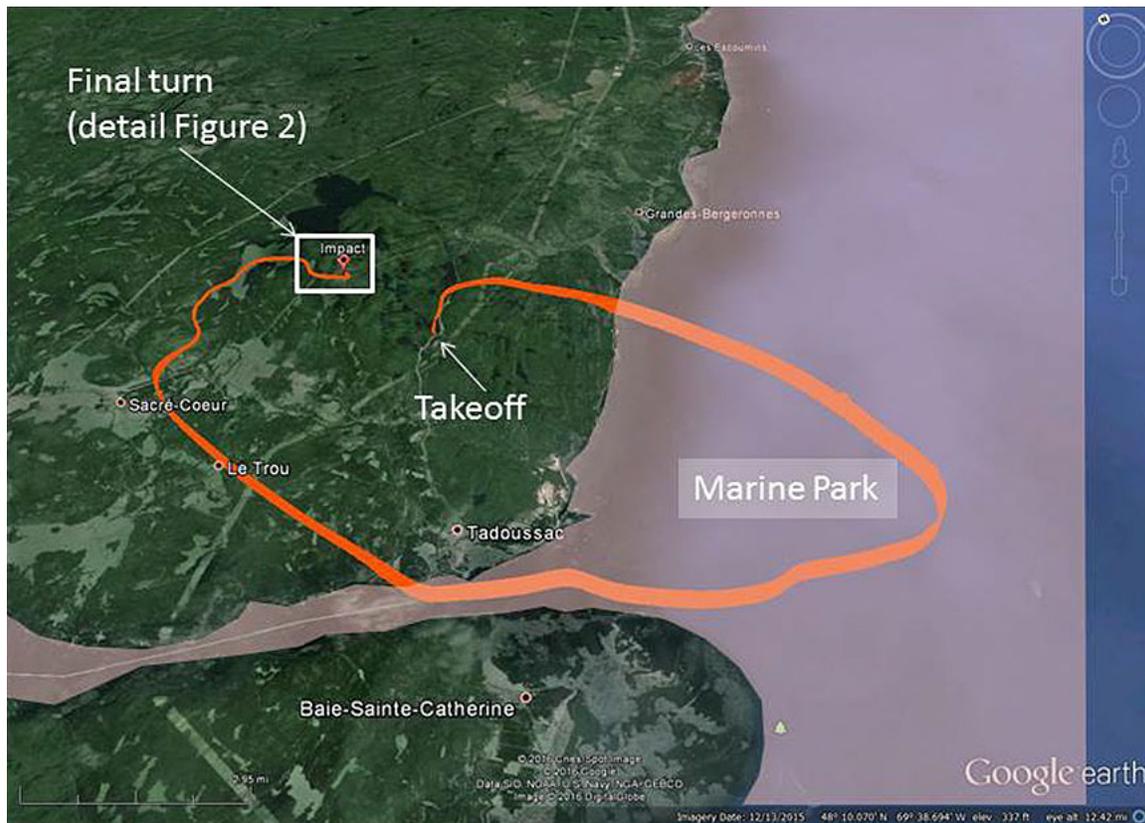
Figure 1. Flight path based on data from global positioning system (Source: Google Earth, with TSB annotations)

After takeoff, C-FKRJ climbed to 2000 feet above sea level (ASL), then headed south above the Saguenay–St. Lawrence Marine Park,³ flying over this area from 1107 to 1116. It then passed above the mouth of the Fjord du Saguenay before turning north and leaving the restricted zone of the marine park (Figure 1).

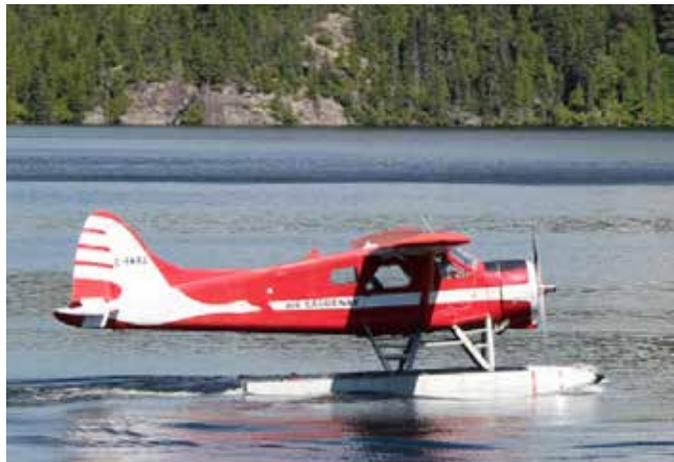
Figure 3. C-FKRJ (Source: J. Arcelin)

C-FKRJ had a single set of flight controls that could be pivoted to the left or right side of the cockpit. The aircraft was equipped with EDO 58-4580 floats in accordance with a type A-22 certificate (Figure 3).

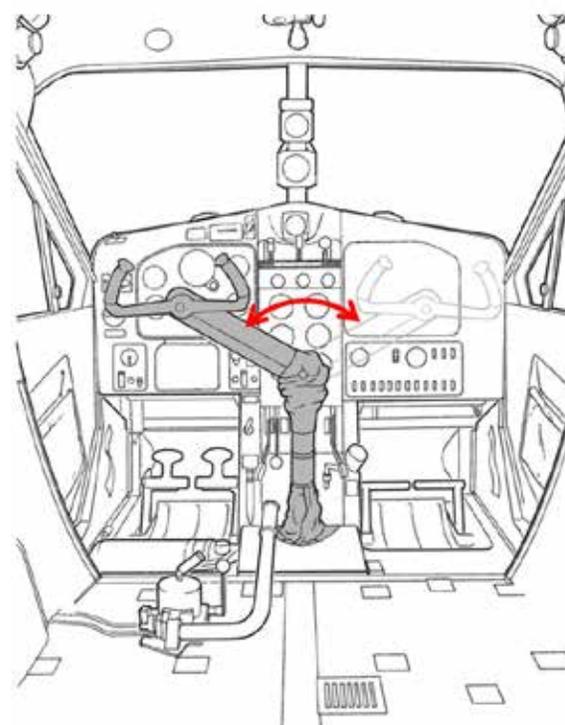
Figure 4. Flight controls (Source: DHC-2 Beaver flight manual, Figure 1-5, with TSB annotations)

The primary flight controls of the DHC-2 are conventional and consist of a control column and rudder pedals. C-FKRJ did not have a handwheel on the right side (that of the co-pilot). However, it did have a control column, the upper portion of which includes the handwheel and can tilt from left to right. It is held in position by a bolt in the hinge (Figure 4). Tilting the handwheel in straight flight does not affect the aircraft's control or balance.

The damage observed on the hinge bolt and on the flight control column are consistent with what would have been caused by forward deformation with the control wheel in the left-hand position (pilot side) at the moment of impact.

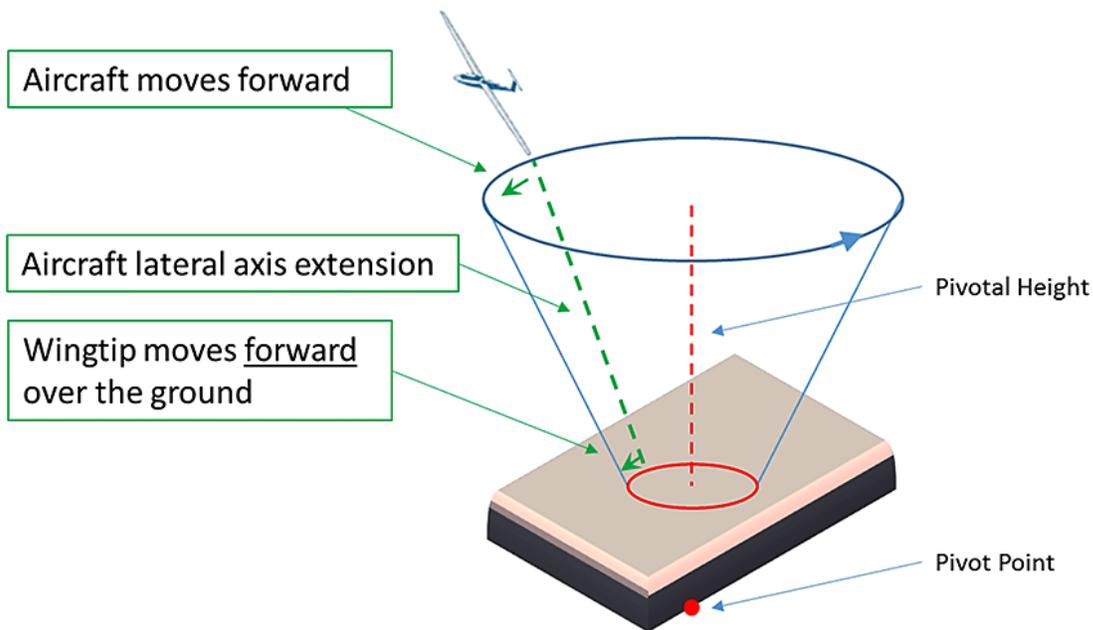
Figure 12. Turn below pivotal height (Source: Based on original image by R. Hildesheim)

When turns are made below pivotal height, the lower wingtip moves forward over the ground in the same direction as the aircraft. If the pilot focuses on a point on the ground near the centre of the turn, it may seem that the lower wingtip is moving faster than usual, which may prompt the pilot to apply rudder toward the inside of the turn. If the speed is close to the stall speed, this rudder input may cause the lower wing to stall, leading to an incipient spin (Figure 12).

In this accident, C-FKRJ initiated a turn at approximately 110 feet AGL, whereas the pivotal height for the turn was 328 feet AGL.⁴⁷

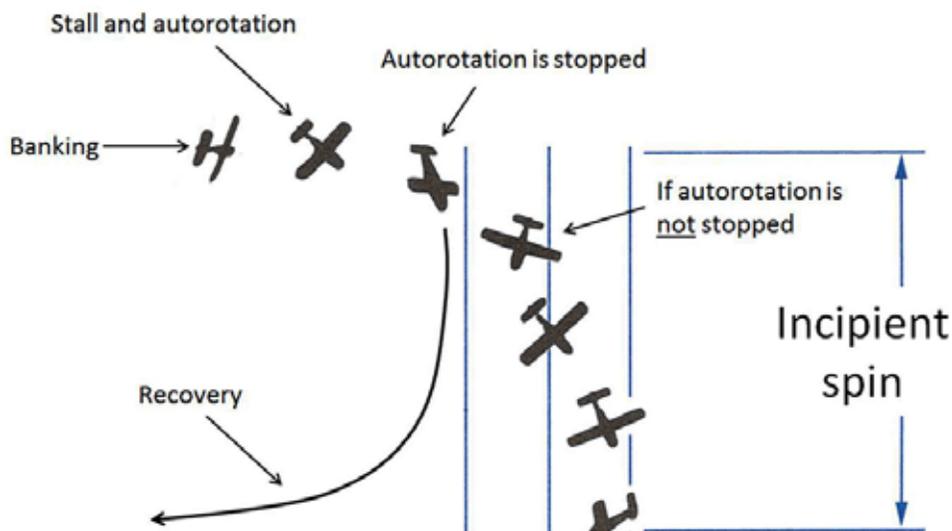
Figure 14. Incipient spin (Source: Transport Canada, TP 1102, *Flight Training Manual*, 4th edition, with TSB annotations)

An incipient spin occurs when an aircraft stalls and one wing produces more lift than the other. Because the descending wing is at a greater angle of attack, it stalls even further and has more drag, which triggers an autorotation. During this phase of the incipient spin, the flight path changes from horizontal to vertical.⁴⁹

Generally, even if the pilot takes the necessary measures to stop the autorotation as soon as it begins, the aircraft is in a vertical position while accelerating rapidly, and a high altitude is necessary to regain a horizontal flight path (Figure 14). If the autorotation continues, the aircraft could stabilize in a spin, spiralling downward.
