## **1.1 RESEÑA DEL VUELO**

**El 6 de Febrero de 1996, aproximadamente a las 03:45 horas UTC. la aeronave Boeing 757, matrícula TC-GEN operada por la firma Birgenair como un vuelo fletado por la Línea Aérea Alas Nacionales se accidentó minutos después del despegue, del Aeropuerto Internacional Gregorio Luperón, Puerto Plata, República Dominicana. El vuelo se efectuaba bajo un plan de vuelo por instrumentos (IFR). La aeronave se destruyó y los 176 pasajeros y 13 tripulantes perecieron. Dicho vuelo se originó a las 03:40 con destino a Frankfurt, Alemania con escala en Gander, Canadá y Shonefeld Berlín, Alemania.**

**La causa probable del accidente fue la falta por parte de la tripulación de vuelo de reconocer la activación del sacudidor de palanca (stick-shaker) como una advertencia inminente de una entrada en pérdida aerodinámica y la falla de la tripulación de ejecutar los procedimientos para recuperación de la entrada en pérdida. Antes de la advertencia de sacudidor de palanca (Stick-shaker), existía una confusión de la tripulación de vuelo debido a indicaciones erróneas de aumento de velocidad relativa y un aviso de sobre-velocidad.**

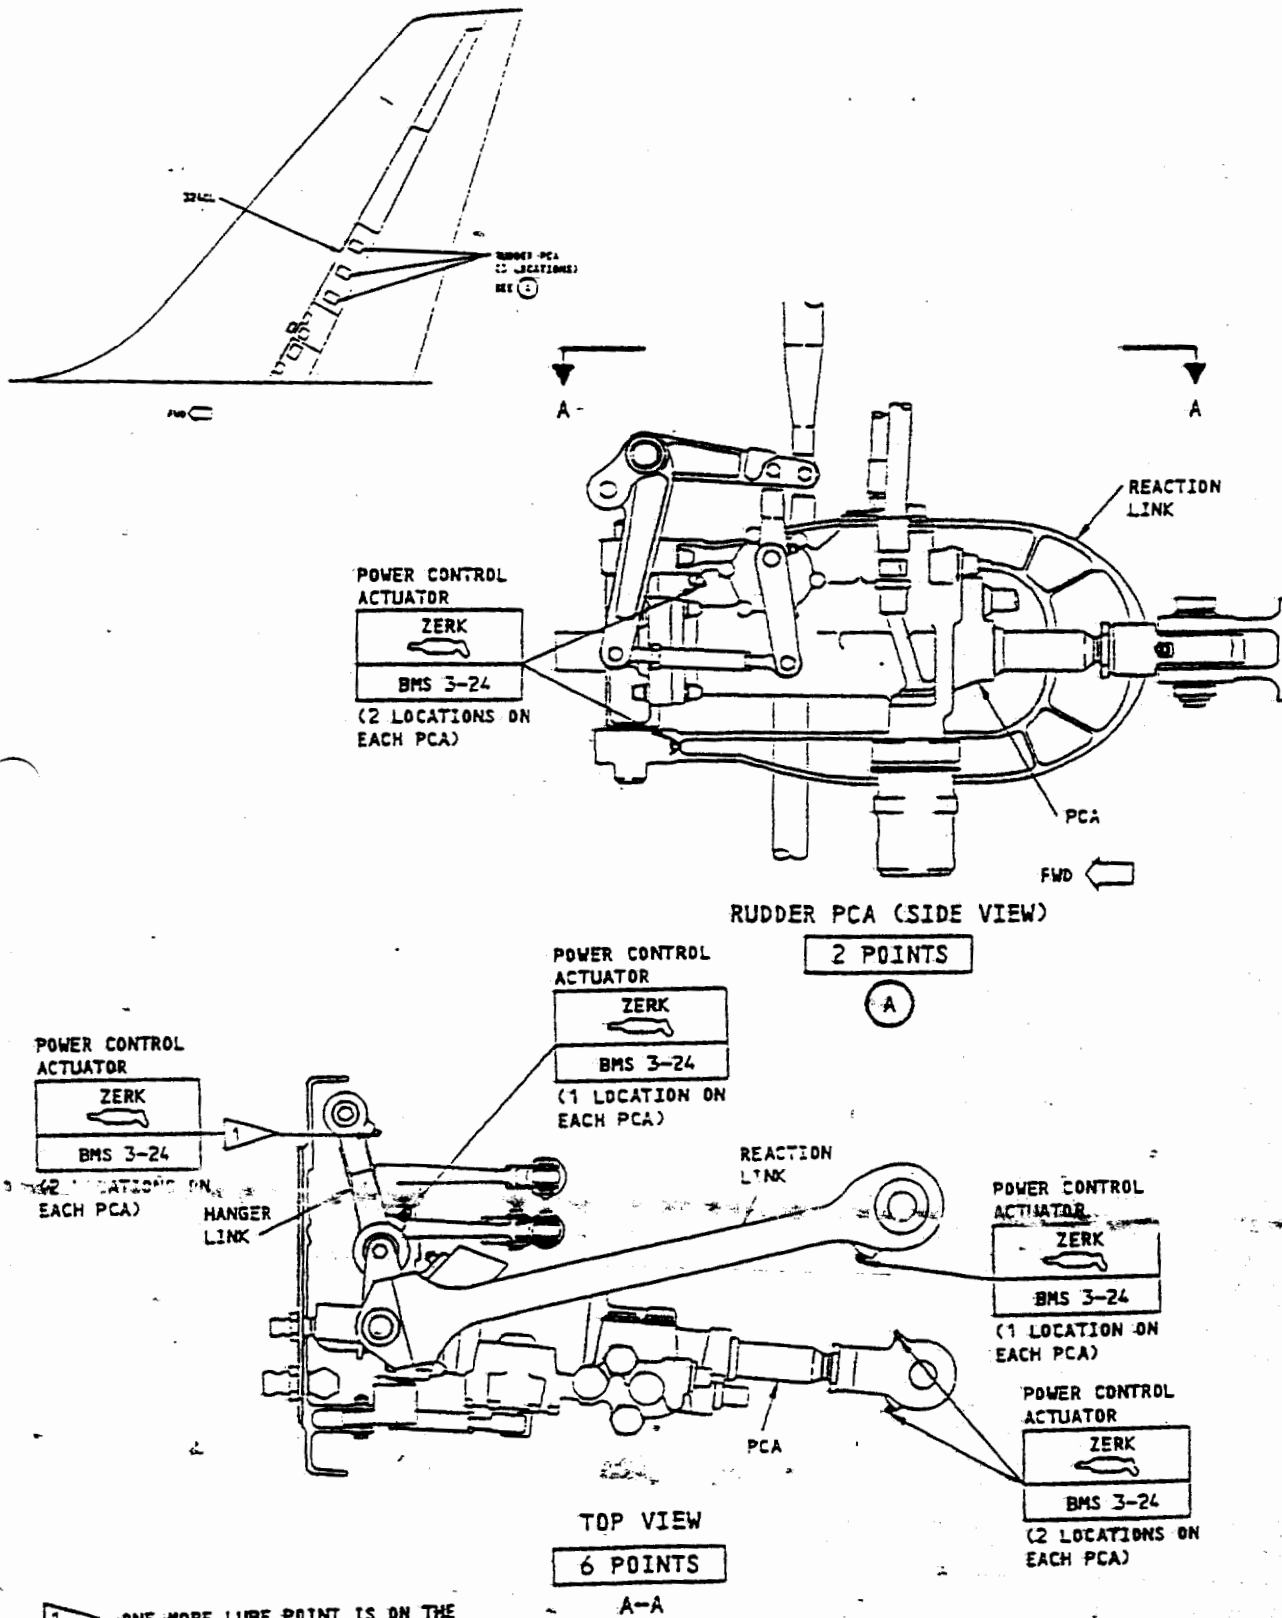
FIG 2 DESCRIPTION : LUBRICATION OF RUDDER POWER-CONTROL-ACTUATOR

ITEM NR	DEFERRED BY	DEFERRED DISCREPANCY DESCRIPTION	REMARKS
004	S.K.	RUDDER ACTUATOR LUBRICATION

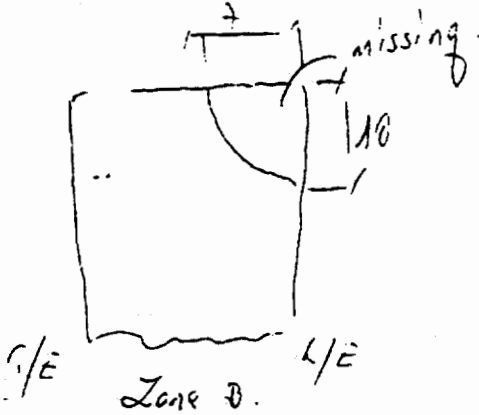
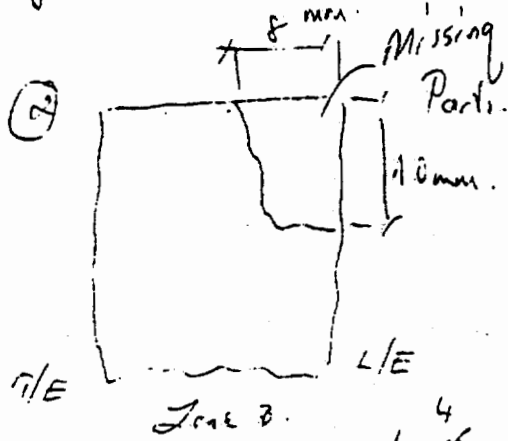
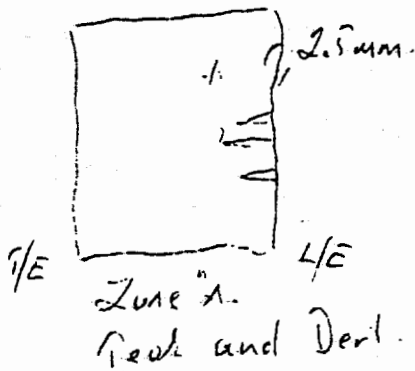
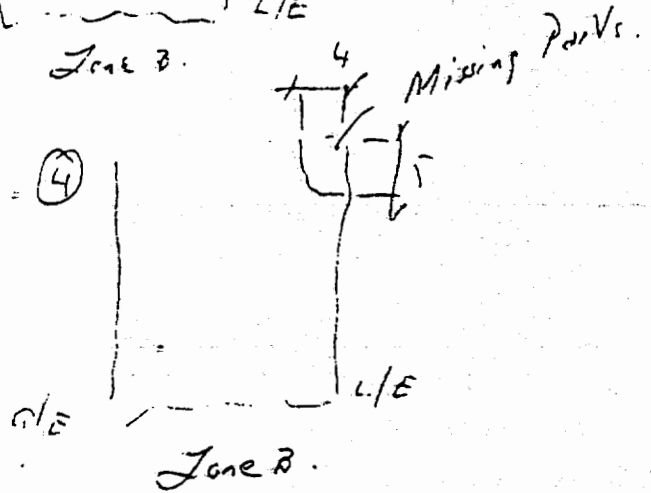
### 3rd Stage

H.P. Compressor Rotor Blades Stg 1 thru 6  
*3rd. Stg. 2 blades have missing moldrills on C/E.  
 4 blades have dents. (see next page.)*

- ⑤ - Three blades have nicks in leading edge and Zone B. Ranging from 2mm long x 2mm deep.
- One blade has nicks in leading edge Zone A. Ranging from 2mm long x 2mm deep.
  - Four blades have bends and dents in leading edge and Zone B. Ranging from 2mm long x 2.5mm deep.
