No. 23BOAC HERMES IV. Forced Landed in French West Africa
on 26 May 1952

(Note. - The inquiry was conducted by France in accordance
with Annex 13 of the Convention of ICAO)

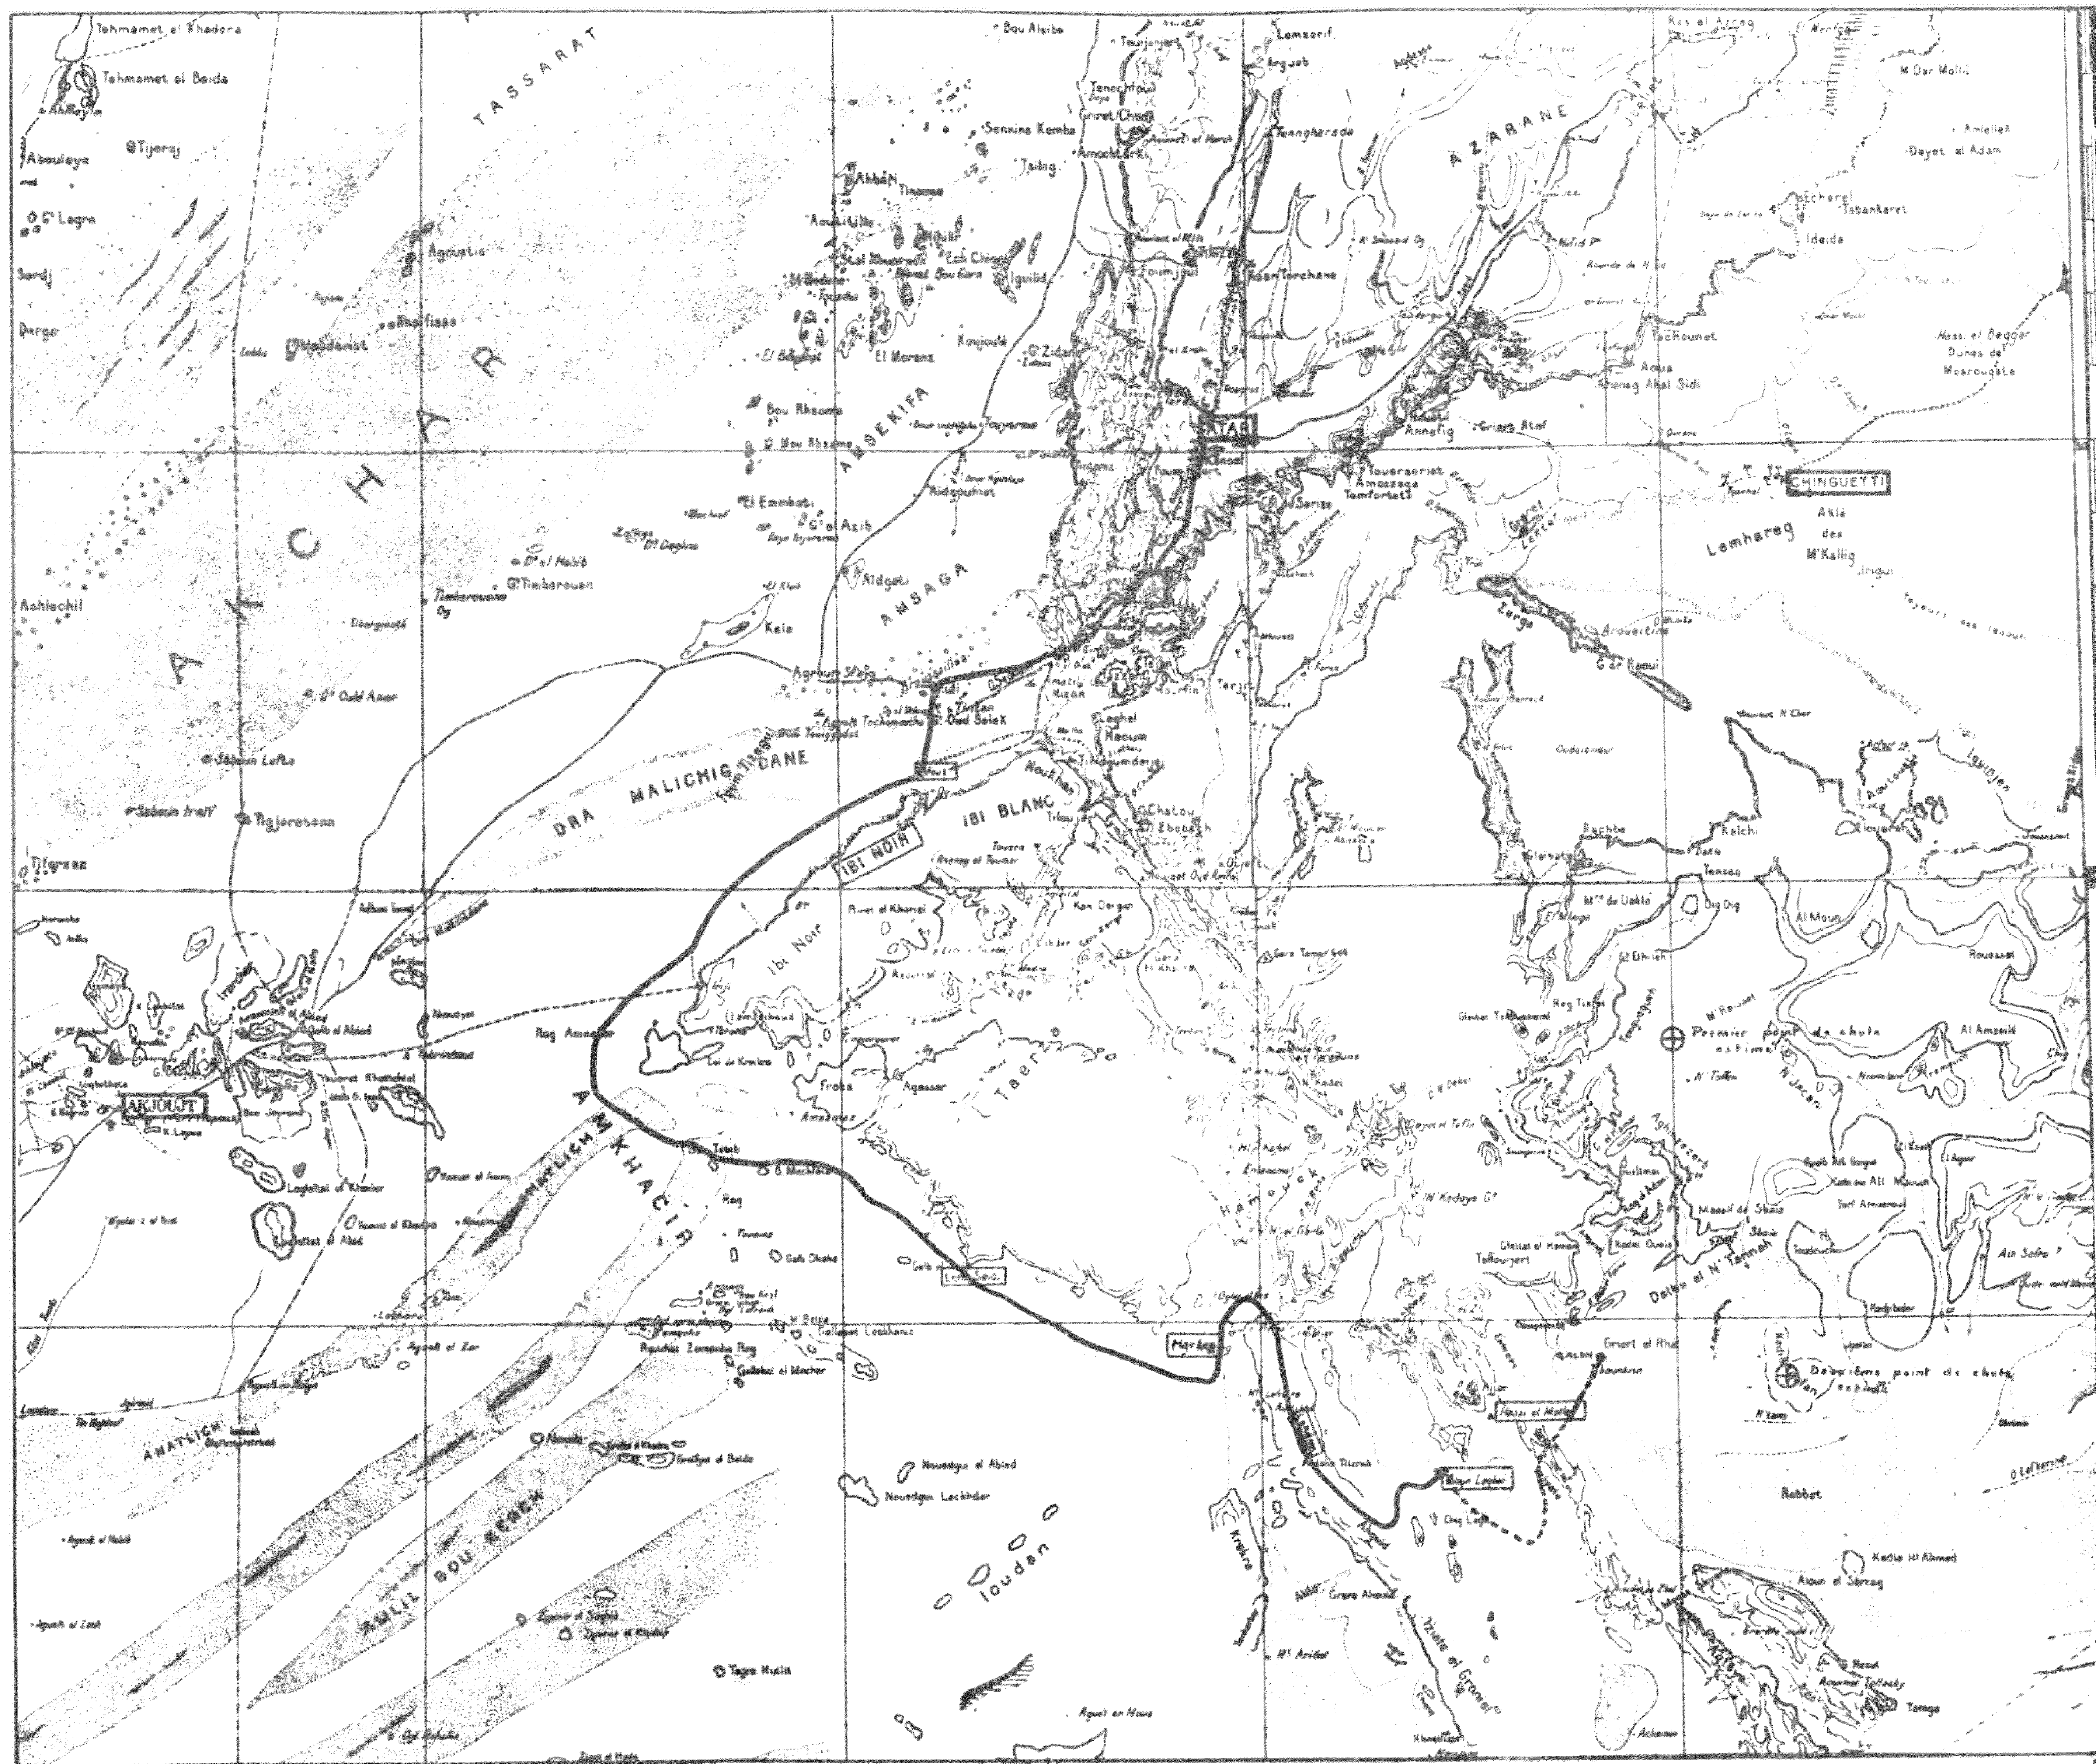
Trayecto en camión,

Trayecto en camello,

Dress. dress. et alio par le Service Géographique de l'AGE à Dakar en 1961. 1^{er} volume de 1961

Scale - Echelle - Escala : 1:500.000
