**AIRCRAFT ACCIDENT REPORT**

**ROCKY MOUNTAIN AIRWAYS, INC.  
DeHAVILLAND DHC-6 Twin Otter  
N25RM**

**Near STEAMBOAT SPRINGS, CO. COLORADO  
DECEMBER 4, 1978**

1. Report No. NTSB-AAR-79-6	2. Government Accession No.	3. Recipient's Catalog No.	
4. Title and Subtitle Aircraft Accident Report - Rocky Mountain Airways, Inc., DeHavilland DHC-6 Twin Otter, N25RM, near Steamboat Springs, Colorado, December 4, 1978		5. Report Date May 3, 1979

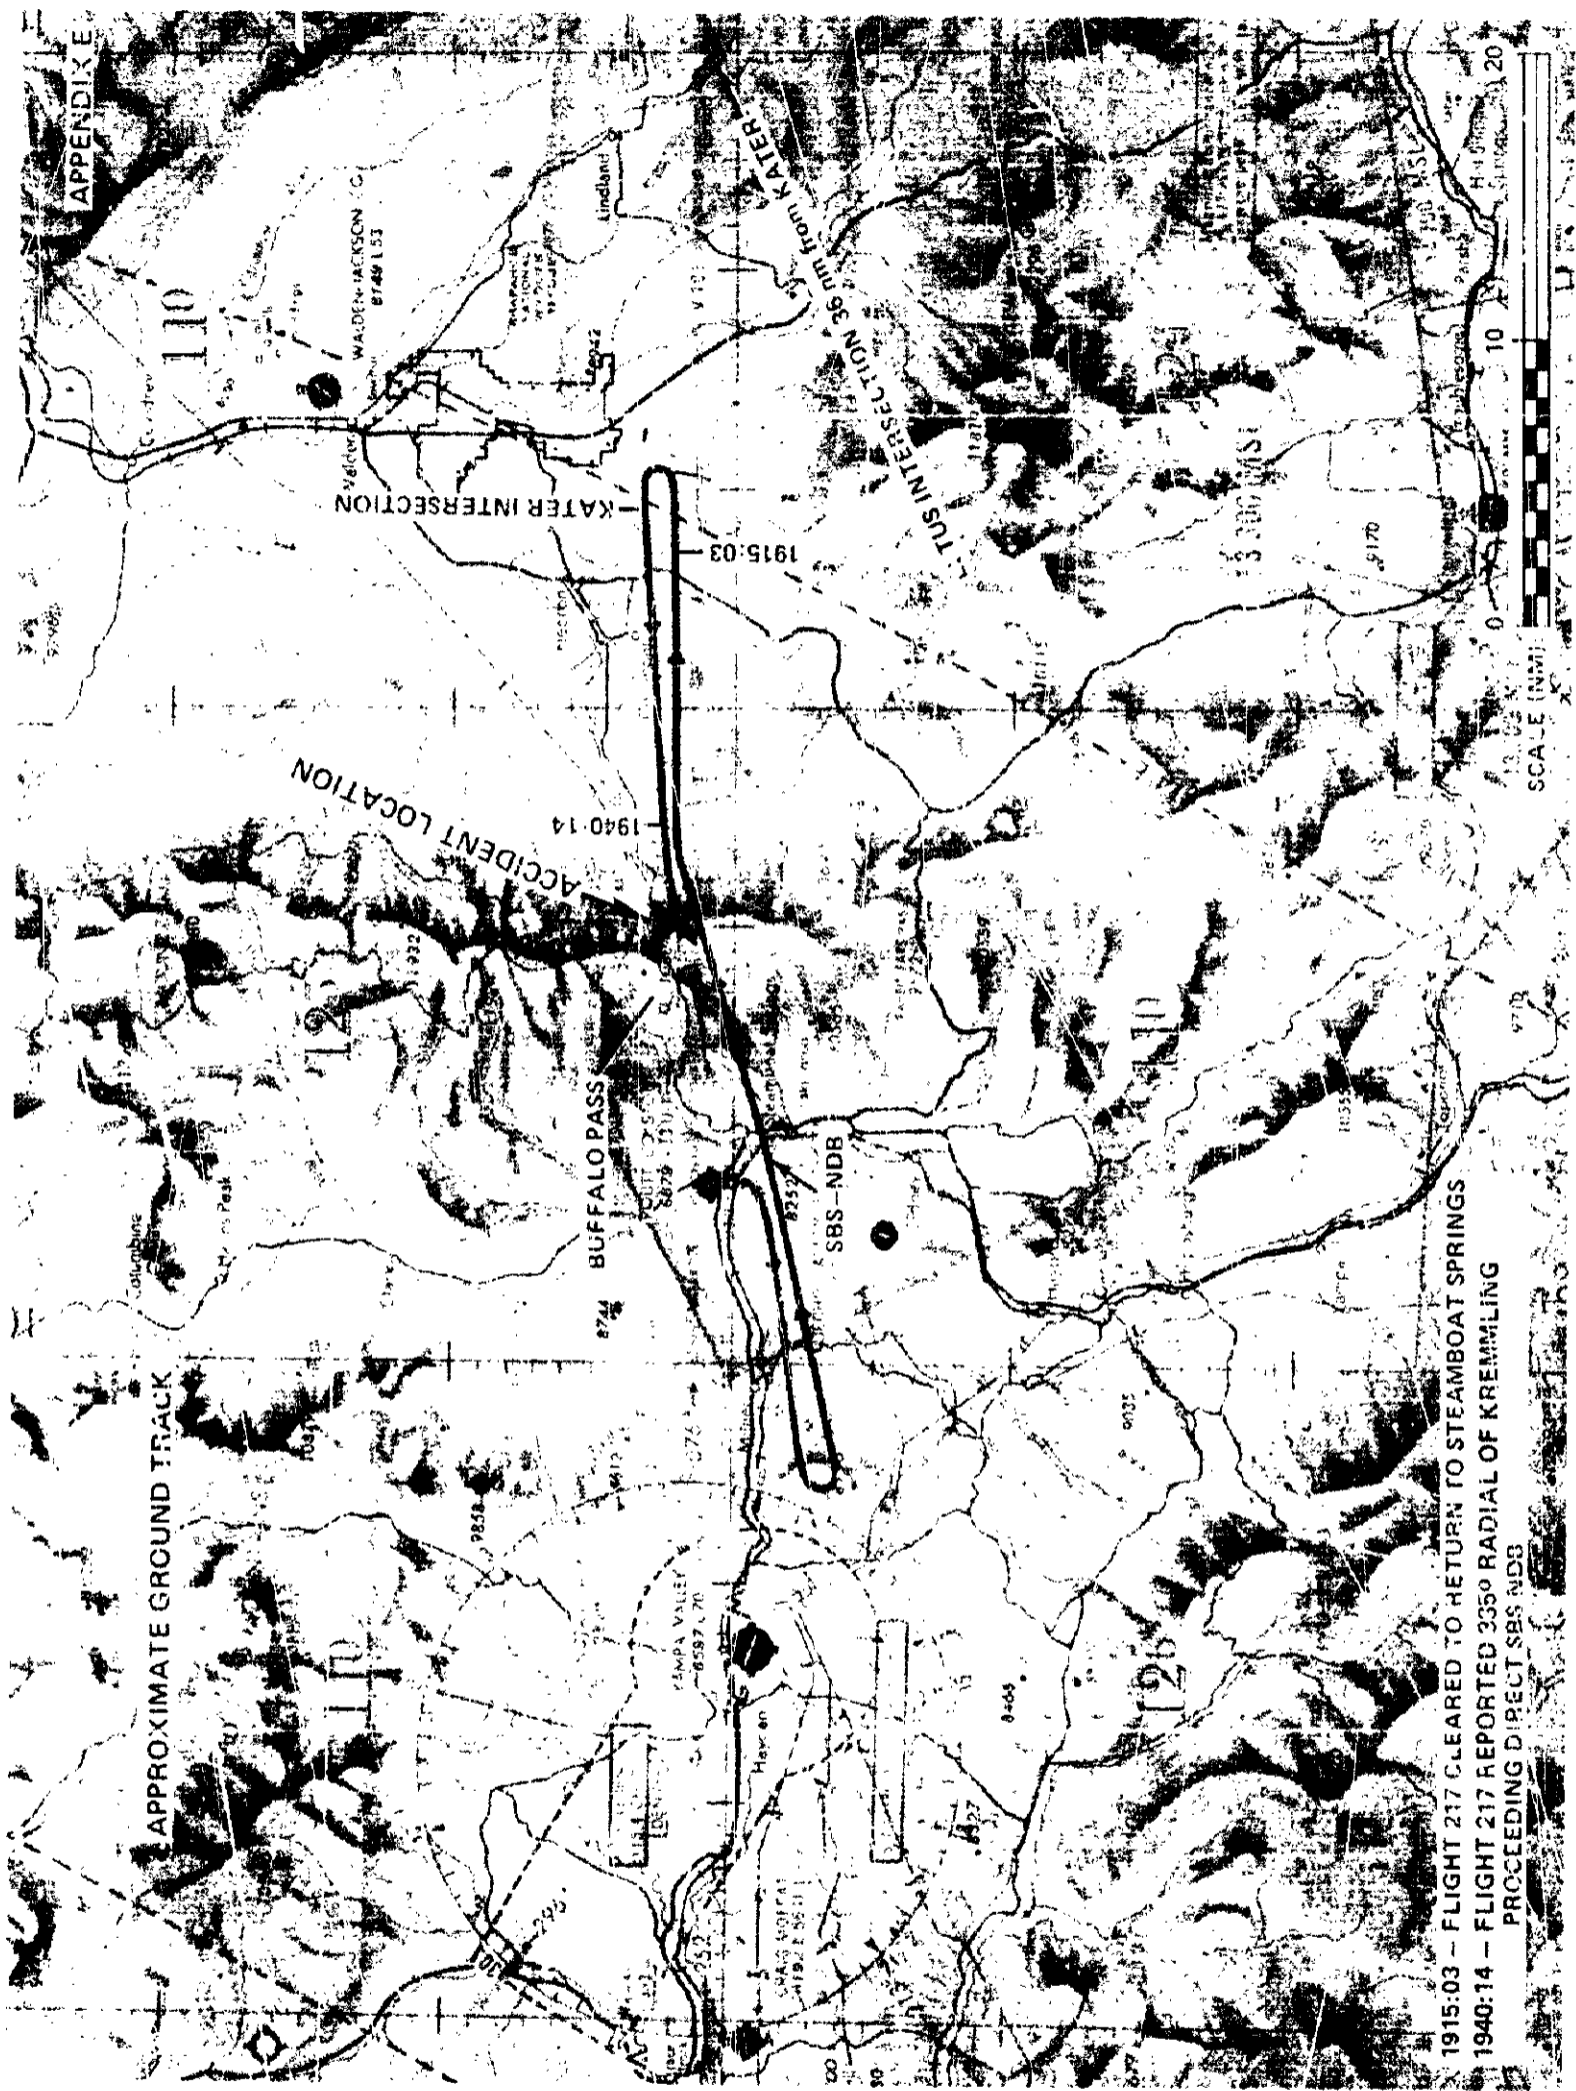
1915:03 - FLIGHT 217 CLEARED TO RETURN TO STEAMBOAT SPRINGS  
 1940:14 - FLIGHT 217 REPORTED 3350 RADIAL OF KREMMLING  
 PROCEEDING DIRECT SBS-NDB

According to the first officer, when Flight 217 crossed the 355° radial of the Kremmling VOR, the captain began a 180° turn to return to Steamboat Springs. Shortly thereafter, the aircraft entered severe icing conditions for about 12 sec, and the captain was unable to keep the aircraft at 13,000 ft with maximum climb power applied. He lowered first 5° and then 10° of flaps to arrest the descent, but the aircraft descended to 11,600 ft. The first officer said that the pre-stall buffet was occasionally encountered if the airspeed decreased to about 85 kns. They were able to maintain 11,600 ft with 10° of flaps extended and with the indicated airspeed between 90 and 100 kns. While at 11,600 ft, the captain remarked that they were at minimum obstruction clearance altitude (MOCA) <sup>5/</sup> and that they "had it made." The first officer said that the engines were running well and that the ice was shedding from the propellers and from the wing deicer boots. On the unheated portions of the windshield, the ice was about 1 1/2 to 2 ins. thick.
