AIRCRAFT ACCIDENT REPORT

**TEXASGULF AVIATION, INC.
LOCKHEED JETSTAR N520S
NEAR WESTCHESTER COUNTY AIRPORT
WHITE PLAINS, NEW YORK
FEBRUARY 11, 1981**

NTSB-AAR-81-13

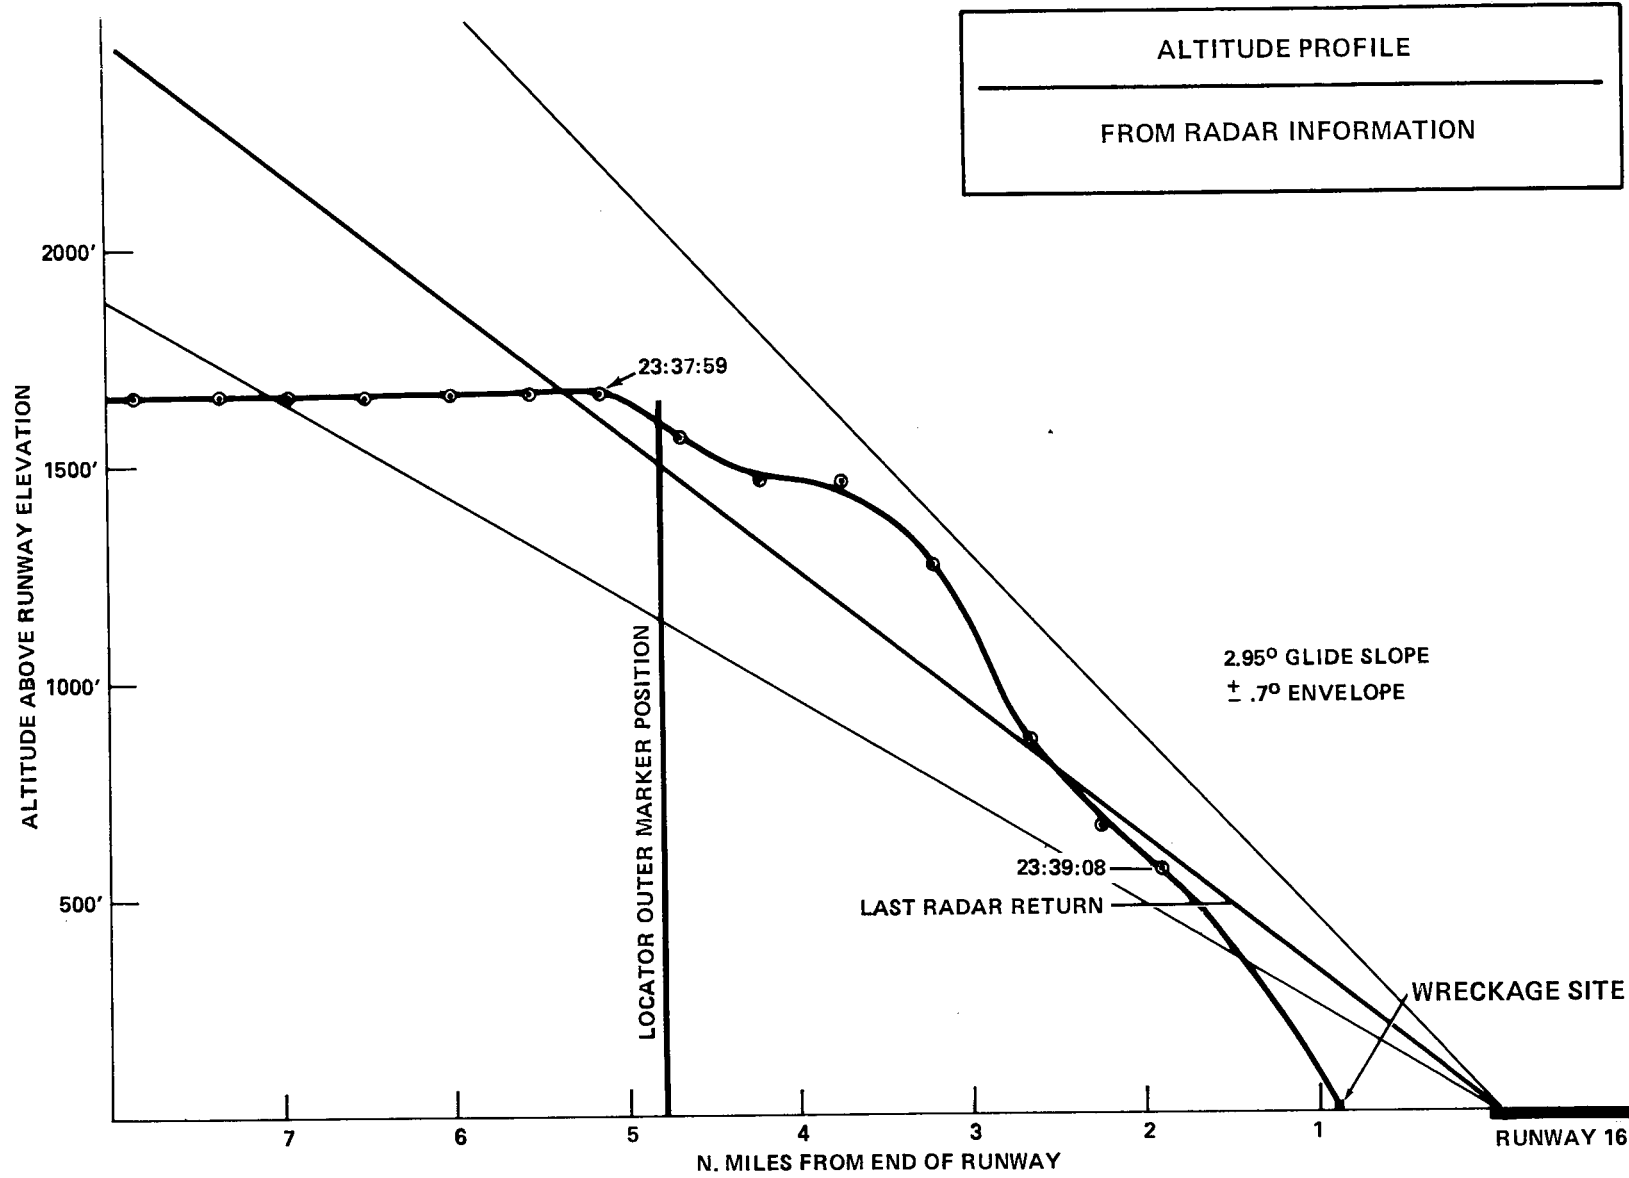
PROBABLE GROUND TRACK FROM RADAR INFORMATION

LAST RADAR RETURN
 WRECKAGE SITE
