## Noncompliance With Departure Procedures Sets Course for Impact With Mountain

*Investigators said that the controlled-flight-into-terrain accident resulted from the flight crew's failure to properly plan for a night departure from an unfamiliar airport. The crew of the U.S. Air Force C-130H did not follow published instrument departure procedures.*

At 2250 local time Aug. 17, 1996, a U.S. Air Force (Lockheed) C-130H struck a mountain ridge during departure from Jackson Hole Airport in Jackson, Wyoming, U.S. The aircraft was destroyed, and the eight crewmembers and a passenger were killed.

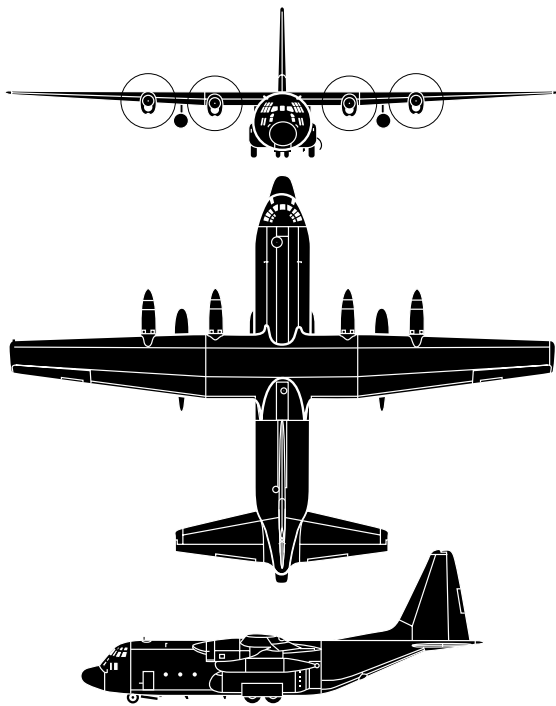
## U.S. Air Force C-130H

C-130 is the U.S. Air Force designation for the Lockheed 382 Hercules. The medium-range to long-range combat transport aircraft was designed to an Air Force specification issued in 1951. Deliveries of the C-130 began in 1952.

The flight deck has accommodations for five crewmembers. The aircraft has a galley and sleeping quarters for relief crewmembers. The cabin can accommodate 92 regular troops or 64 paratroops. The flight deck and main cabin are air-conditioned and pressurized. Maximum pressure differential is 7.5 pounds per square inch (0.52 bar).
