AIRCRAFT ACCIDENT REPORT
OCCURRENCE NUMBER 03/3733
FLETCHER FU24-950M
ZK-BXZ
10 NM SOUTH-WEST OF TE KUITI
19 DECEMBER 2003

AIRCRAFT ACCIDENT REPORT

OCCURRENCE No 03/3733

Aircraft type, serial number and registration:	Fletcher FU24-950M, 65, ZK-BXZ
Number and type of engines:	1 Lycoming IO-720-A1B
Year of manufacture:	1956
Date and time:	19 December 2003, 1500 hours ¹ (approx)
Location:	Mairoa, 10 nm south-west of Te Kuiti Latitude ² : S 38° 22.9' Longitude: E 174° 57.0'
Type of flight:	Agricultural – topdressing
Persons on board:	Crew: 1
Injuries:	Crew: 1 fatal
Nature of damage:	Aircraft destroyed
Pilot's licence:	Commercial Pilot Licence (Aeroplane)
Pilot's age:	57 years
Pilot's total flying experience:	14335 hours, 5000 on type
Information sources:	Civil Aviation Authority field investigation
Investigator in Charge:	Mr A Buckingham (Transferred to Mr M Carrelli)

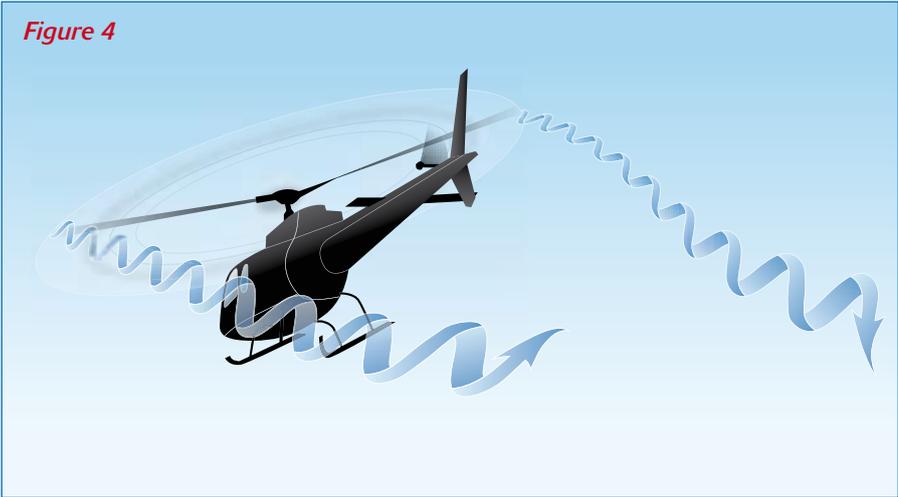
Figure 4

Simplified wake vortices generated from a helicopter in forward flight.

The vortex cores were observed to be closer together during ascents and further apart during descent. The wake vortices also did not sink in a predictable manner and in some cases remained at a similar altitude to where they were generated.

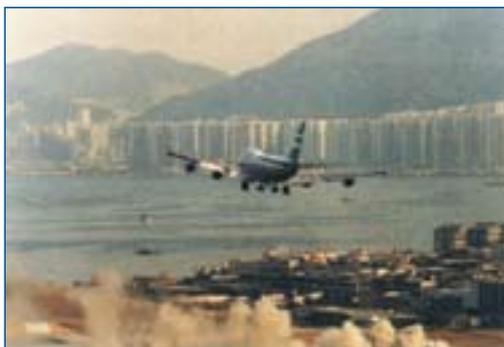
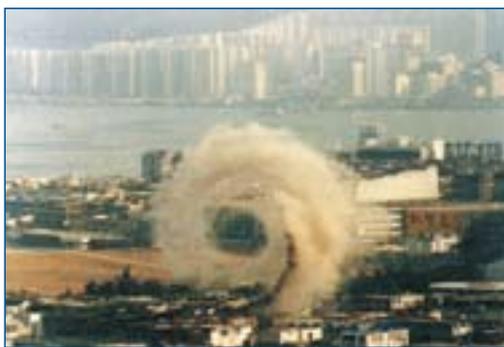
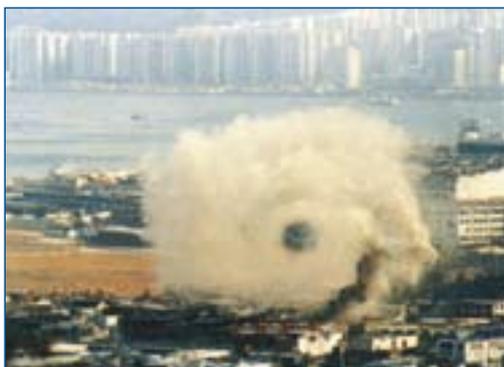
A CX 747-200 on approach to Kai Tak airport, Hong Kong.

Taken from the chequerboard at a time when there was a fire in Kowloon City, thus making the vortices very visible.
