Aviation Investigation Final Report

Location:	St. Simons Island, Georgia	Accident Number:	ERA23LA376
Date & Time:	September 21, 2023, 14:36 Local	Registration:	N434FX
Aircraft:	EMBRAER S A EMB-545	Aircraft Damage:	Substantial
Defining Event:	Hard landing	Injuries:	8 None
Flight Conducted Under:	Part 91 subpart k: Fractional

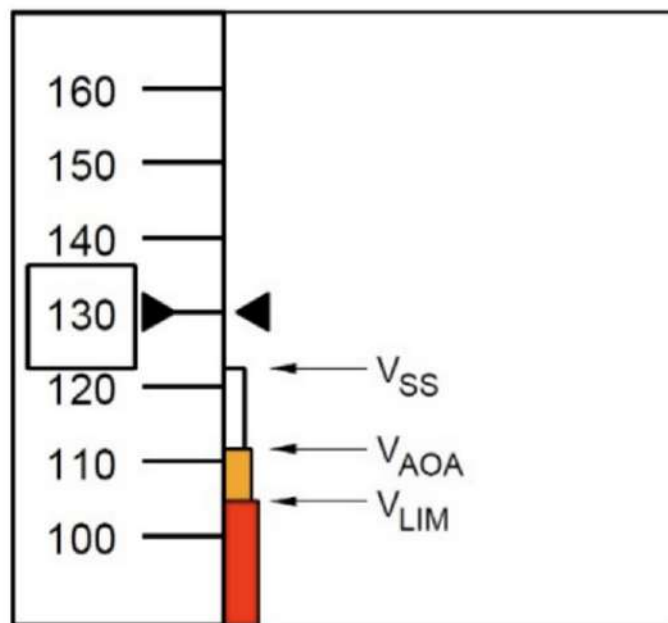
The low-speed awareness indication displays over the speed tape on the primary flight display to alert the flight crew of a low-speed condition. In normal mode, the AOA limiter protection function is available, and the low-speed awareness is displayed. The three low-speed awareness color bands on the speed tape are defined as follows:

- V_{SS} : This speed, defined as the stable velocity speed, is represented by the top of the white band. It indicates a low energy state and is not a function of the AOA or load factor. For a 1g flight, it is equivalent to about 1.13 times the stall speed. In normal conditions, if airspeed goes below V_{SS} , an audible “low speed” alert will sound.

- V_{AOA} : This speed, defined based on the AOA that engages the AOA limiter protection, is represented by the top of the yellow band. For a 1g flight, it corresponds to about 1.08 times the stall speed.

- V_{LIM} : This speed, defined based on association with the maximum allowable AOA limit, is represented by the top of the red band. For a 1g flight, it corresponds to about 1.03 times the stall speed.

Figure 1. Exemplar low-speed awareness indication color bands.

In addition, when the AOA limiter protection is engaged, the airspeed readout background becomes yellow at or below V_{AOA} , turning red at V_{LIM} . Since V_{AOA} and V_{LIM} are based on the AOA, they may vary according to flight conditions.

a sudden AOA increase caused by wind gusts. In this case, the low-speed awareness white band will not be seen, as it will be overlapped by the yellow and red bands, and the “low speed” aural alert will not sound.

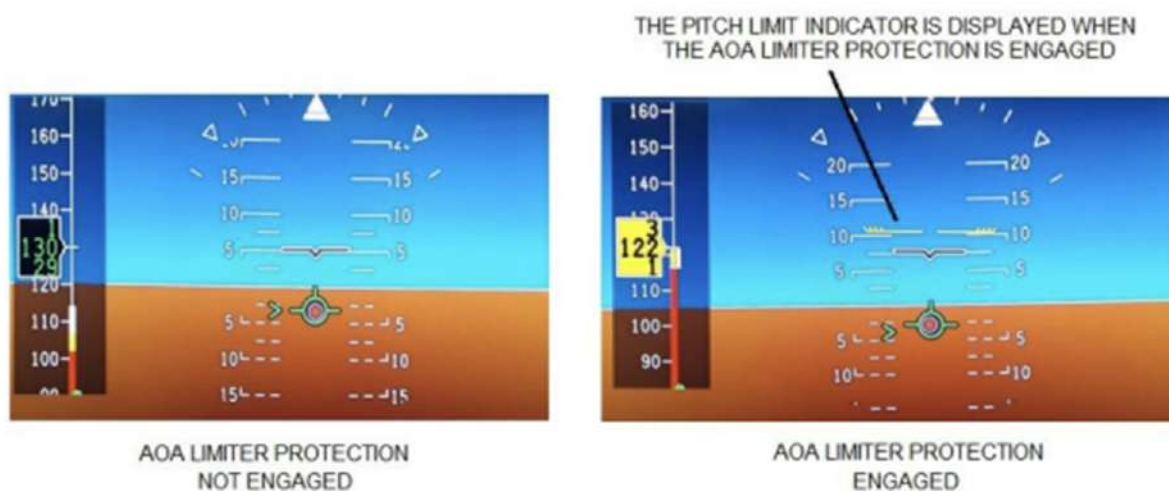
The Pitch Limit Indicator is displayed on the pitch angle scale on the primary flight display when the AOA increases above the AOA limiter protection engagement value and the AOA limiter protection is engaged. (The Pitch Limit Indicator is not displayed unless the AOA limiter protection is engaged.) The Pitch Limit Indicator shows the difference between the AOA and the maximum AOA limit when the fly-by-wire system is in normal mode. The Pitch Limit Indicator is displayed in yellow when the AOA is between AOA limiter protection engagement value and the maximum AOA limit, and it is displayed in red if the AOA increases to the maximum AOA limit.

Figure 2. Primary flight display for flight in normal mode before (left) and after (right) AOA Protection Limit engagement, showing the appearance of the Pitch Limit Indicator.
