AIRCRAFT ACCIDENT REPORT

STERLING AIRWAYS INC.
CARAVELLE SE-210-10B3, OY-STL
FUJAYRAH, 50 NM EAST OF DUBAI AIRPORT
14. MARCH 1972

of the Investigation into the Accident involving Sterling Airway's
Caravelle Aircraft OY-STL in the Emirate Fujayrah on the 14th. March 1972.

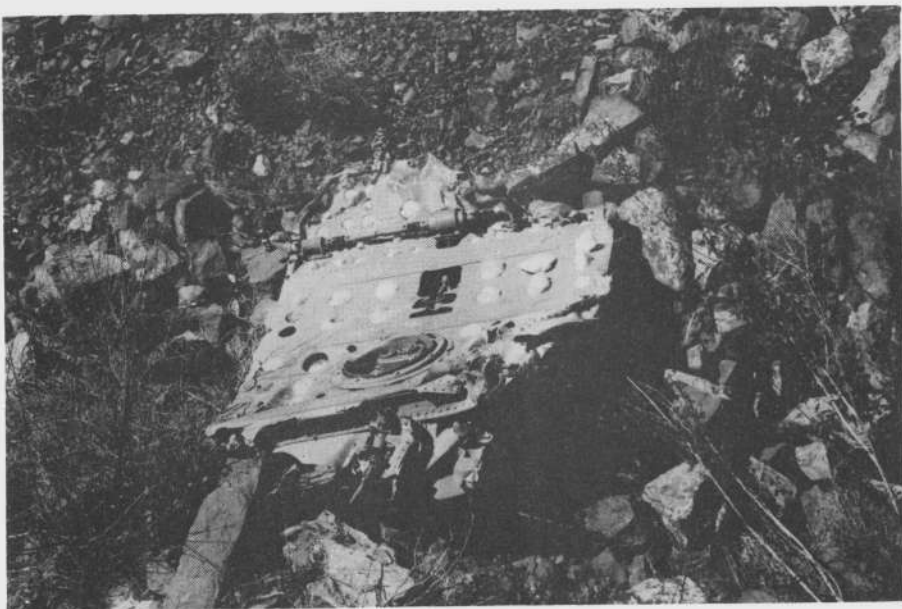
138.

<u>Picture No.</u>	<u>Plotting No.</u>	
138	C12	Maindoor
139	C12	"
140	C13	Wing junction fitting
141	C13	Wing junction fitting
142	C14	Central wing section
143	C15	Wheel brake
144	C16	Burner section
145		Flying the approach to the scene at about double altitude
146		"
147		"
148		View from impact I to impact II
	D1	Part of left inner aileron
	D2	Flap vane
	D3	Fuel tank skin
	D4	LH spoiler
	D5	Fuselage lower part near cabin heater ground connection and LH innerwing
	D6	Inner part of LH outer flap and flap interconnection rod
	D7	Fuel tank skin and speed brake
	D8	Fuel tank skin
	D9	Stairway forward part
	D10	Speed brake
149	E	The scene of first impact. Principal parts: LH outer aileron
150	E	and outer trailing edge. LH outer wing with a large piece of fuel skin
151		The road to Hayl
152		"
153		Fujayrah.
