AIRCRAFT ACCIDENT INVESTIGATION REPORT

**Formosa Airlines
SAAB-340, B-12255
March 18, 1998**

June 5, 2001

Civil Aeronautics Administration

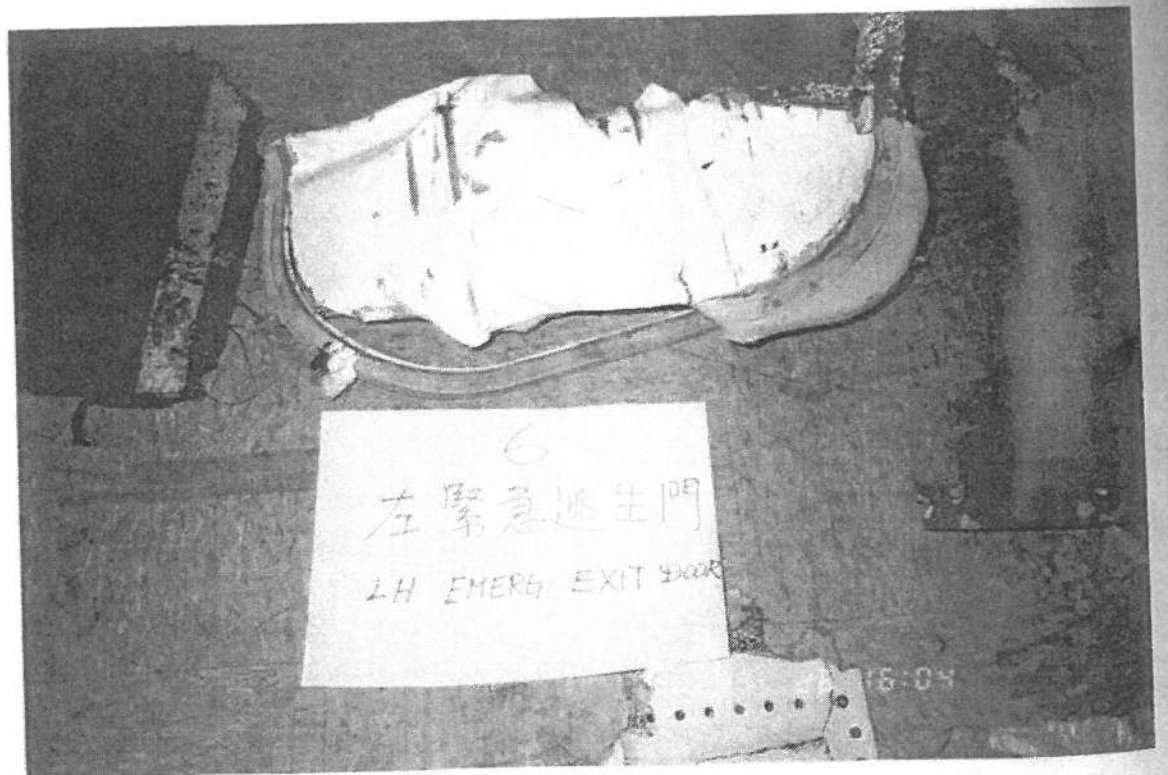
6

LH EMERG. EXIT DOOR

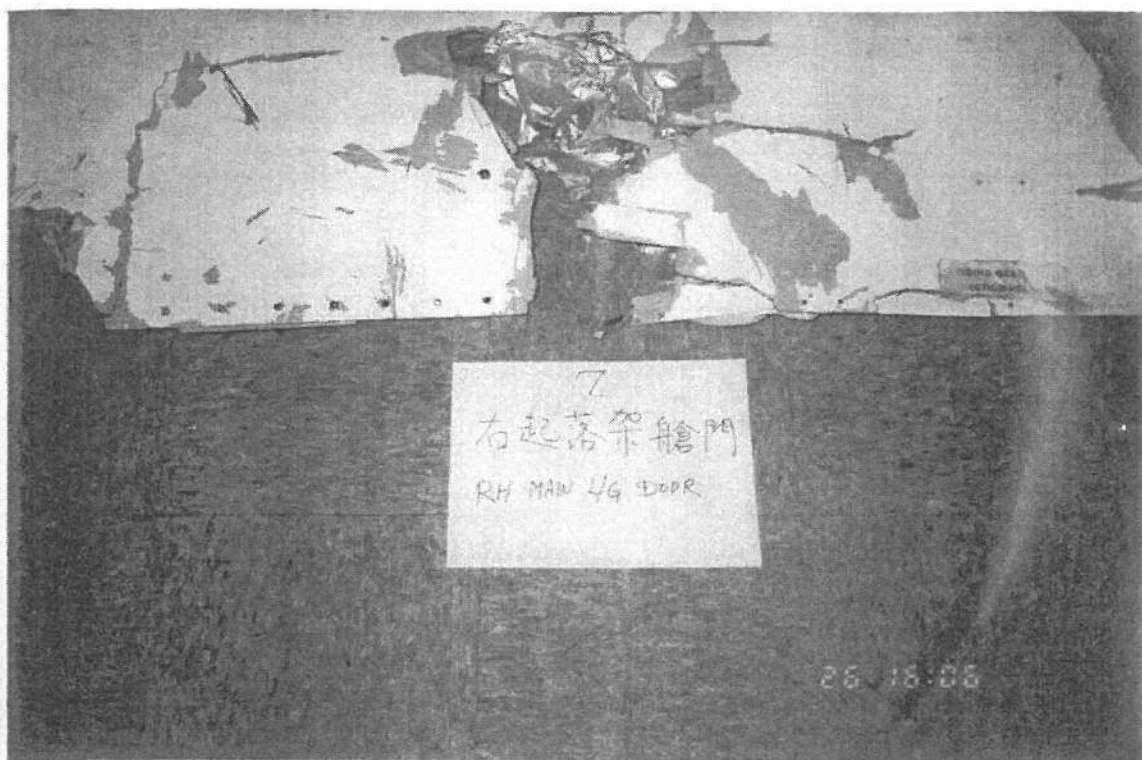
7

RH MAIN L/G DOOR

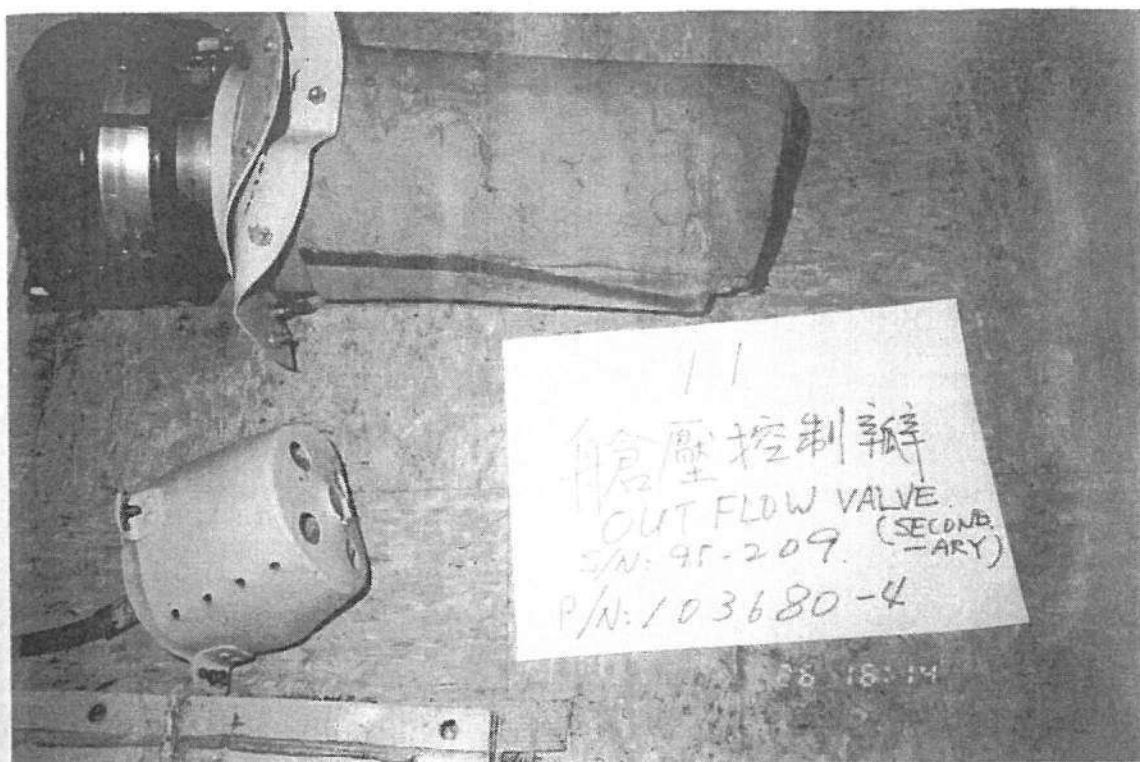
11

OUT FLOW VALUE(SECONDARY)

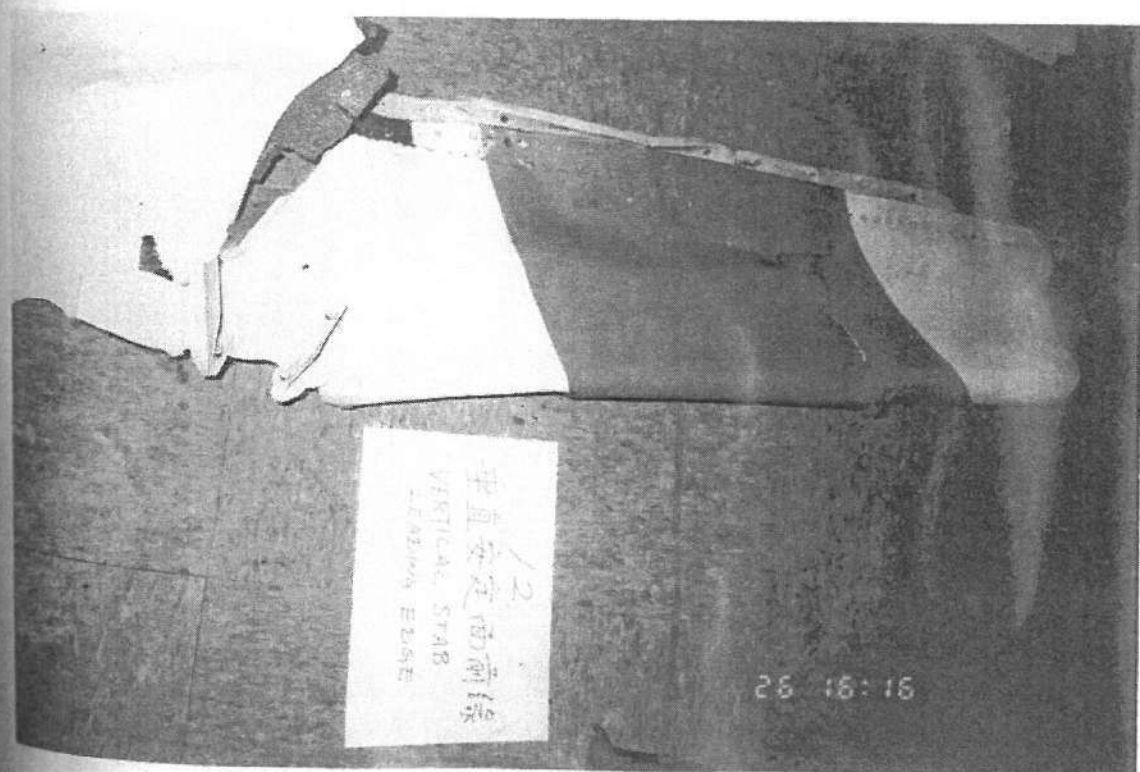
12

VERTICAL STAB:LEADING EDGE.

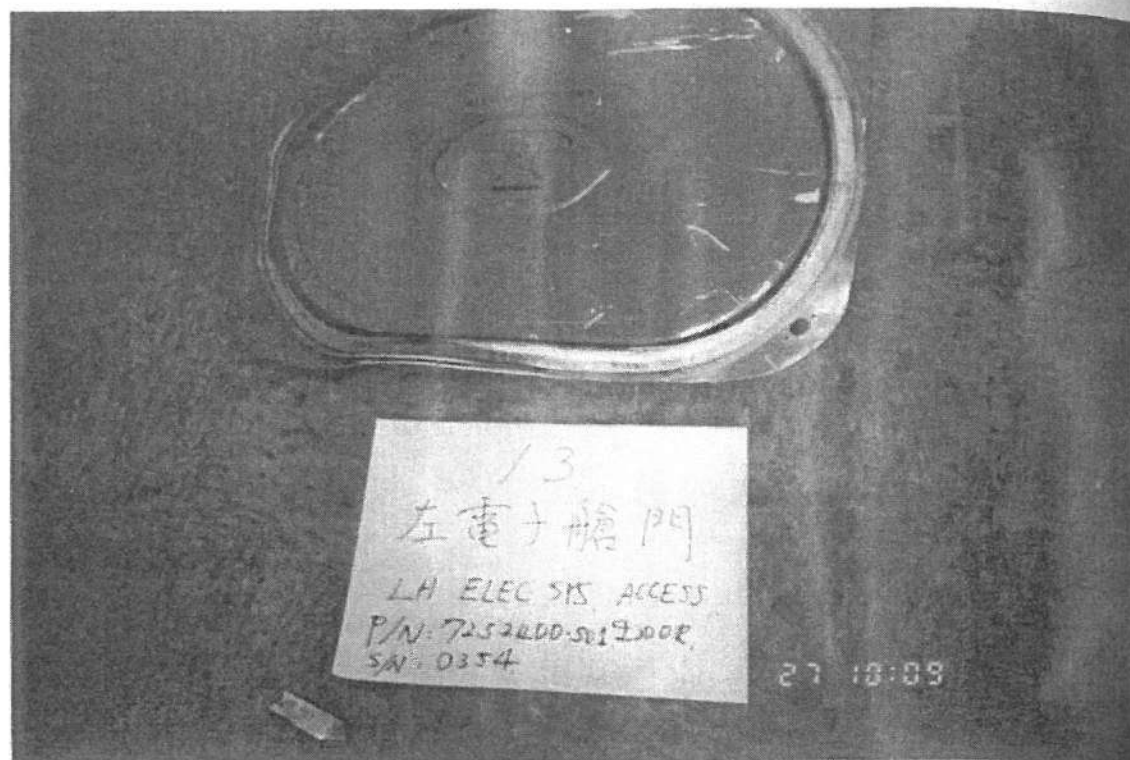
13 LH ELEC. SYS. ACCESS DOOR
P/N: 7252400-501
S/N: 0354
左電子艙門

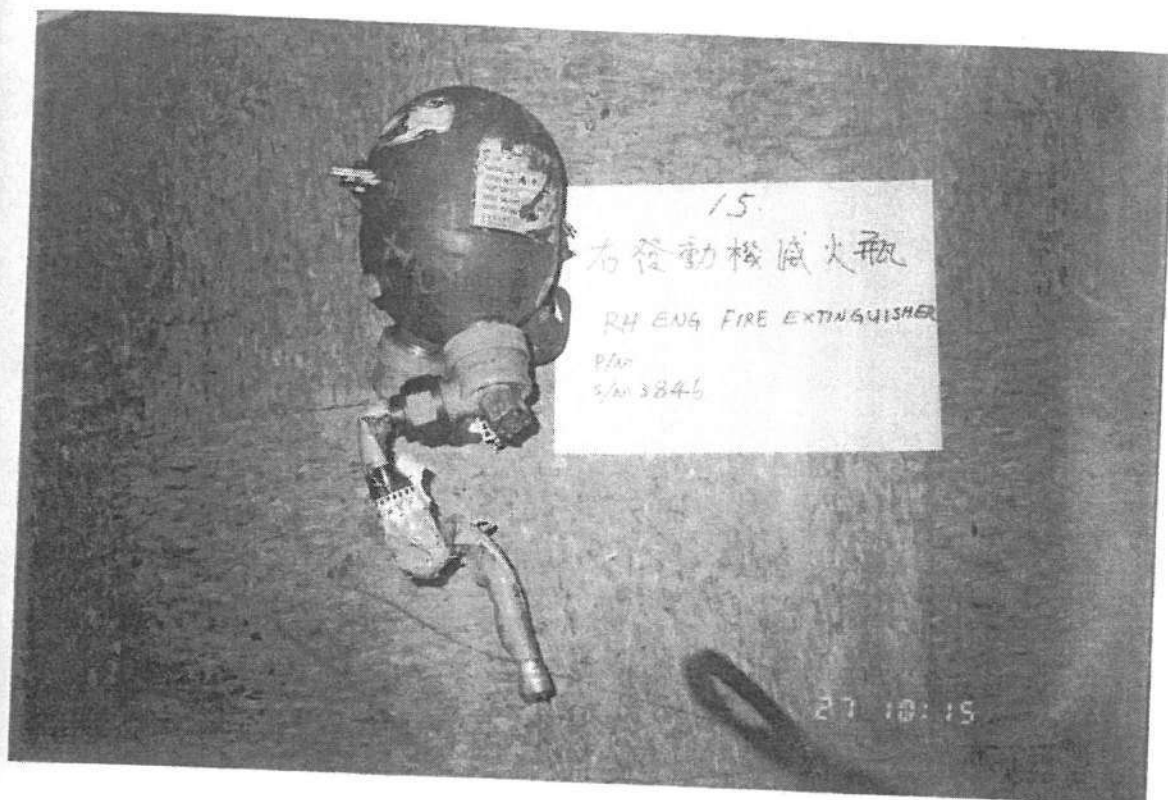
15

RH ENG FIRE EXTINGUISHER

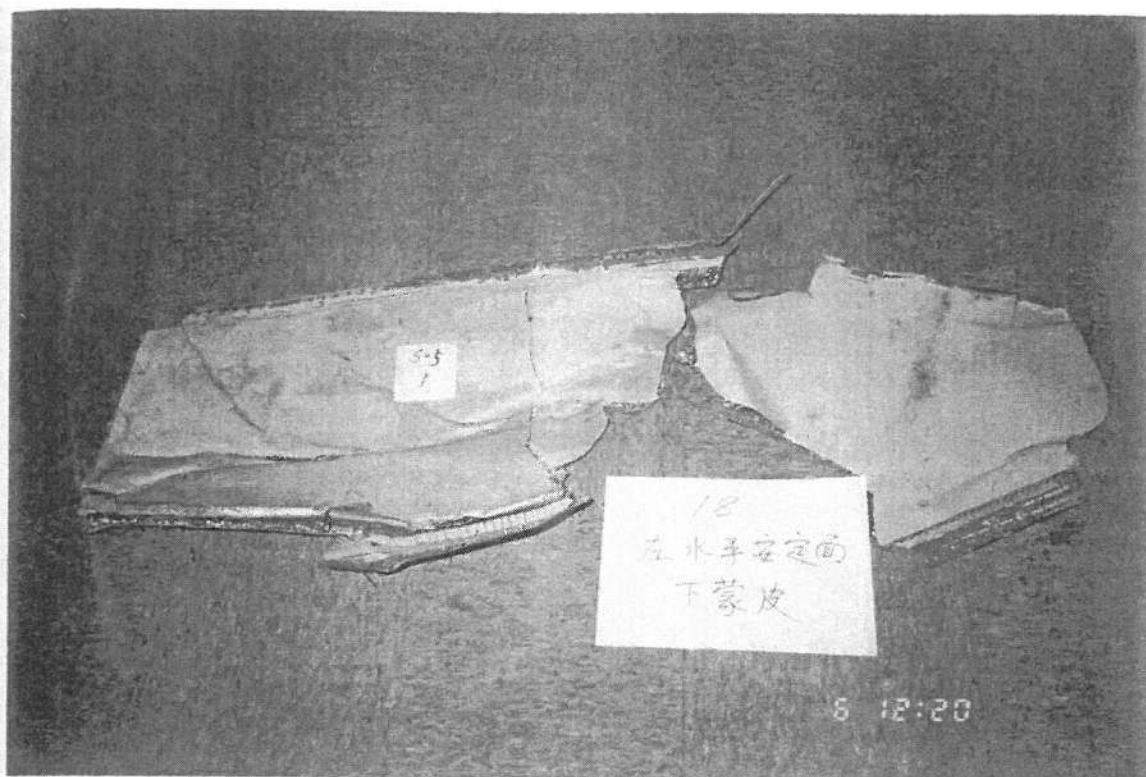
18. LOWER SKIN OF LH HORIZONTAL
STABILIZER

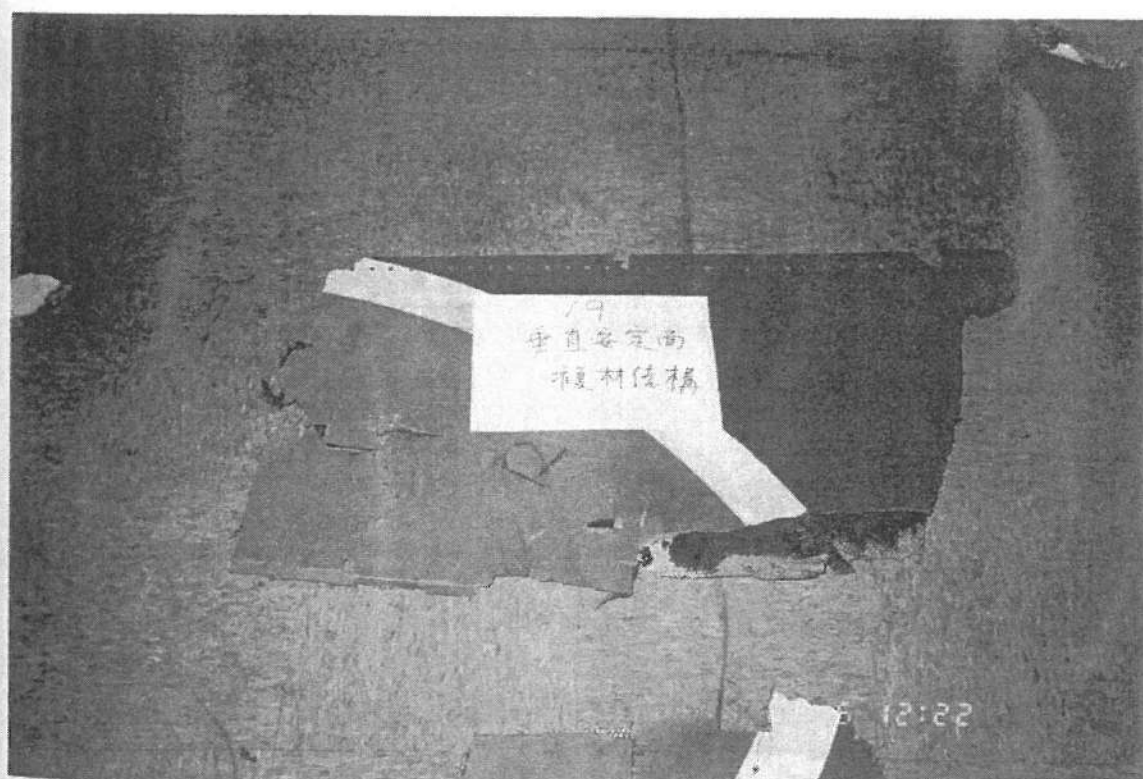
19. VERTICAL STABILIZER (COMPOSITE

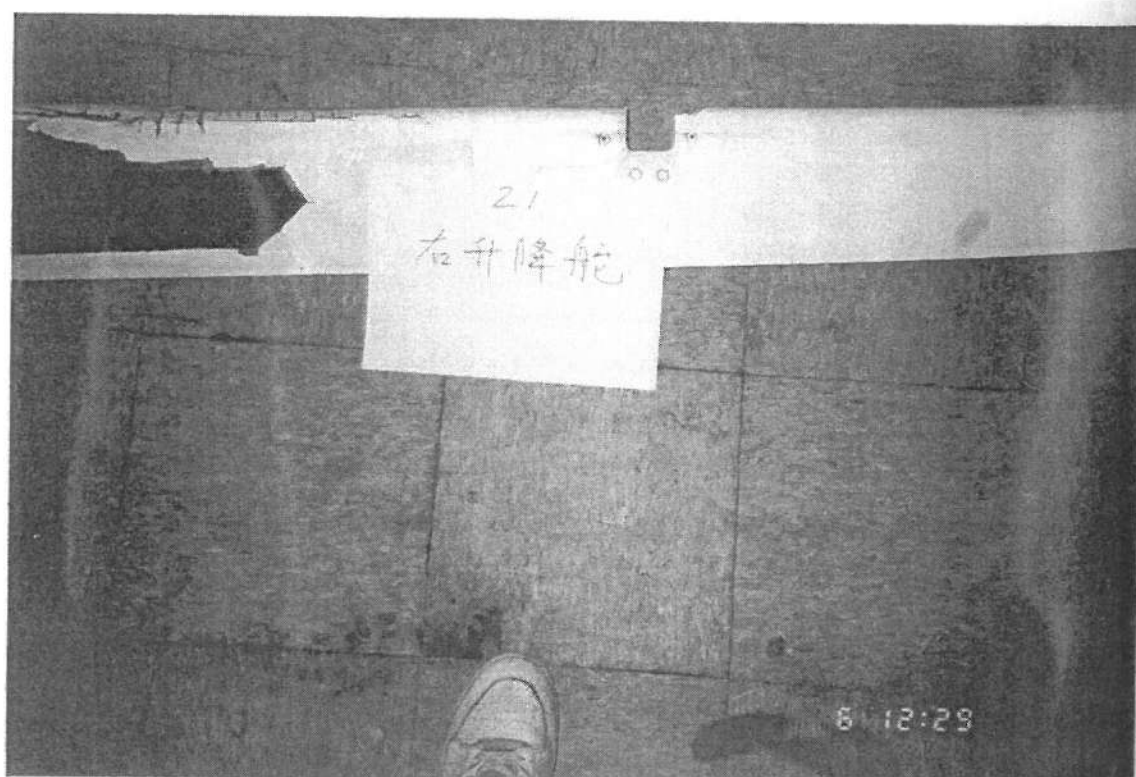
ELEVATOR
21. RH RUDDER
右升降舵

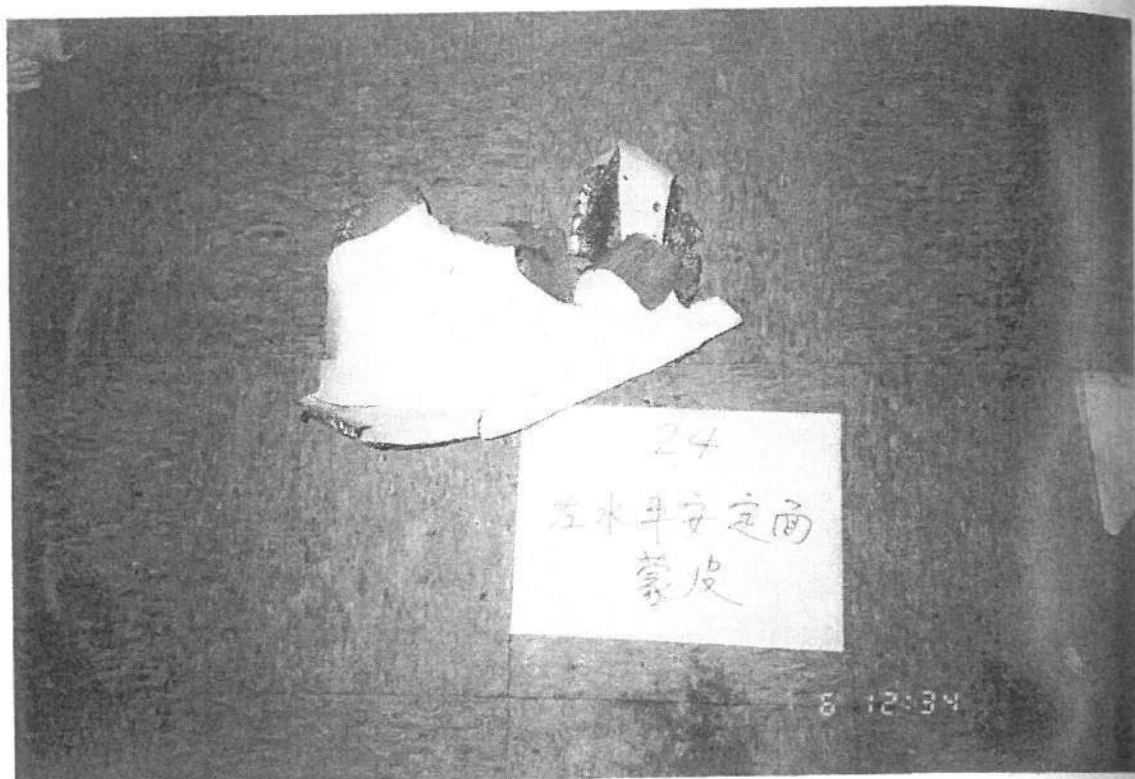
24. SKIN OF LH HORIZONTAL STABILIZER
左水平安定面蒙皮

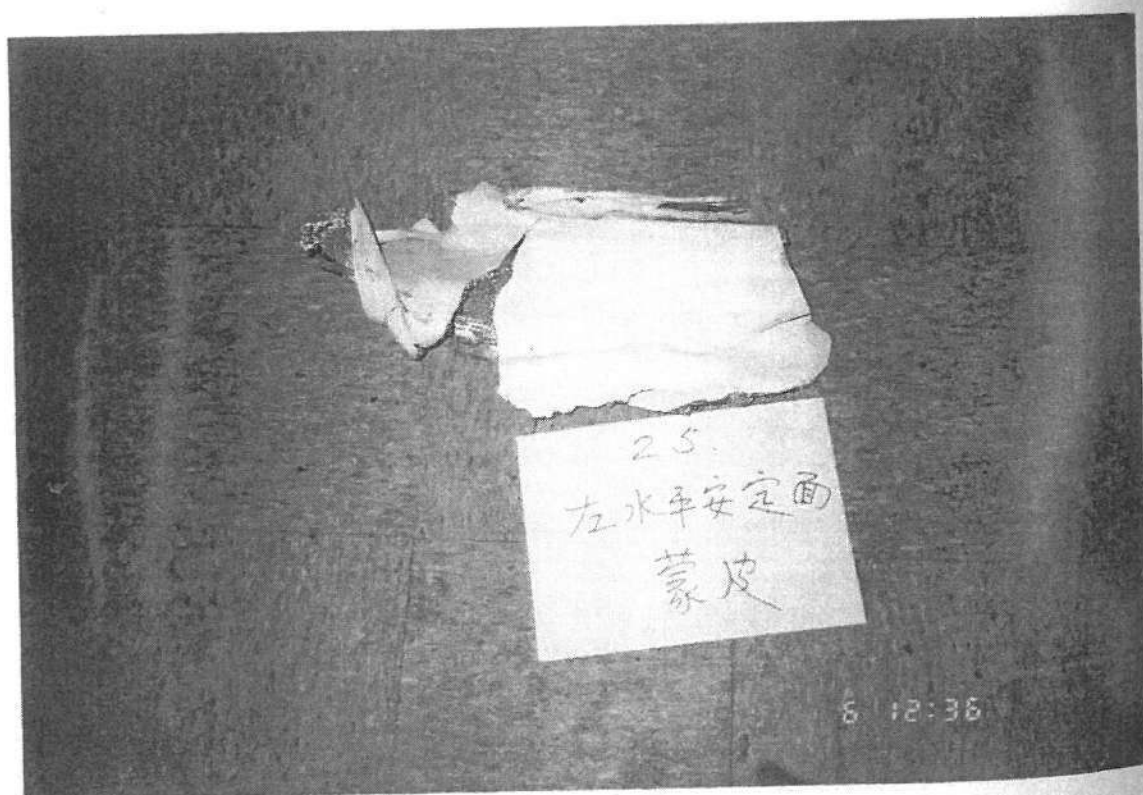
25. SKIN OF LH HORIZONTAL STABILIZER
左水平安定面蒙皮

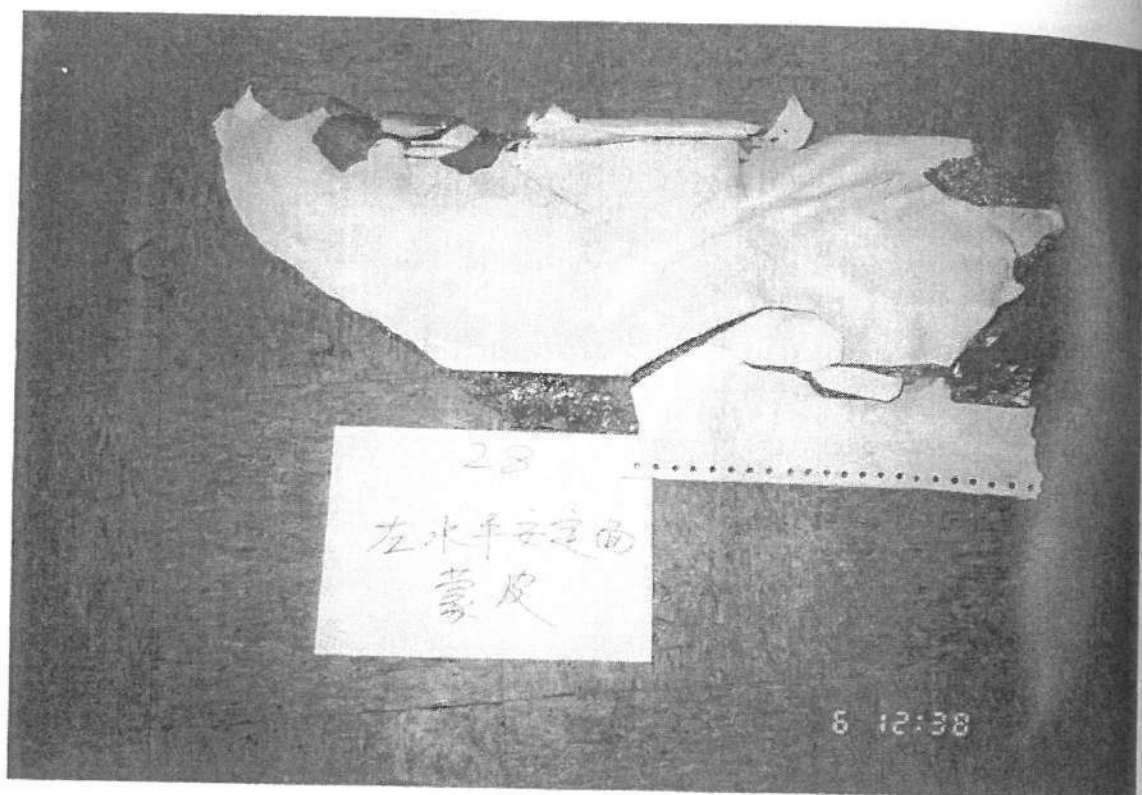
28. SKIN OF LH HORIZONTAL STABILIZER
左水平安定面蒙皮

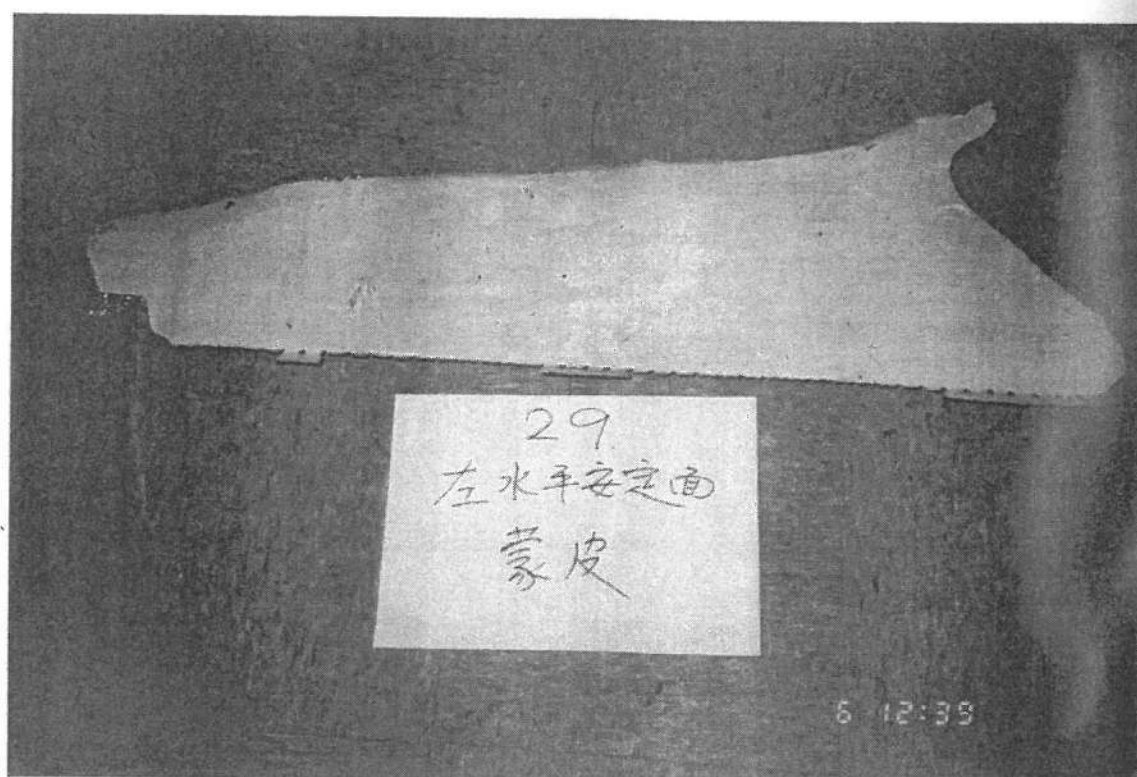
29. SKIN OF LH HORIZONTAL STABILIZER
水平安定面蒙皮

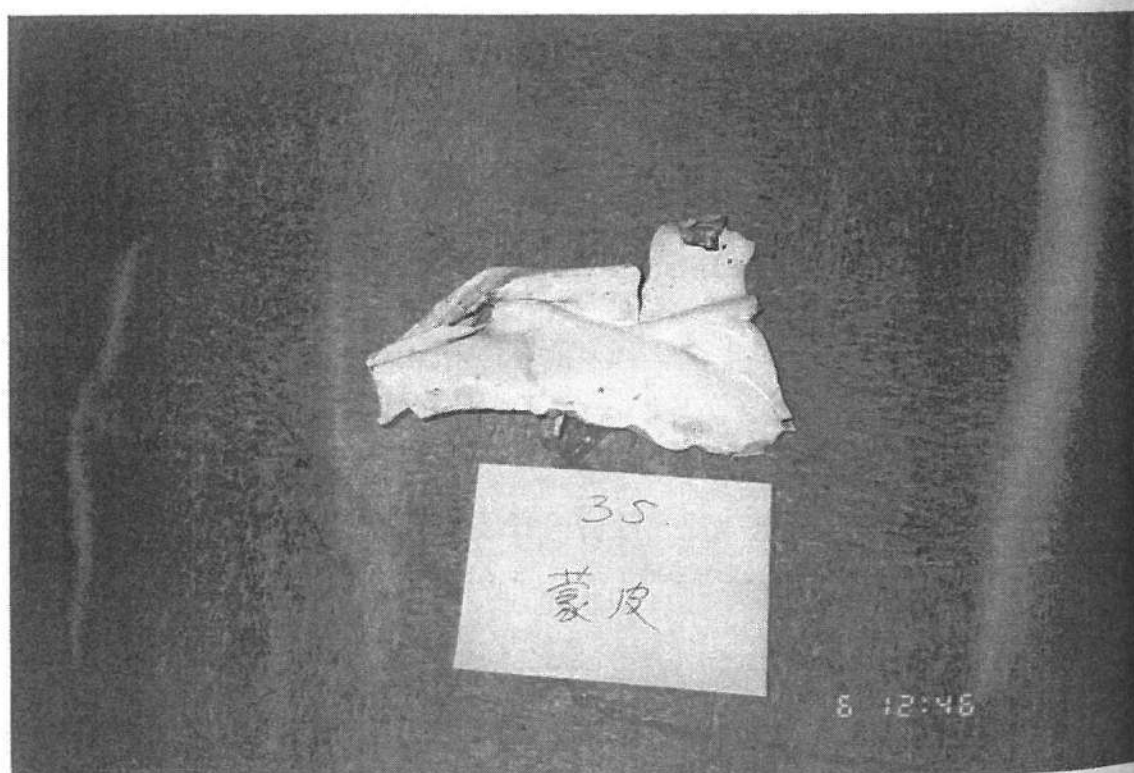
35. SKIN
蒙皮

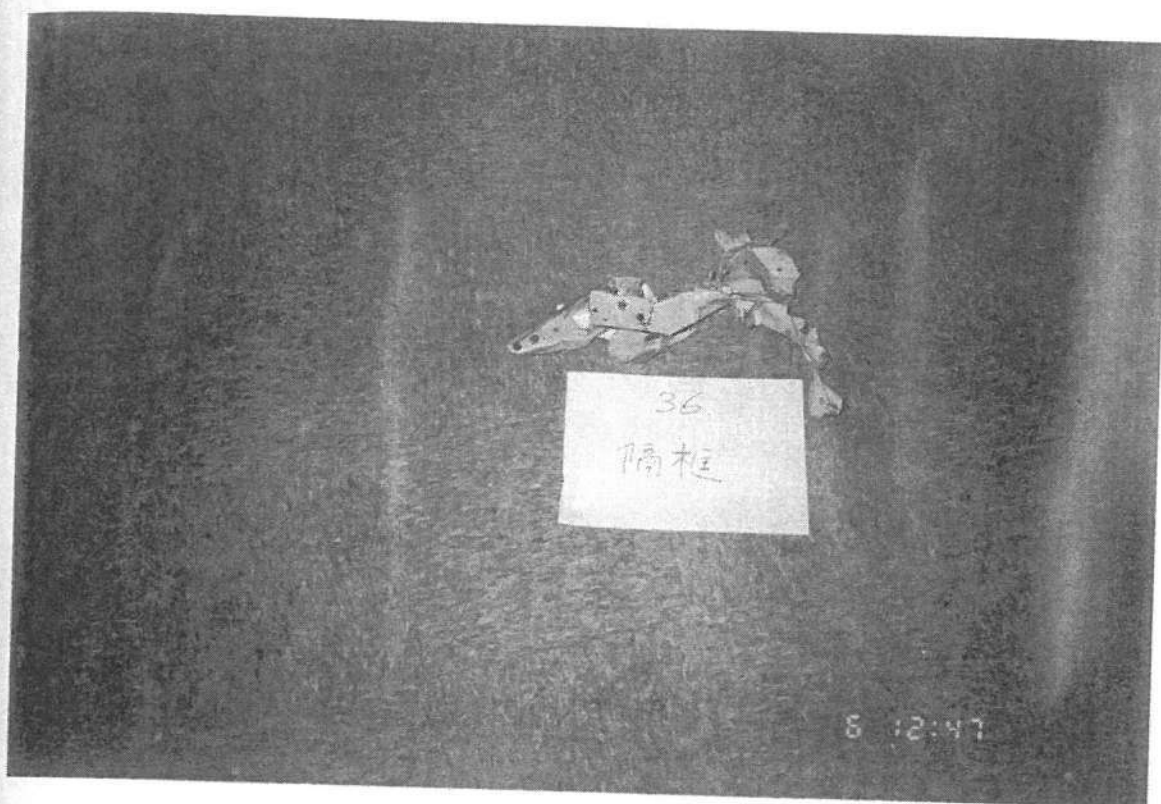
36. FRAME
